NOTICE OF VIOLATION

INSPECTION REPORT

Electrical Corporation:	Pacific Gas and Electric Company
Report Number:	CAD_PGE_IAG_20250129_1617
Inspector:	Ivan Garcia
WMP Year Inspected:	2024
Quarterly Data Report (QDR) Referenced:	Quarter 2 (Q2)
Inspection Selection:	Energy Safety viewed the contents of the Q2 QDR and performed an analysis that resulted in the selection of the WMP initiatives and locations referenced in this report.
Relevant WMP Initiative(s):	8.1.2.1 -Covered Conductor Installation - Distribution
Date of inspection:	January 29, 2025
City and/or County of Inspection:	Cool, El Dorado County
Inspection Purpose:	Assess the accuracy of PGE’s QDR data, completeness of its work, compliance with WMP requirements, and compliance with its protocols.

Exhibit A: Photo Log

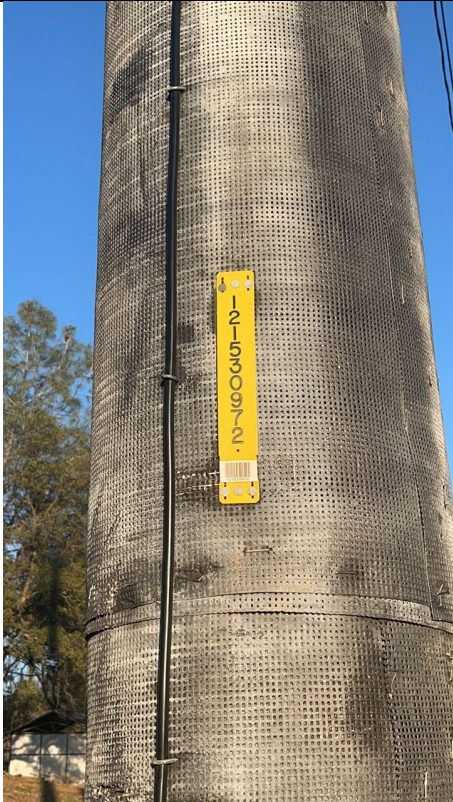
Structure ID: 121530972

A photograph showing a utility pole in a rural setting. The pole is made of wood and has several power lines attached to it. A white transformer is mounted on the pole. In the foreground, there is a wooden fence and a grassy area. The background consists of trees and a clear blue sky.
<p>Item1Gimg1: Pole ID</p>	<p>Item1Gimg2: Overall pole</p>

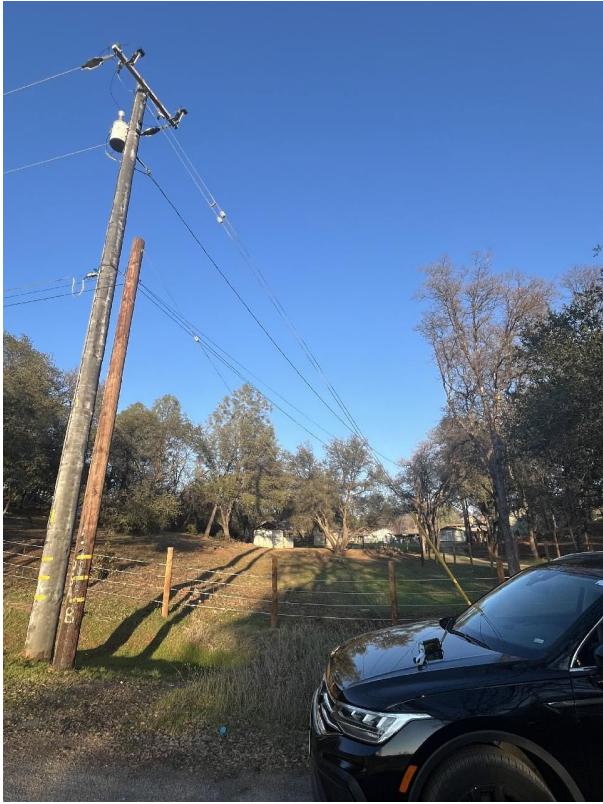
On pole ID 121394336, Grid Hardening ID 35293673 at 2344-2350 Talking Pines Ct, Cool, CA, 95614, USA, 38.896734279315865, -121.00891927372464, the inspector observed no covered conductor installation on the pole east of pole ID 121530972. The inspector's observation is documented in Violation 1 photographs, which are attachments to this report. Photo numbers Item1IA1Img1, Item1IA1Img2, depict no covered conductor installation. PG&E reported that work on WMP initiative 8.1.2.1 -Covered Conductor Installation – Distribution was completed at this location.

1. PG&E reported that covered conductor was installed east of pole ID 121530972 in PG&E's 2024 Q2 QDR data.
2. Covered conductor was not installed east of pole ID 121530972.
3. A secondary distribution line and a secondary service pole were observed at this location, east of pole ID 121530972.

Item1IA1img1: No covered conductor installed east of pole 121530972

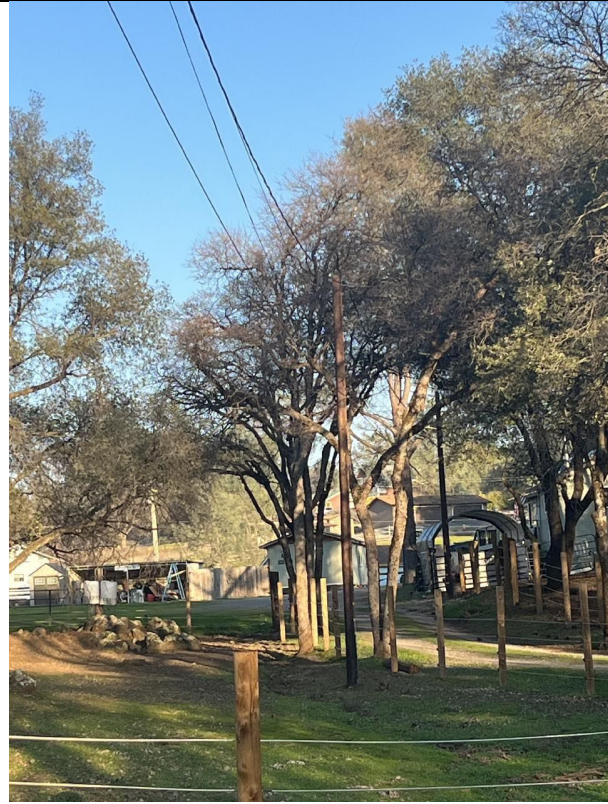
Item1IA1img2: Pole east of 121530972 was observed as a secondary service pole.
