**CALIFORNIA UNDERGROUND SAFETY BOARD  
INVESTIGATION DIVISION**

**INVESTIGATION REPORT**

**Case No.:** N250371836

On December 20, 2024, Modern Muse Construction was working a jobsite without first contacting the regional notification center and, with a shovel, damaged a 1.5” plastic natural gas line, while cutting roots. Upon the escape of natural gas from the subsurface installation, Modern Muse Construction did not call 911 emergency services to report it. No one was injured and no equipment, other than the 1.5” plastic natural gas line, was damaged.

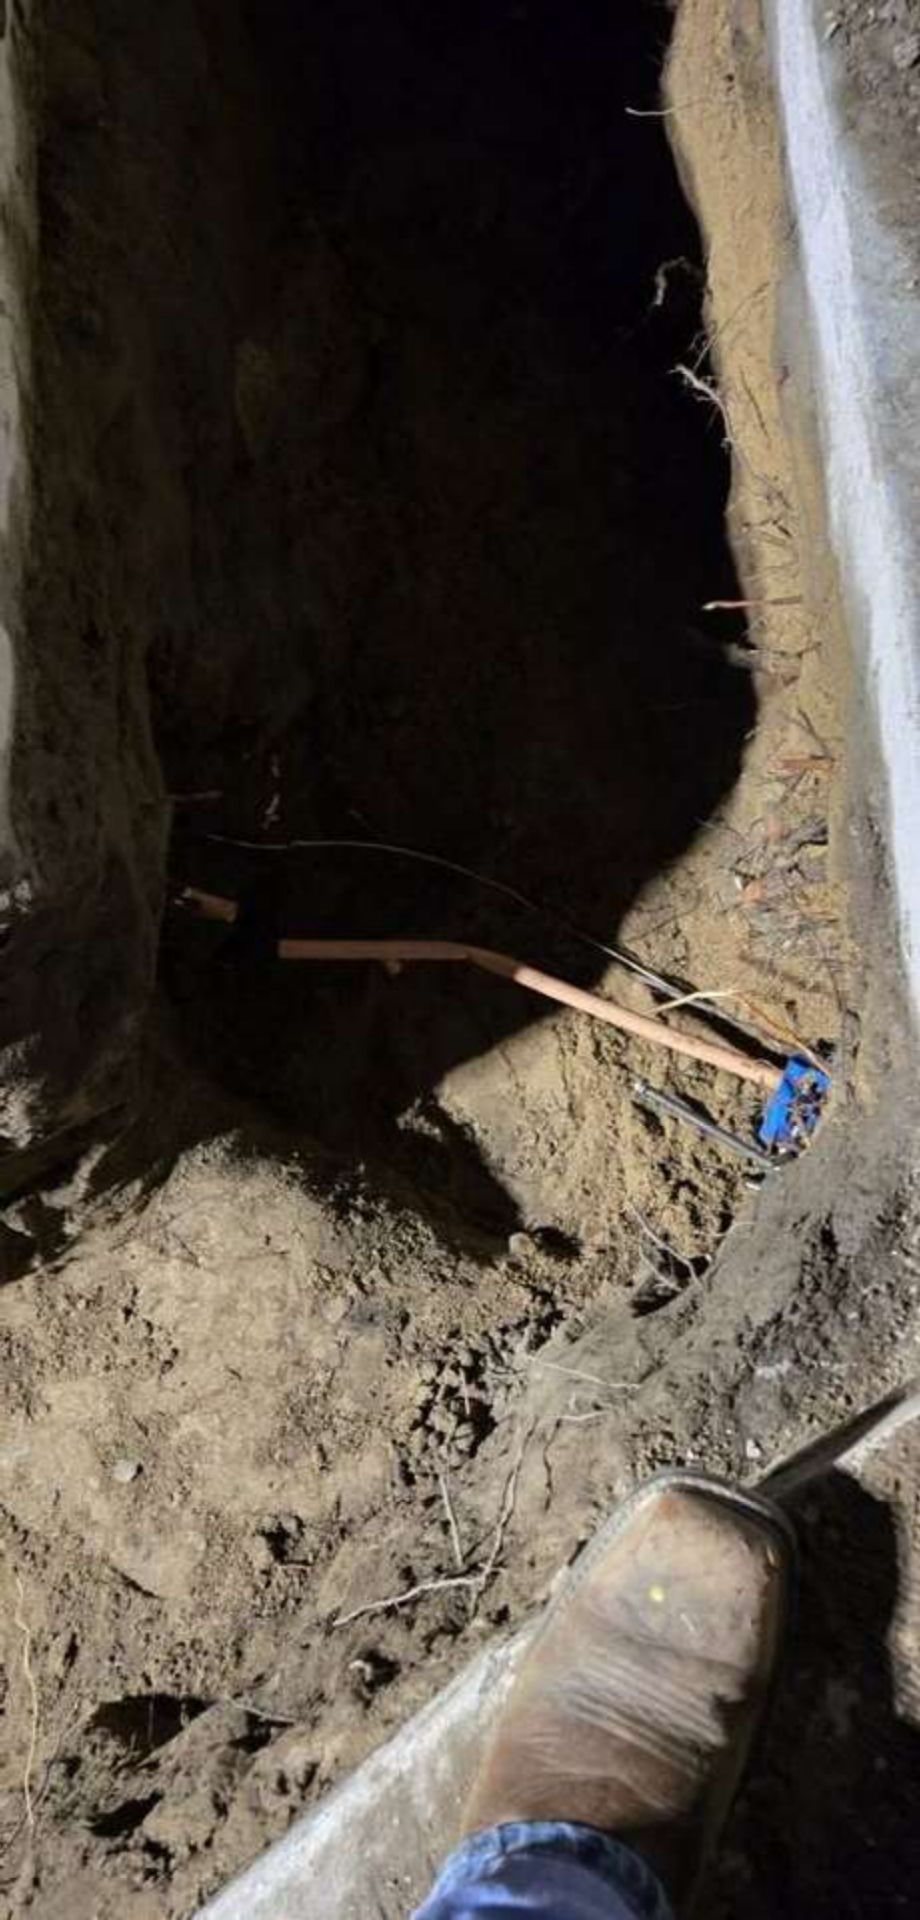
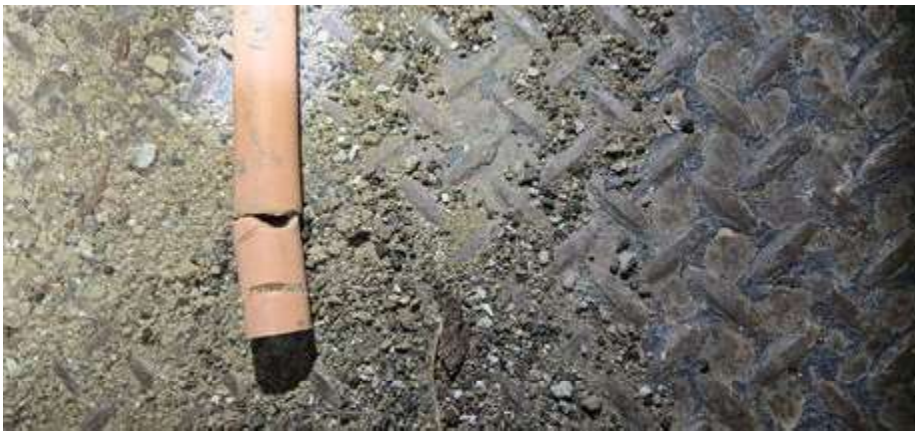
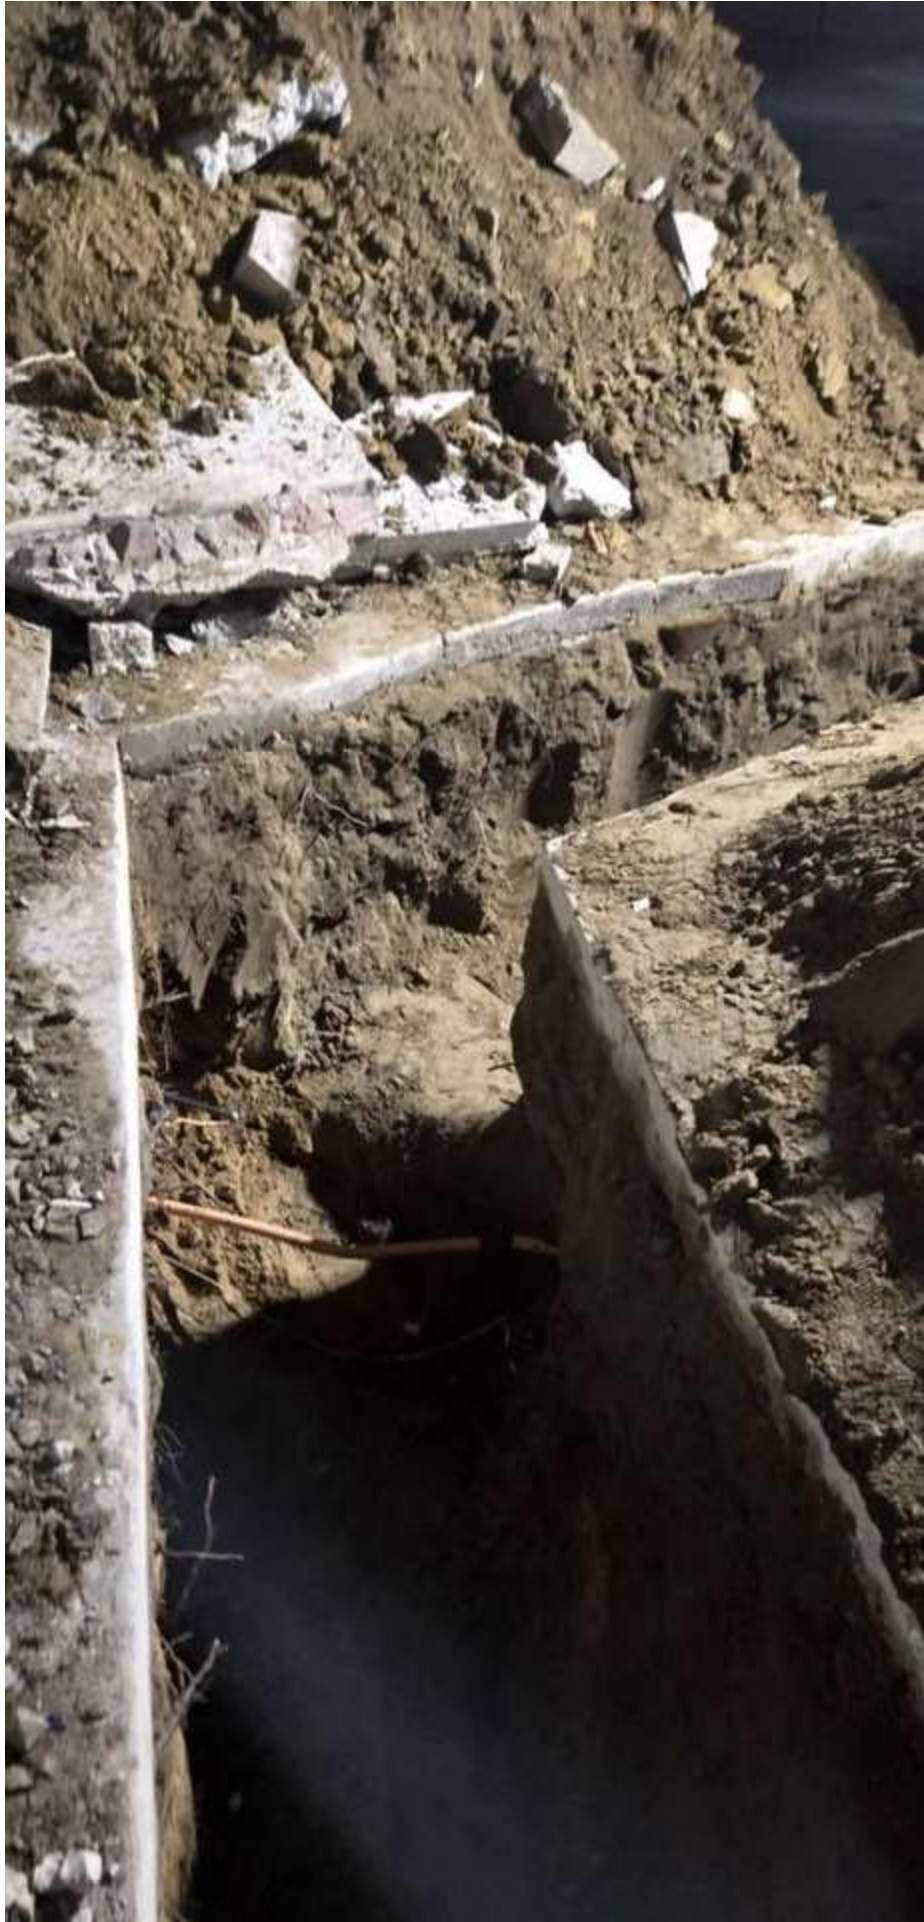
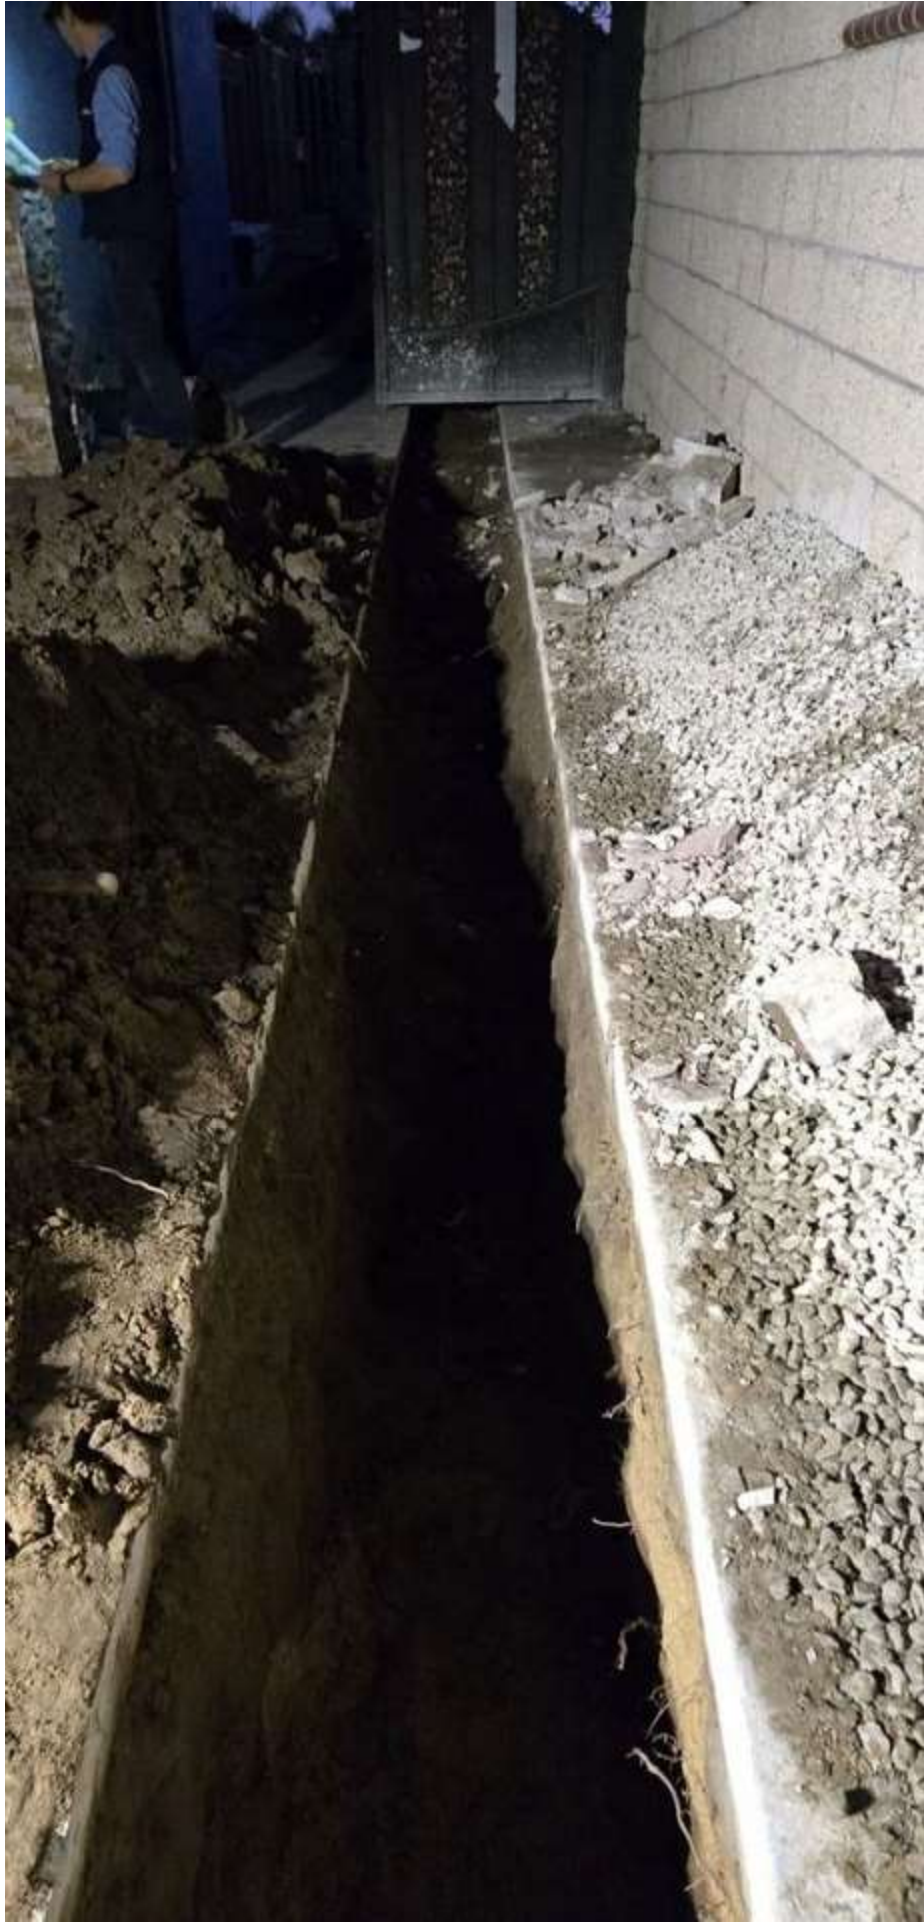
Please attach all Photos.

The damage on our ½ IPS looks like it was cut into when they were cutting a root out. Then they completely cut our plastic service so they can fold it back to control the leak. Their trench is for a sewer line from the back house being built.

If they had called USA they would have known there was a service line below the roots they were cutting

Found 1/2 IPS service cut through and bent back and tied with wire
