NOTICE OF DATA INACCURACY

INSPECTION REPORT

Electrical Corporation:	Liberty Utilities
Report Number:	CAD_LU_CYA_20250507_1252
Date of inspection:	May 7, 2025
City and/or County of Inspection:	Tahoma, El Dorado County
Inspector:	Cecilia Yaniz
WMP Year Inspected:	2024
Quarterly Data Report (QDR) Referenced:	Quarter 4 (Q4)
Inspection Selection:	Energy Safety viewed the contents of the Q4 QDR and performed an analysis that resulted in the selection of the WMP initiatives and locations referenced in this report.
Relevant WMP Initiative(s):	8.1.2.3 - Distribution pole replacements and reinforcements
Inspection Purpose:	Assess the accuracy of Liberty Utilities' QDR data, completeness of its work, compliance with WMP requirements, and compliance with its protocols.

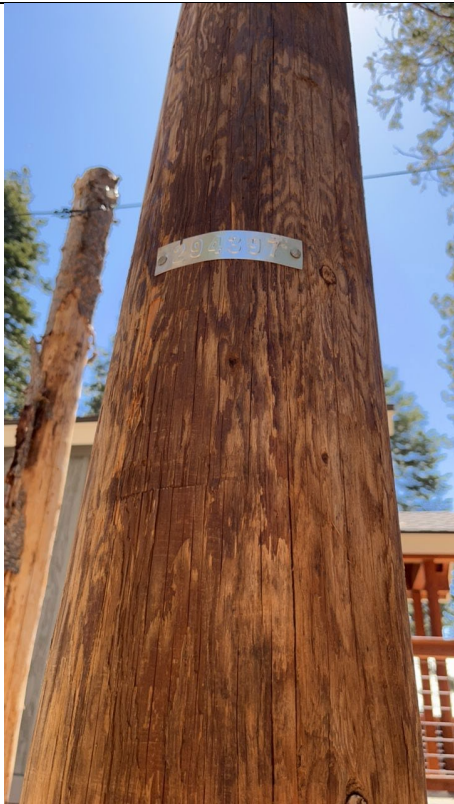
On Pole ID 294397, Grid Hardening ID 61c86ed2-76b7-480f-95ed-d0b3022e780d at 7231 8th Ave, Tahoma, CA, 96142, USA, 39.0593325099474, -120.131907314726, the inspector observed that a new pole was installed at this location. The inspector's observation is documented in Data Inaccuracy 1 photographs, which are attached to this report as Item1GImg1. In the 2024 Q4 Quarterly Data Report submission, LU reported that work on WMP initiative 8.1.2.3 - Distribution pole replacements and reinforcements were completed at this location on Pole ID 294397, Grid Hardening ID 61c86ed2-76b7-480f-95ed-d0b3022e780d.

1. There was no existing distribution pole at this point to replace or reinforce.
2. A new distribution pole was installed.
3. Nearby residents stated that the pole was installed within the last year.

A photograph showing a tall, slender wooden utility pole standing in a wooded area. The pole is light brown and appears to be newly installed. In the background, there are several tall evergreen trees and a portion of a wooden building with a corrugated metal roof. The ground is covered with dry leaves and pine needles.

A close-up photograph of the wooden utility pole. A white identification tag with the number '294397' is attached to the pole. The wood is weathered and shows some signs of decay. A power line is visible running across the pole.
Item1GImg1: Overall Pole; New installation	Item1GImg2: Pole ID

Within 30 days from the issuance date of this NODI, LU should provide a response advising Energy Safety of corrective actions taken or planned to remedy the identified data inaccuracy or inaccuracies.
