NOTICE OF NON-PERFORMANCE

INSPECTION REPORT

| Report Number: | NON_ESD_PGE_RGA_20250407_1543 |

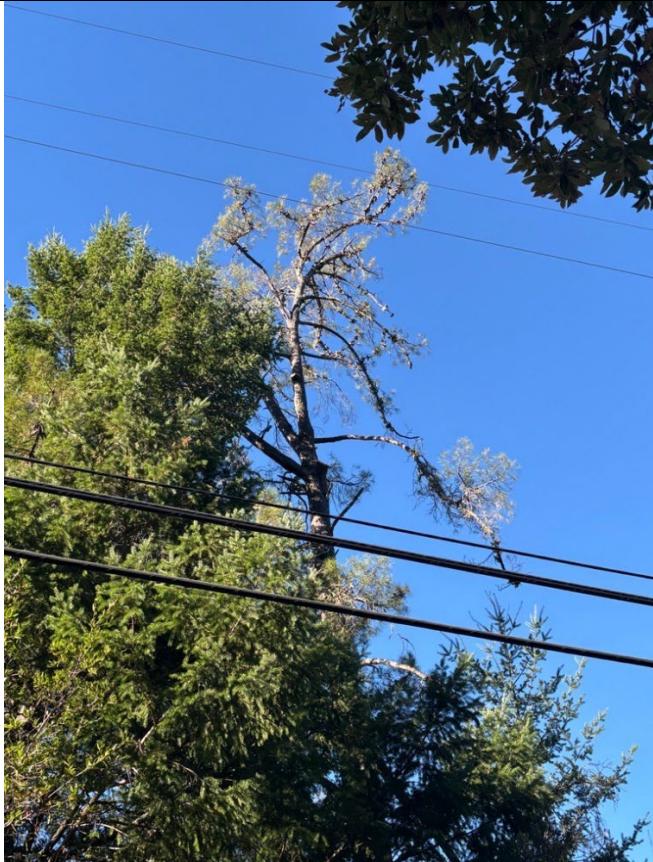
On April 7, 2025, Energy Safety conducted an inspection of PG&E's WMP initiatives in the vicinity of Santa Cruz, California. During the inspection, Energy Safety identified a declining pine tree located within striking distance of the conductors near support structure ID 101681244 and coordinates 37.043816652372, -122.108385937438 along Empire Grade Road. This initial finding was reported to PG&E via E-mail on April 29, 2025 as a Wildfire Safety Concern (WSC). In response, PG&E prescribed full removal of the tree on May 5, 2025 under RX-04749736, with a required removal deadline of October 2, 2025, in accordance with the 180-day removal timeframe specified in PG&E's WMP initiative number 8.2.2.2.2. On December 12, 2025, Energy Safety conducted a follow-up inspection and confirmed that the tree had not been removed. As of the December 12, 2025 inspection, 221 days had elapsed since the prescription date of May 5, 2025, exceeding the removal deadline. The inspector's observation is documented in photos 1 and 2, which are exhibits to this report.

Photo 1: Photo of declining pine tree taken during the inspection on December 12, 2025.

Deficiency 1. Energy Safety observed that in implementing 2025 WMP initiative 8.2.2.2.2 Distribution Second Patrol (VM-17) near coordinates 37.043816652372, -122.108385937438, PG&E failed to adhere to its protocol of removing dead, declining or dying trees within 180 days of identification. Energy Safety considers this non-performance to be in the Moderate risk category. PG&E must complete a corrective action for this non-performance by two months from the date of this notice.¹

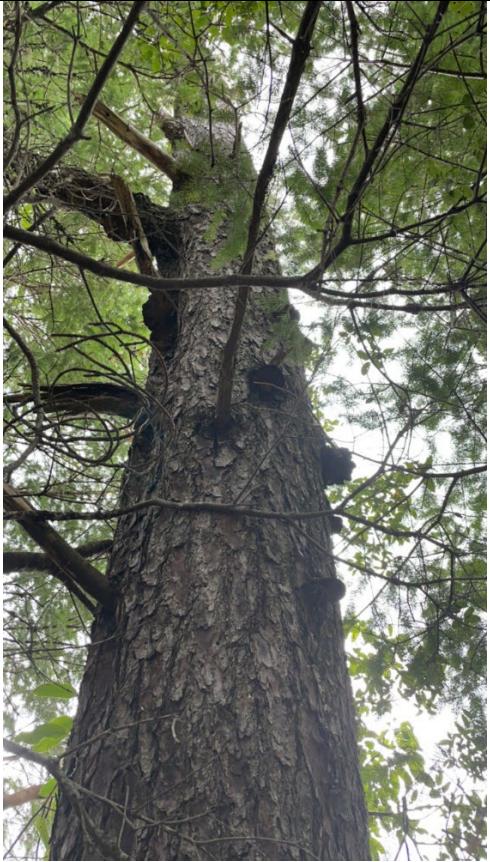
Photo 2: Photo of conks along the trunk of declining pine taken during the inspection on April 7, 2025.
