NOTICE OF NON-PERFORMANCE

INSPECTION REPORT

Deficiency 1

Structure ID: 121820742

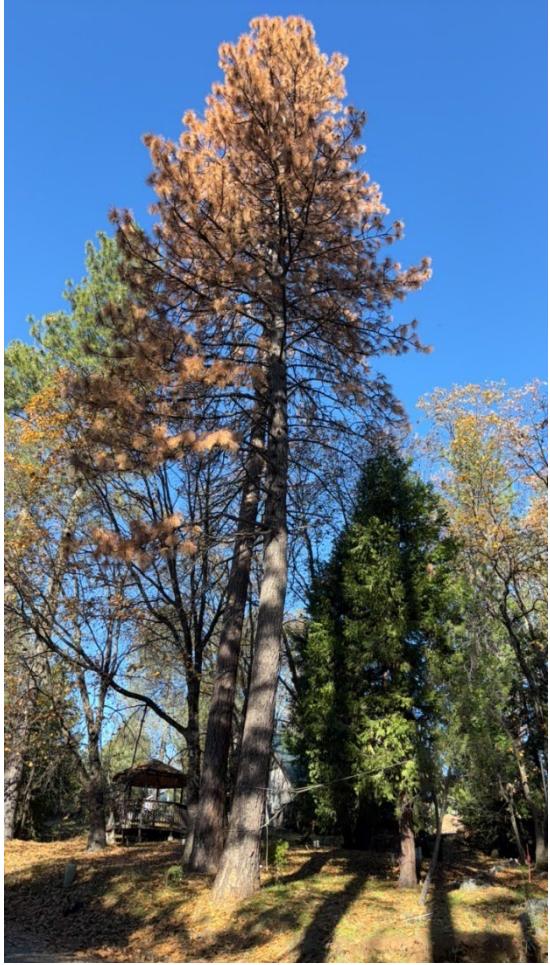
On December 9, 2025, Energy Safety conducted an inspection of PG&E's WMP initiatives in the vicinity of Pioneer, California. During the inspection, Energy Safety identified two dying pine trees near support structure ID 121820742 and at coordinates 38.4315548168236, -120.5783171065 along Golden Circle Drive. These initial findings were reported to PG&E via email on December 19, 2025 as Wildfire Safety Concerns (WSCs). In response, PG&E informed Energy Safety that it had prescribed full removal of one of the trees on July 11, 2025 under RX-05669471 and the second on December 22, 2025 under RX-06681045. On January 9, 2025, Energy Safety conducted a follow-up inspection and confirmed that neither of the trees had been removed. The inspector's observations are documented in photos 1, 2, and 3, which are exhibits to this report.

<p>Photo 1: Photo of two dying pine trees during the inspection on December 9, 2025.</p>	<p>Photo 2: Photo of the same dying pine trees during the inspection on January 9, 2026.</p>

Deficiency 1. Energy Safety observed that in implementing its 2025 WMP initiative 8.2.2.2, which requires compliance with Public Resources Code section 4293, PG&E failed to remove two dead, declining or dying trees near coordinates 38.4315548168236, -120.5783171065. Energy Safety considers this non-performance to be in the Moderate risk category. PG&E must complete corrective actions for this non-performance by six months from the date of this notice.¹

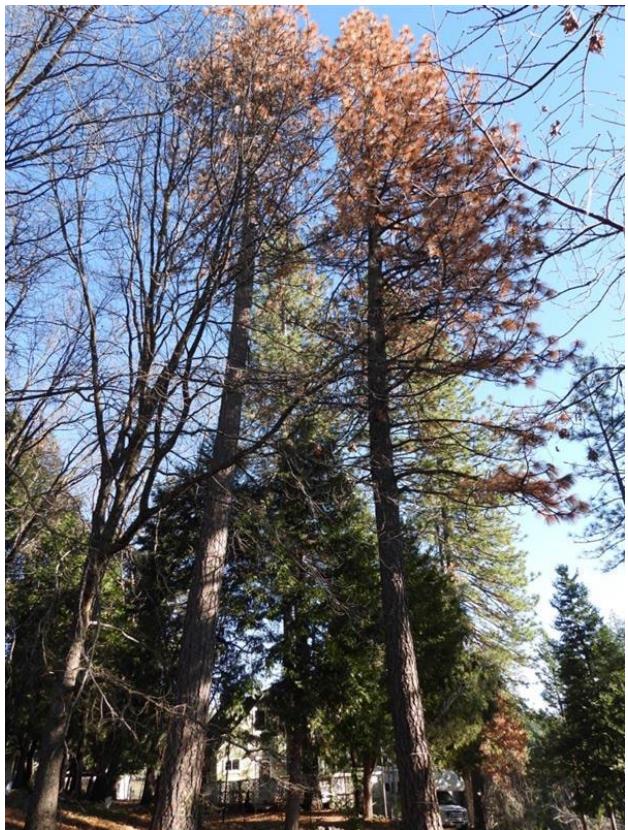
Photo 3: Photo of the dying pine trees during the inspection on January 9, 2026.
