RE: Energy Safety ID: CAD_PGE_CYA_20250116_1153
Notice of Violation: Government Code § 15475.1 and the California Code of Regulations, Title 14, Division 17 § 29302(b)(2)

This letter is in response to the above referenced Notice of Violation (NOV) dated March 21, 2025, (NOV Letter) regarding the Office of Energy Infrastructure Safety (Energy Safety) inspection of Pacific Gas and Electric Company's 2024 Wildfire Mitigation Plan Initiatives in the vicinity of the city of Jackson, California in HFTD Tier 2 on January 16th, 2025.

Violation 1. Energy Safety observed that in implementing 2024 WMP initiative 8.1.2.10.5 – Non-Exempt Expulsion Fuses, PG&E failed to complete work on pole ID 121702867, Grid Hardening ID 31658288, at coordinates 38.36037254723159, -120.76546862422926. Energy Safety considers this completeness violation to be in the Minor risk category.

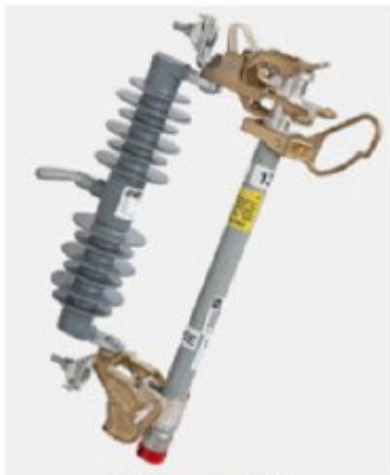
Figure 16
Part 63H

The exempt fuses are shown hanging on the poles steps and conform to PG&E guidance document 15225 (1.C.1) for care and handling of Type E Power fuses. As shown in Image 1 and Image 2 below, both the Part63H cutout and the Type E Power Fuse have distinct features that distinguish them from Part 44H cutouts and the non-exempt universal fuses they can accept. Part63H cutouts are noticeably larger than Part 44H cutouts, and the Type E Power Fuses have an oblong ring to support installation and removal. Another identification characteristic is the cap installed on the bottom of the fuse and the absence of a visible fuse element exiting the fuse holder.

Image 1: Part 63H cutout with CalFire Exempt Type E Power fuse (Labeled Figure 16)

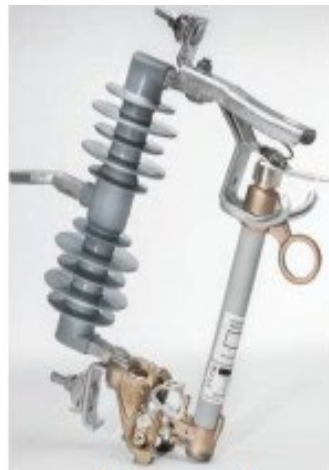
Figure 1
Parts 44H and 44HSB

Image 2: Part 44H Cutout with Non-Exempt Universal Fuse (Labeled Figure 1)

In contrast, Part 44H cutouts are smaller than Part 63H, and universal fuses have a round pull ring and a visible fuse element visible existing at the bottom of the fuse holder. The excerpt below details the care and handling of Type E power fuses.

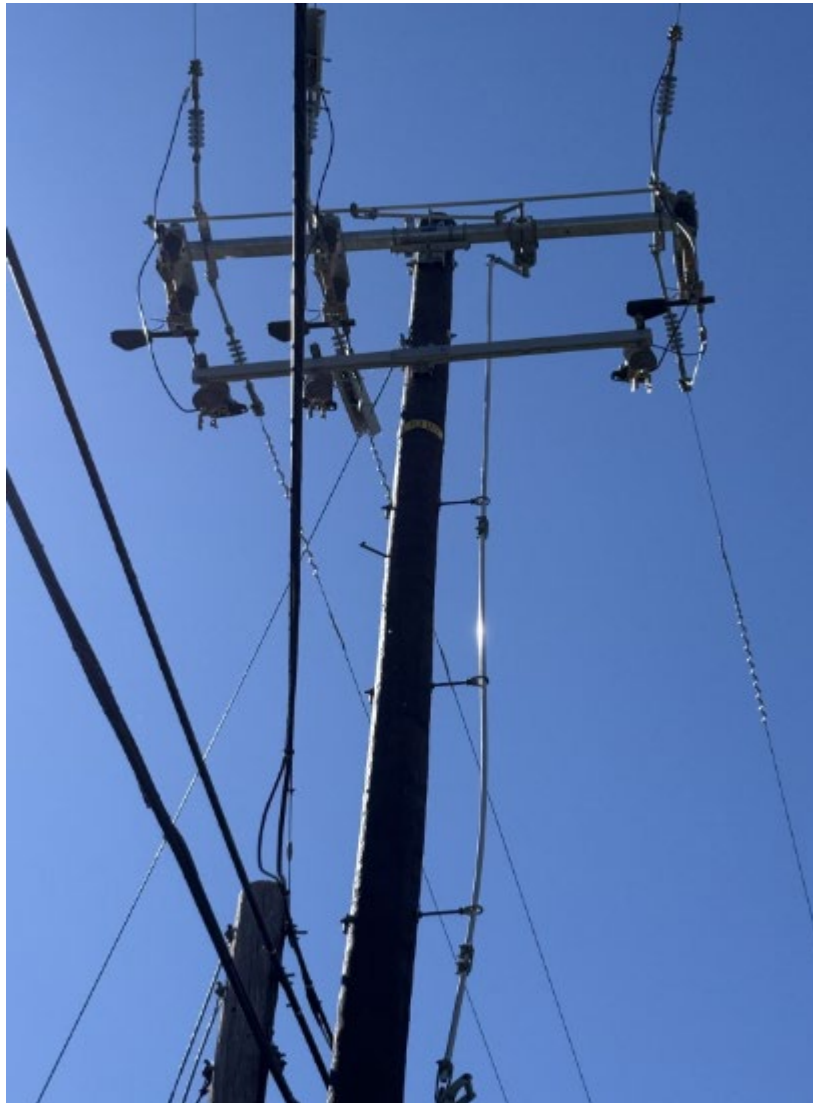
Please see the photo evidence below for removal of CalFire Exempt fuses from the pole step.

The storage practice of hanging fuses on pole steps is not a component of the GH-10 commitment. During a consultation with Energy Safety on March 4, 2026, PG&E voluntarily decided to remove the fuses from the pole steps to initiate a testing protocol to confirm that the fuses are not compromised by water ingress and therefore storing them on pole steps is appropriate, when desired. As communicated to Energy Safety, we believe the storage of the fuses on the pole steps is safe and compliant with our standards; this testing protocol will enable us to demonstrate this storage method is appropriate. Once testing and analysis are complete, PG&E will update Energy Safety on the results of the testing and any forthcoming changes to future operations or guidance documents.
