RE: Energy Safety ID: CAD_PGE_BKA_20250116_1052
Notice of Violation: Government Code § 15475.1 and the California Code of Regulations, Title 14, Division 17 § 29302(b)(2)

This letter is in response to the above referenced Notice of Violation (NOV) dated March 21, 2025, (NOV Letter) regarding the Office of Energy Infrastructure Safety (Energy Safety) inspection of Pacific Gas and Electric Company's 2024 Wildfire Mitigation Plan Initiatives in the vicinity of the city of Jackson, California in HFTD Tier 2 on January 16th, 2025.

Violation 1. Energy Safety observed that in implementing 2024 WMP initiative 8.1.2.10.5 - Non-Exempt Expulsion Fuses, PG&E failed to complete work on pole ID 121607030, Grid Hardening ID 31658594, at coordinates 38.364894, -120.651515. Energy Safety considers this completeness violation to be in the Minor risk category.

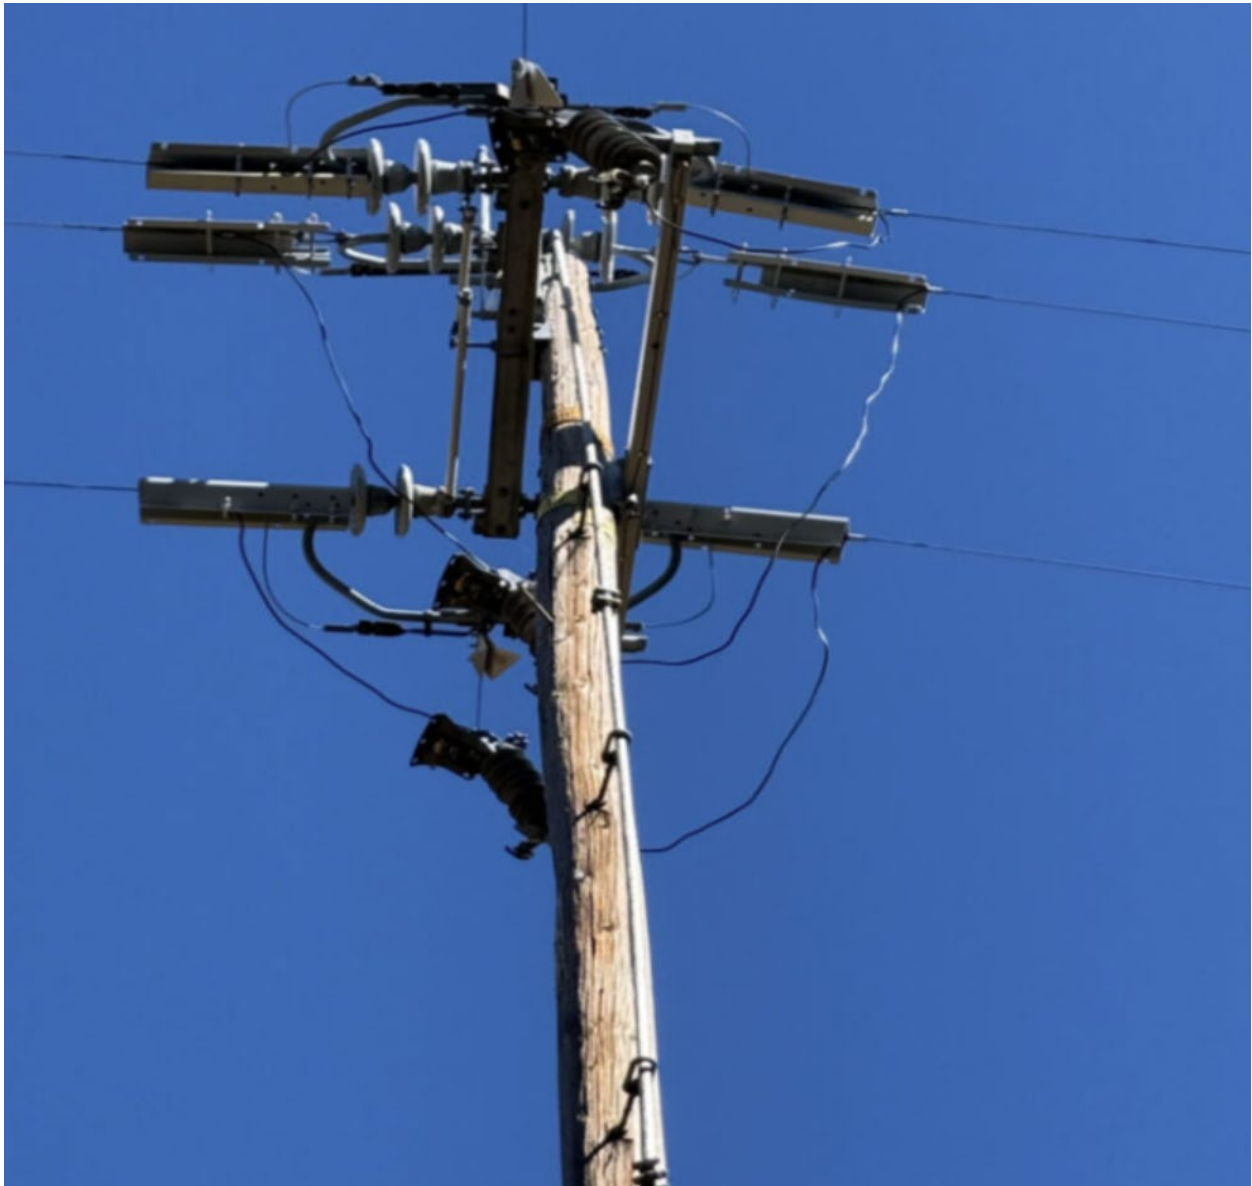
Please see the photo evidence below for the removal of CalFire Exempt fuses from the pole step.

The storage practice of hanging fuses on pole steps is not a component of the GH-10 commitment. During a consultation with Energy Safety on 03/04/2026, PG&E voluntarily decided to remove the fuses from the pole steps to initiate a testing protocol to confirm that the fuses are not compromised by water ingress and therefore storing them on pole steps is appropriate, when desired. As communicated to Energy Safety, we believe the storage of the fuses on the pole steps is safe and compliant with our standards; this testing protocol will enable us to demonstrate this storage method is appropriate. Once testing and analysis are complete, PG&E will update Energy Safety on the results of the testing and any forthcoming changes to future operations or guidance documents.
