RE: Energy Safety ID: CAD\_PGE\_CYA\_20250129\_1053  
Notice of Violation: Government Code § 15475.1 and the California Code of Regulations, Title 14,  
Division 17 § 29302(b)(2)

Violation 1.) Energy Safety observed that in implementing 2024 WMP initiative 8.1.2.10.5 – Non-Exempt Expulsion Fuses, PG&E failed to complete work on pole ID 121262893, Grid Hardening ID 31659207, at coordinates 38.67705798085136, -120.7612152033747. Energy Safety considers this completeness violation to be in the Minor risk category.

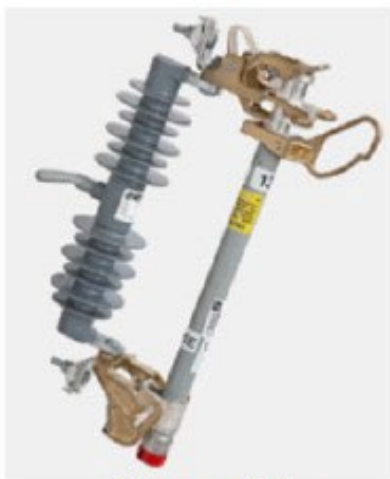
**Figure 16**  
**Part 63H**

The exempt fuses are shown hanging on the poles steps and conform to PG&E guidance document 15225 (1.C.1) for care and handling of Type E Power fuses. As shown in Image 1 and Image 2 below, both the Part63H cutout and the Type E Power Fuse have distinct features that distinguish them from Part 44H cutouts and the non-exempt universal fuses they can accept. Part63H cutouts are noticeably larger than Part 44H cutouts, and the Type E Power Fuses have an oblong ring to support installation and removal. Another identification characteristic is the cap installed on the bottom of the fuse and the absence of a visible fuse element exiting the fuse holder.

*Image 1: Part 63H cutout with CalFire Exempt Type E Power fuse (Labeled Figure 16)*

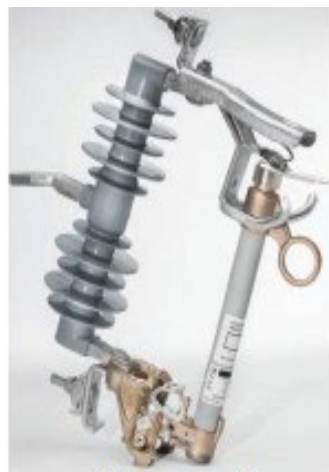
**Figure 1**  
**Parts 44H and 44HSB**

*Image 2: Part 44H Cutout with Non-Exempt Universal Fuse (Labeled Figure 1)*

In contrast, Part 44H cutouts are smaller than Part 63H, and universal fuses have a round pull ring and a visible fuse element visible existing at the bottom of the fuse holder. The excerpt below details the care and handling of Type E power fuses.

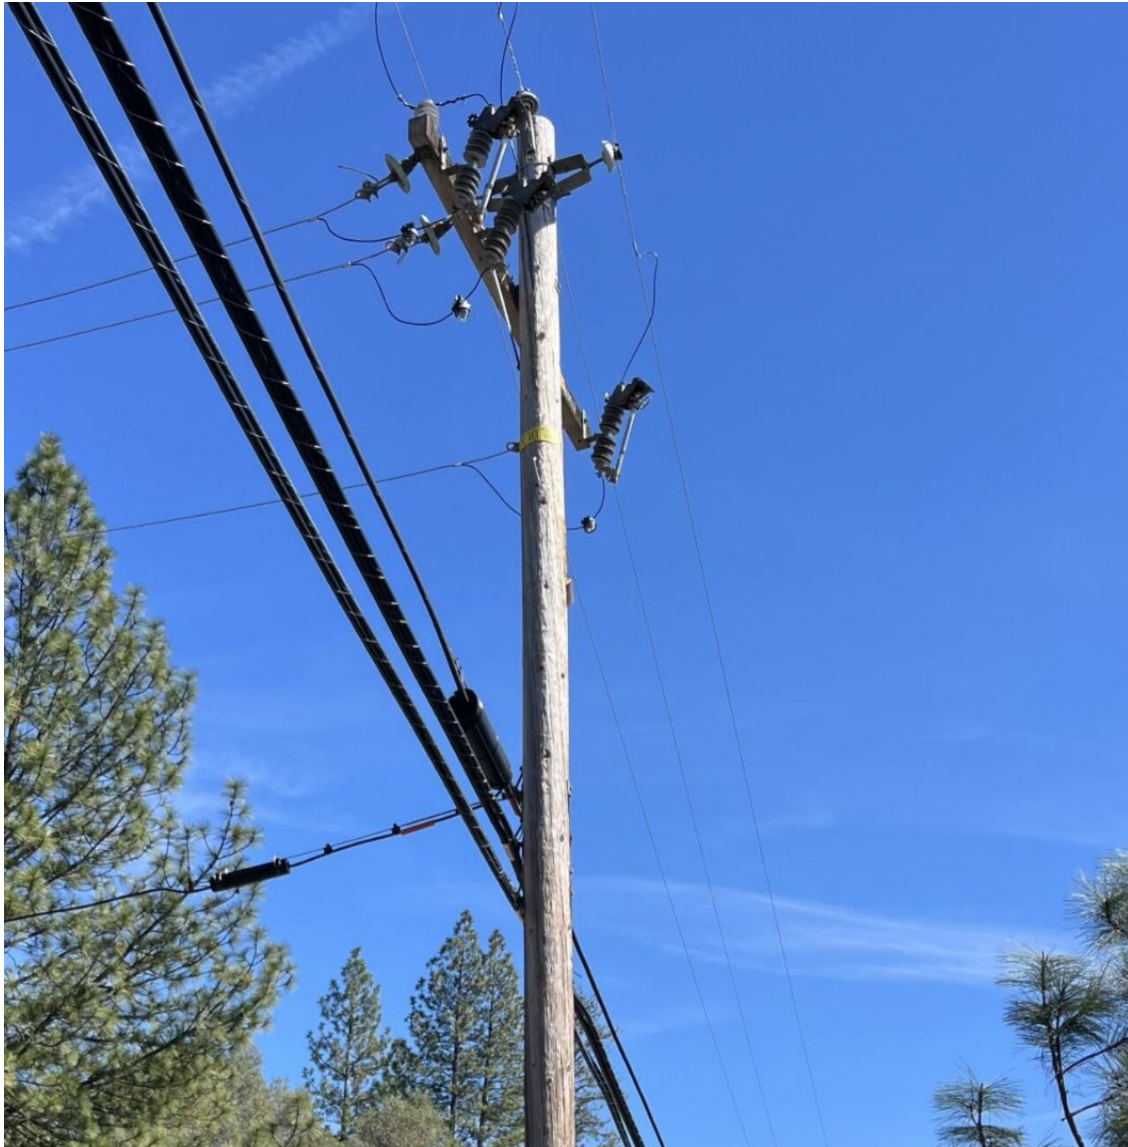
Please see the photo evidence below for the removal of the CalFire Exempt fuse from the pole step.

The storage practice of hanging fuses on pole steps is not a component of the GH-10 commitment. During a consultation with Energy Safety on 03/04/2026, PG&E voluntarily decided to remove the fuse from the pole steps to initiate a testing protocol to confirm that the fuses are not compromised by water ingress and therefore storing them on pole steps is appropriate, when desired. As communicated to Energy Safety, we believe the storage of the fuses on the pole steps is safe and compliant with our standards; this testing protocol will enable us to demonstrate this storage method is appropriate. Once testing and analysis are complete, PG&E will update Energy Safety on the results of the testing and any forthcoming changes to future operations or guidance documents.
