**RE: San Diego Gas & Electric Company's Response to Notice of Non-Performance –
NON_ESD_SDGE_RGA_20260210_1149**

I. SDG&E RESPONSE**A. Deficiency 1 – Pole Clearing, Failure Remove All Vegetation Down to Bare Mineral Soil Within A 10-Foot Radius of Pole ID P249734**

NON_ESD_SDGE_RGA_20260210_1149

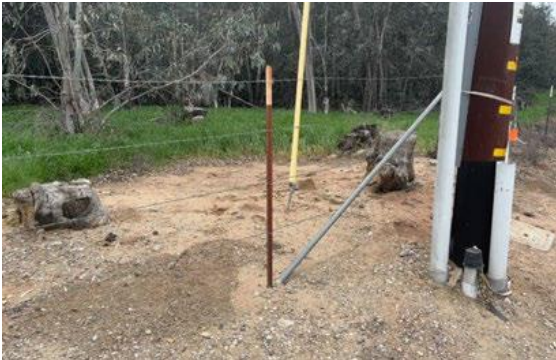
P249734 – Before

Deficiency 1. Energy Safety observed that in implementing 2025 WMP initiative 8.2.3.1 Pole Clearing (WMP.512), which requires compliance with Public Resources Code section 4292, SDG&E failed to remove all vegetation down to bare mineral soil within a 10-foot radius of pole ID P249734, near coordinates 33.01475, -116.86707. Energy Safety considers this non-performance to be in the Moderate risk category. SDG&E must complete a corrective action for this non-performance by six months from the date of this notice.

Please see attached pdf document titled, “NON_ESD_SDGE_RGA_20260210_1149_CAP”. SDG&E is providing the work order documenting the corrective action pole clearing at Pole ID P249734 which was completed on 3/11/26. SDG&E is also providing the before and after photos of the work. Please note in the post-work photo that the dead stumps were removed using a chainsaw as low to the ground as worker safety would allow.

P612226 (YY35993) VMA 393 - Trim 2 large Eucalyptus stumps down to a minimum of 4-inches above ground level.
P249734 (CF328) VMA 393 - Trim 3 large Eucalyptus stumps down to a minimum of 4-inches above ground level.
