CALIFORNIA UNDERGROUND FACILITIES SAFE EXCAVATION BOARD INVESTIGATION DIVISION INVESTIGATION REPORT

CASE No.: 22LA01486

INCIDENT: Landscape contractor excavating holes to plant trees without

Natural Gas 2" plastic main

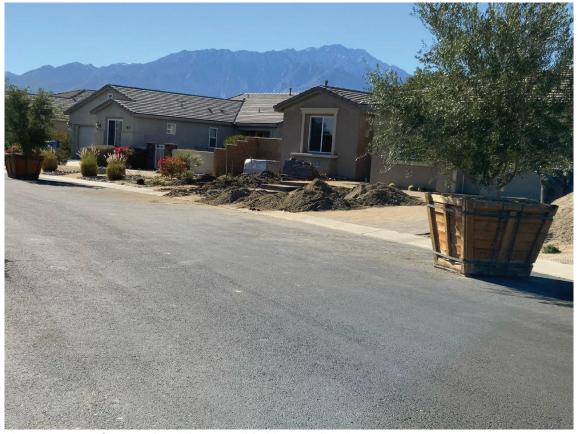
Photo 1 - Area of Excavation (photo provided by SoCal Gas)

Julio Castro (Castro), owner of Desert Concepts Construction, stated during a January 18, 2022 interview (Exh. 3) that his company was hired by the homeowner to do some landscaping including planting trees. He further stated that the trees had been delivered and his employee was instructed to use the heavy equipment (Backhoe) to unload the trees. Castro stated that after the employee unloaded the trees, he began digging a hole with the backhoe to plant the trees. Castro stated that as the employee dug the hole, he hit a 2" gas service line for the property.

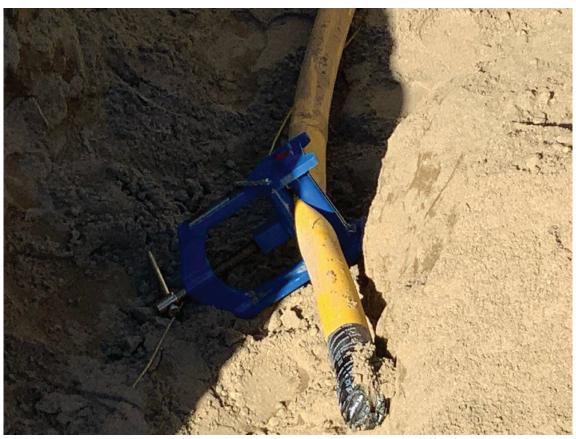
Vega stated that Desert Concepts employees had already tied back one side of the damaged line and pinched the other end by the time she arrived (See Photo -2).

Photo 2 - Gas Line Pinched by Contractor (Photo provided by SoCal Gas)

Vega stated the pinch was not grounded and that tying a line back is not an approved method of stopping the flow of gas. Vega stated that when Desert Concepts owner Julio Castro (Castro) arrived she spoke to him and Guzman at length about the process following a damage and how dangerous it was for them to touch the gas lines and try to control the flow. Vega stated that Castro replied that he has always done this, as he thought it was safer than letting the gas blow.

Vega stated that Desert Concepts employees had already tied back one side of the damaged line and pinched the other end by the time she arrived. Vega stated the pinch was not grounded and that tying a line back is not an approved method of stopping the flow of gas. Vega stated that when Desert Concepts owner Julio Castro (Castro) arrived she spoke to him and Guzman at length about the process following a damage and how dangerous it was for them to touch the gas lines and try to control the flow. Vega stated that Castro replied that he has always done this, as he thought it was safer than letting the gas blow.
