**CALIFORNIA UNDERGROUND FACILITIES SAFE EXCAVATION BOARD  
INVESTIGATION DIVISION  
INCIDENT INVESTIGATION REPORT**

<b>Case Number:</b> 20SA1021	<b>Report Date:</b> April 16, 2020
<b>Subject Name:</b> MGE Underground, AT&T, and Comcast	<b>Notification Date:</b> March 17, 2020

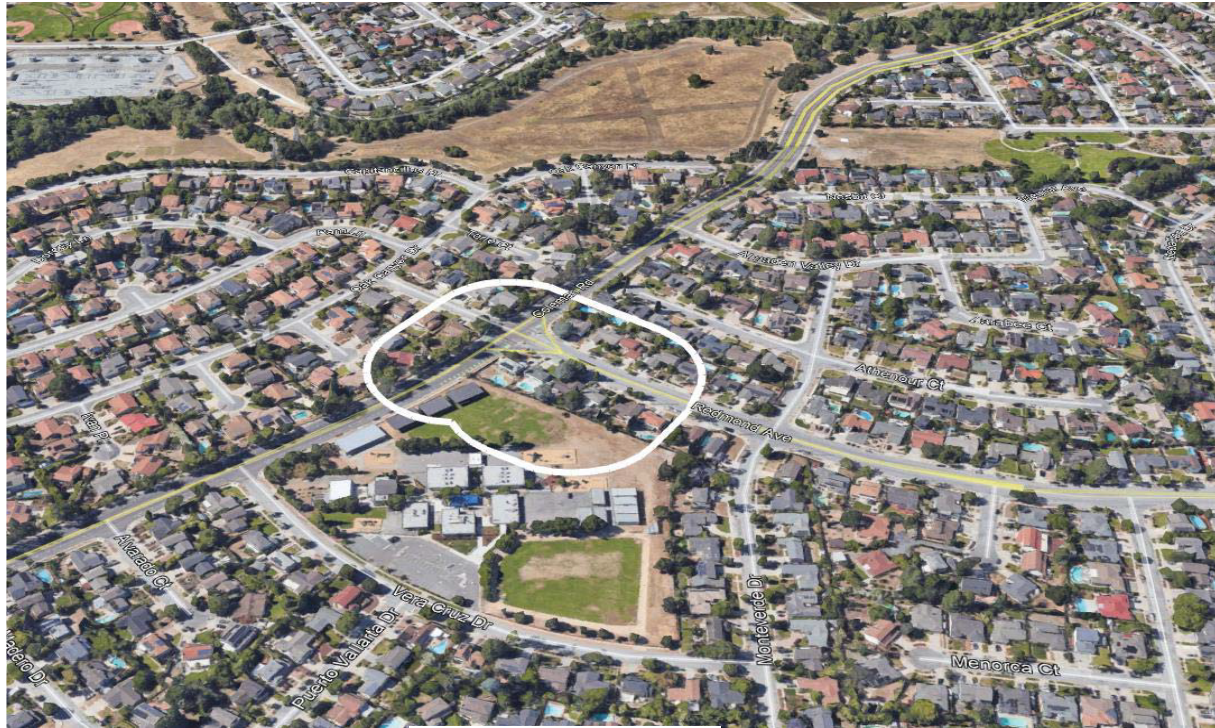
**Scene Description:**

Excavation site was located on [REDACTED] San Jose, California, near the Montevideo and Oak Canyon area of San Jose, in a suburban area. The excavation site is next to Guadalupe Elementary School. (Exhibit 6)
