8  
9 BEFORE THE OFFICE OF ADMINISTRATIVE HEARINGS  
10 OF THE STATE OF CALIFORNIA

11 In the Matter of the Notices of  
12 Violation Against,

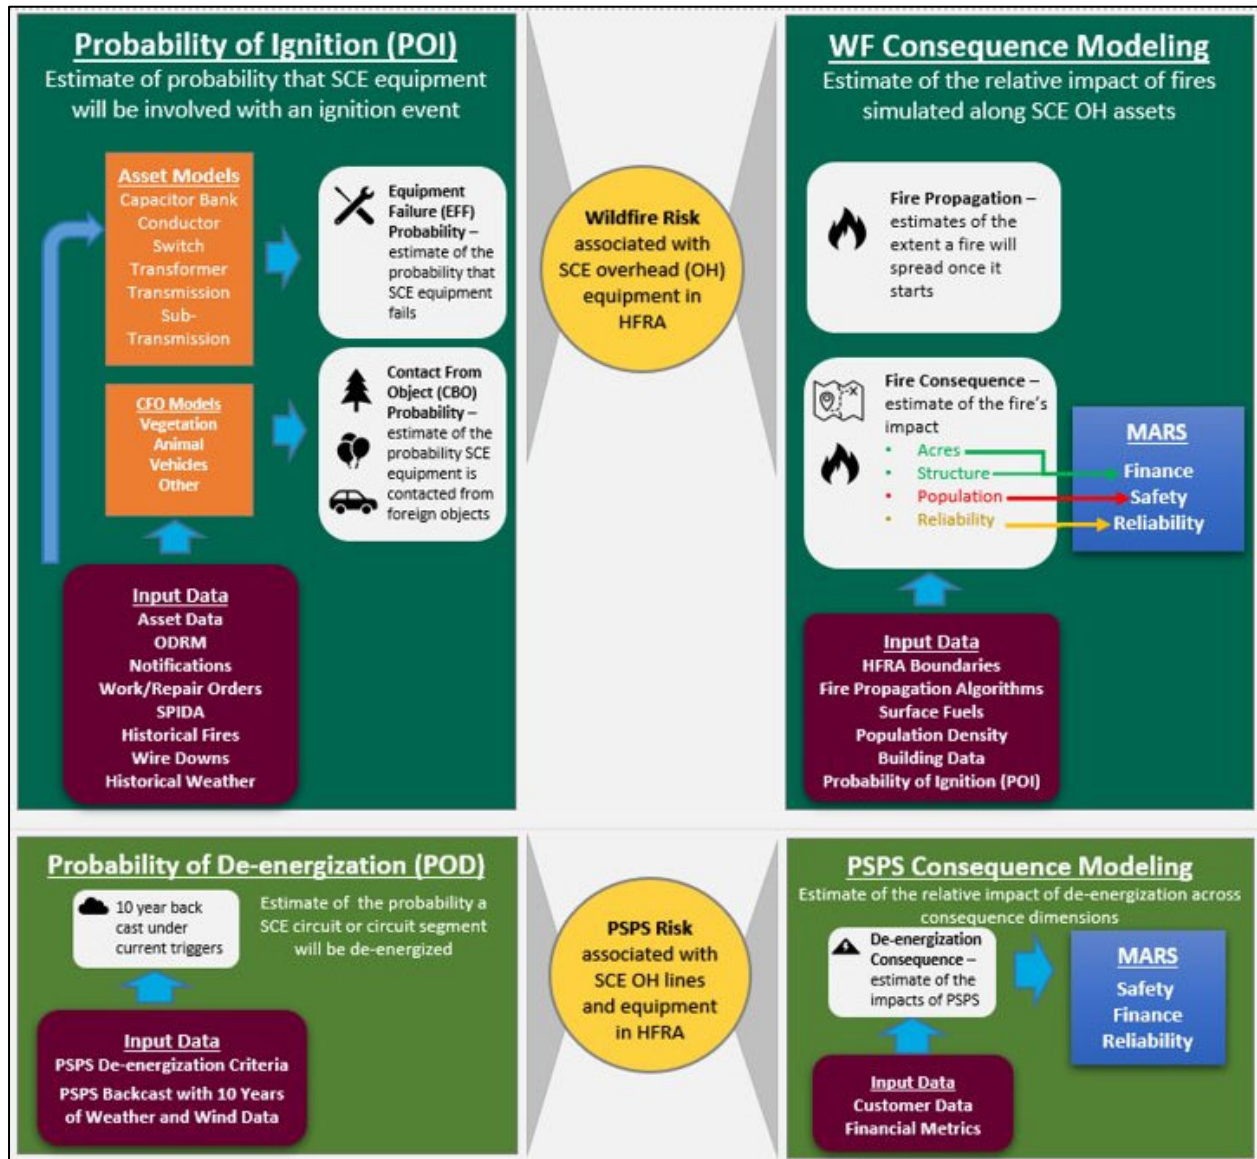
In 2020, SCE transitioned from Reax to Technosylva for its wildfire consequence modeling. Details on the improvements from this transition are described in the sections below.

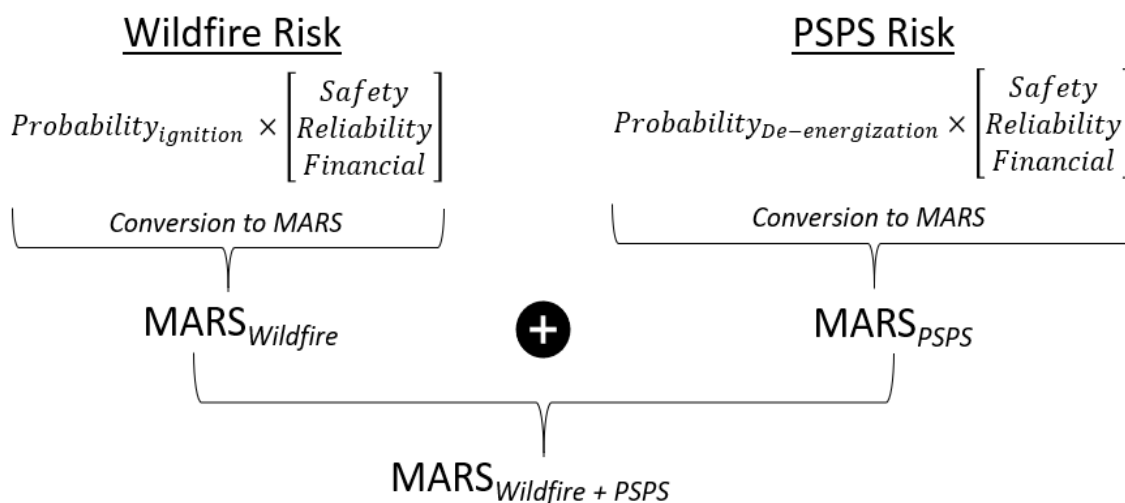
**Figure SCE 4-1  
Wildfire + PSPS Stacked Risk**

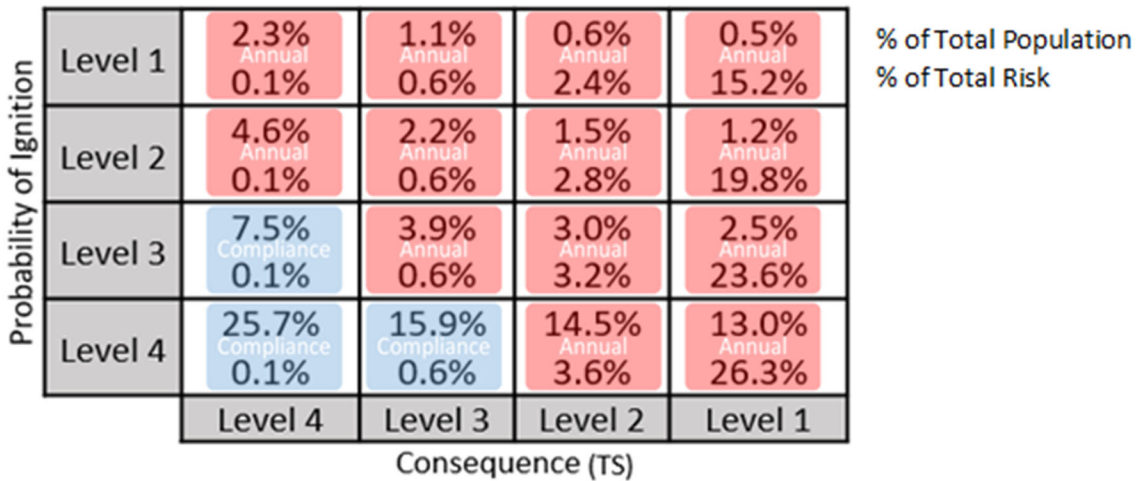
**Figure SCE 7-4  
Visualization of Risk Analysis**

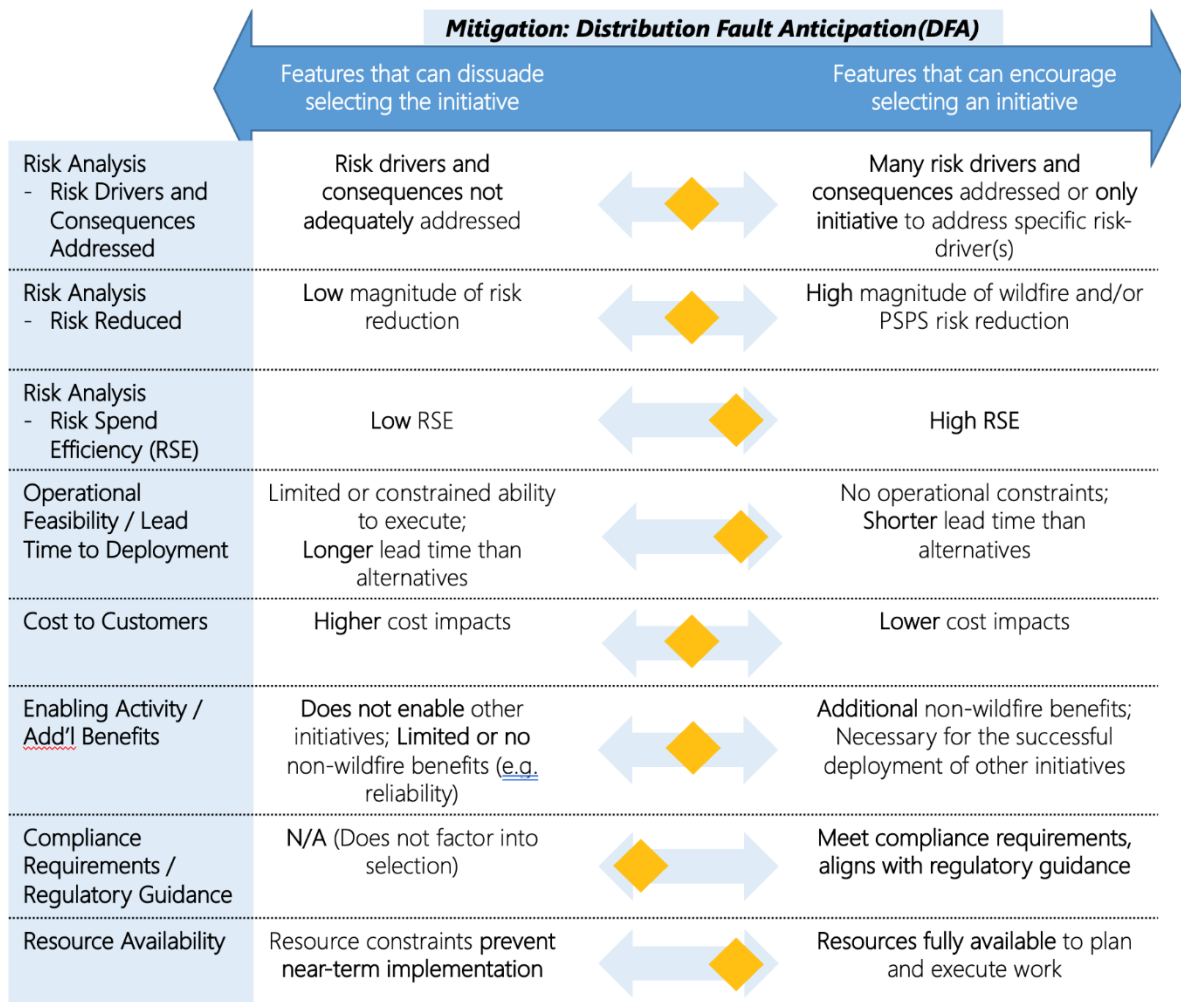
#### Decision-Making Factors

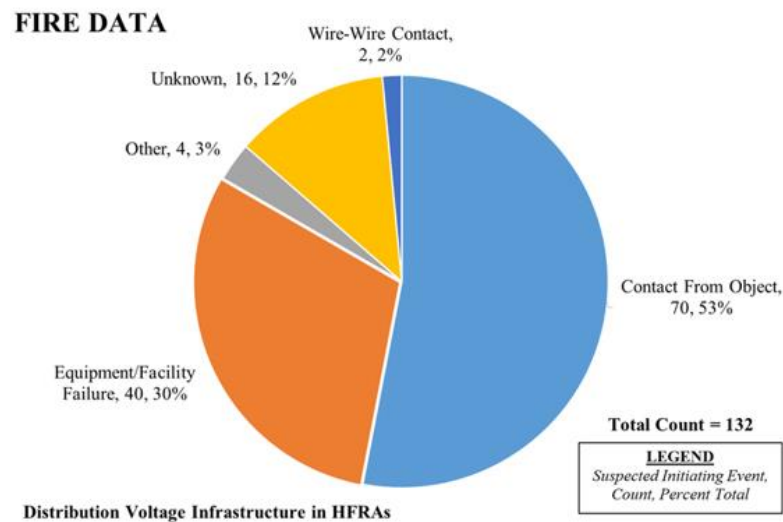
### 2. Identifying Mitigations

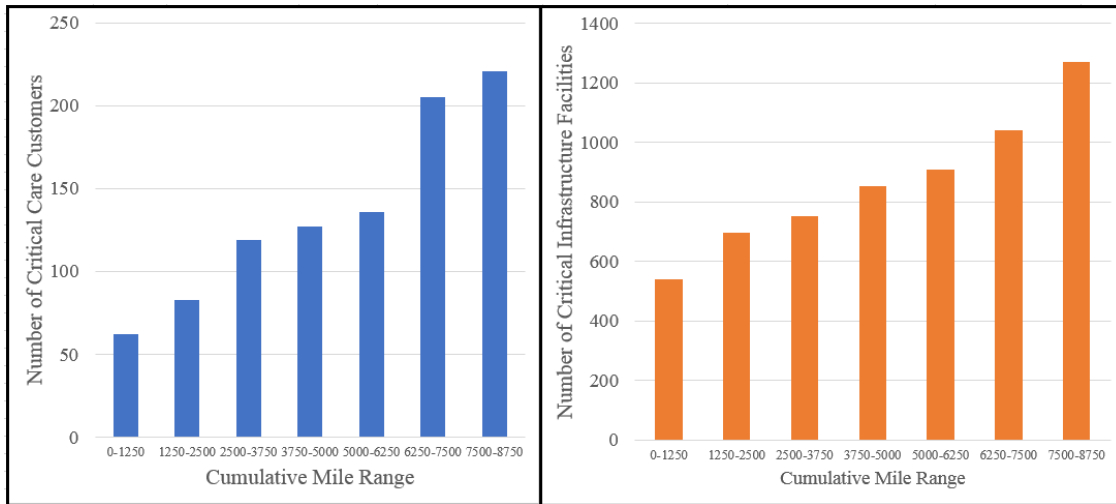
Moreover, the statement that “SCE’s current covered conductor installation plan also fails to address the riskiest circuit segments identified, with only 581 miles of highest risk circuits in the 1,883 miles of planned covered conductor projects”<sup>185</sup> is both inaccurate and irrelevant. It is inaccurate because that figure is derived from SCE’s planned 2021 deployment only (as calculated at the time of SCE’s response to a data request – SCE’s current 2021 plan for those circuits is 694 miles).<sup>186</sup> It is irrelevant because it is derived from Cal Advocates’ list of SCE’s 71 “riskiest” circuits – not circuit segments. SCE appropriately prioritizes covered conductor deployment on the most relatively risky circuit segments, and different segments of overall circuits often have markedly different relative risk scores.

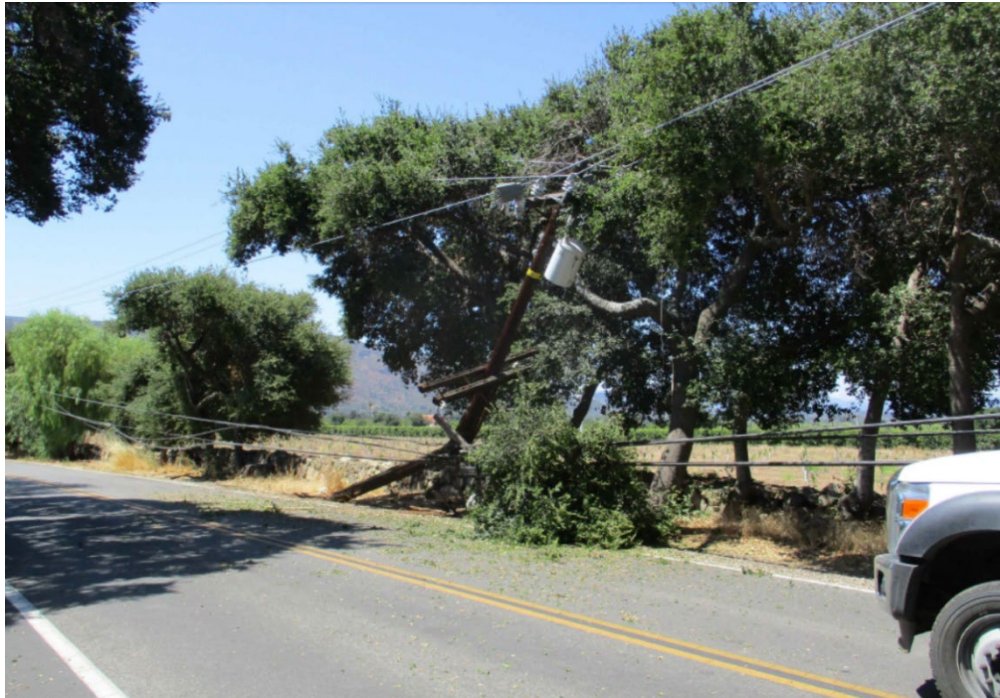
The table below summarizes data from five circuits that both experienced CPUC-reportable ignition events from 2016 to 2020 and subsequently had covered conductor installed. Since covered conductor deployment in these circuits, no ignition associated with the risk drivers covered conductor is designed to prevent, namely contact from object, wire-to-wire contact, and equipment failure have occurred.<sup>195</sup> Though the data is limited, the early outcomes are promising and validate SCE’s benchmarking and testing results.

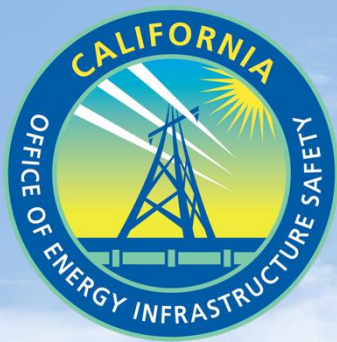
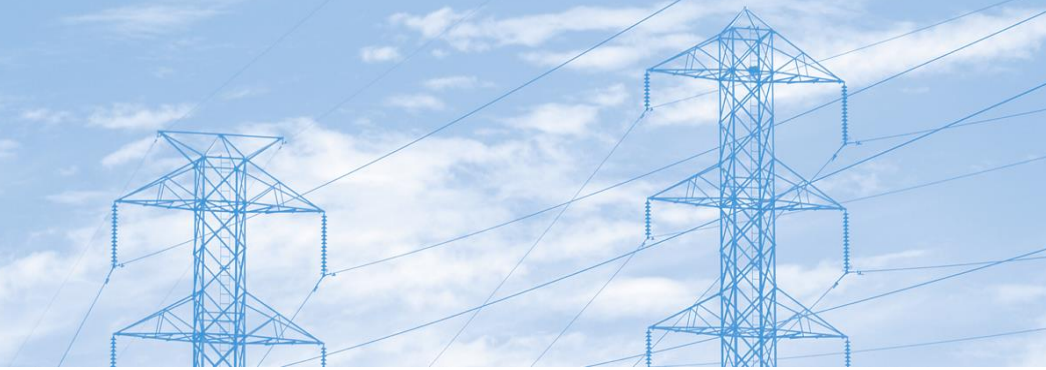
**Table 1. Risk Category and Correction Timelines**

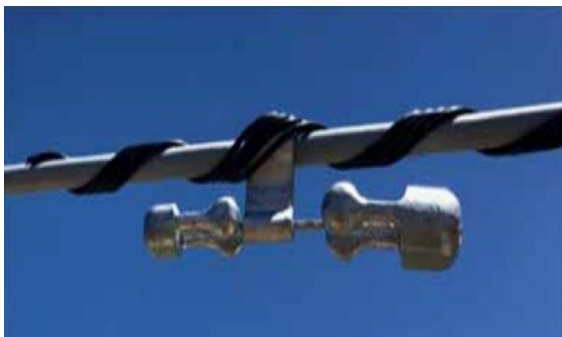
Figure 1: Stockbridge Damper

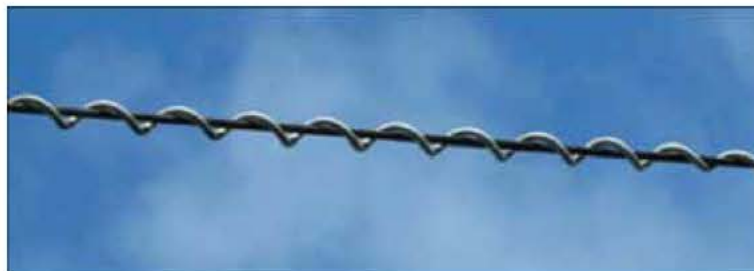
**Figure CC 190-2: Stockbridge Damper**

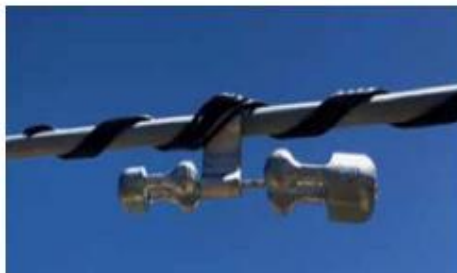
Figure 1: Stockbridge Damper

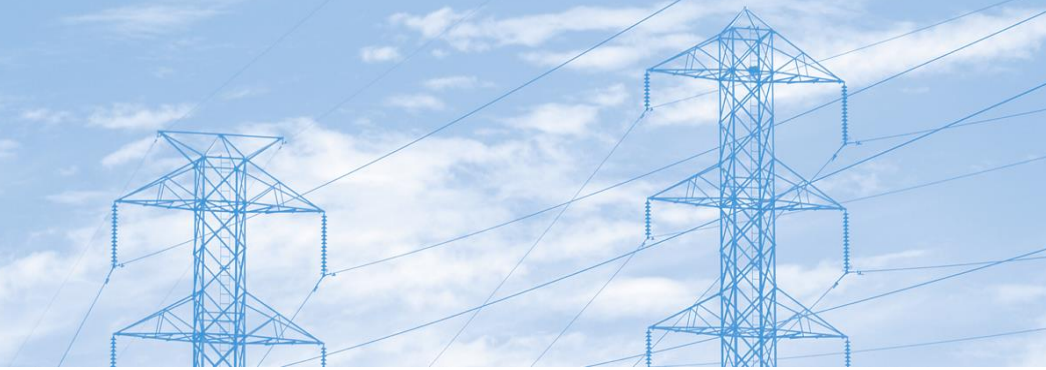
*regulated entity is noncompliant with its duties and responsibilities or has otherwise committed violations of any laws, regulations, or guidelines within the authority of the office.*

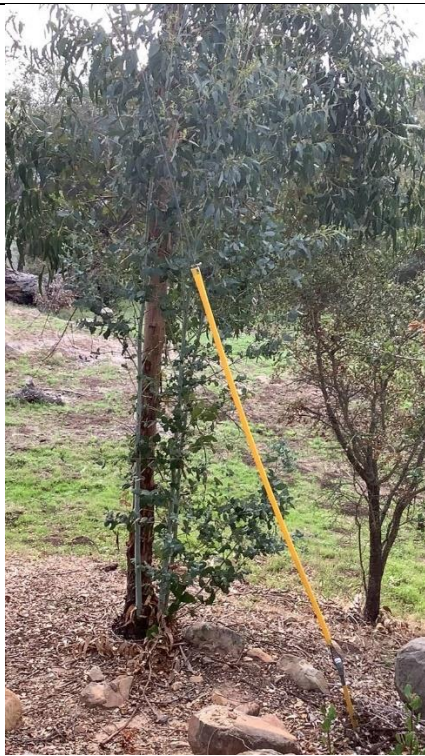
**Item1GW1Img1:** Loose guy wire

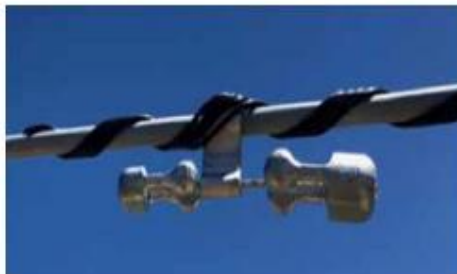
Figure 1: Stockbridge Damper

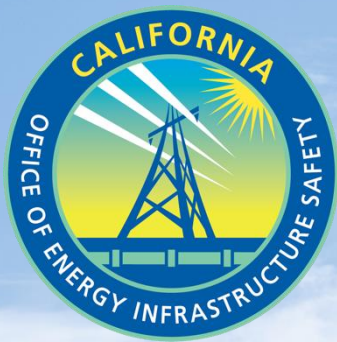
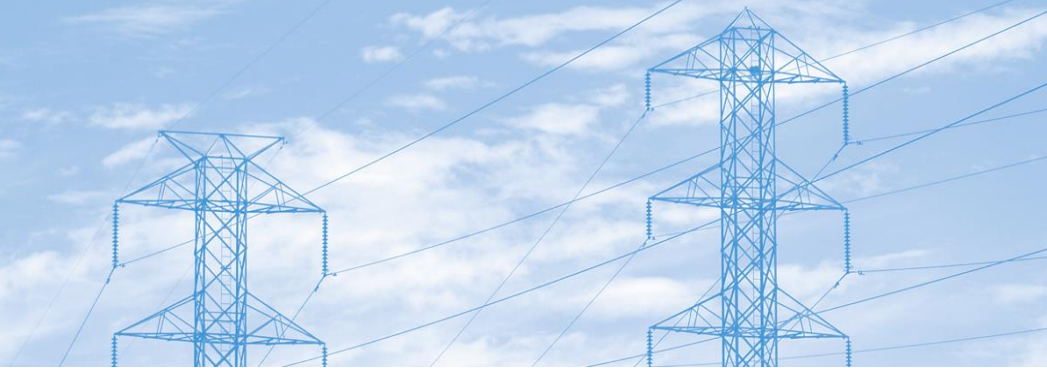
<b>Risk Category</b>	<b>Violation and defect correction timeline</b>
Minor	<ul style="list-style-type: none"><li data-bbox="467 543 1170 577">• 12 months or resolution scheduled in WMP update</li></ul>

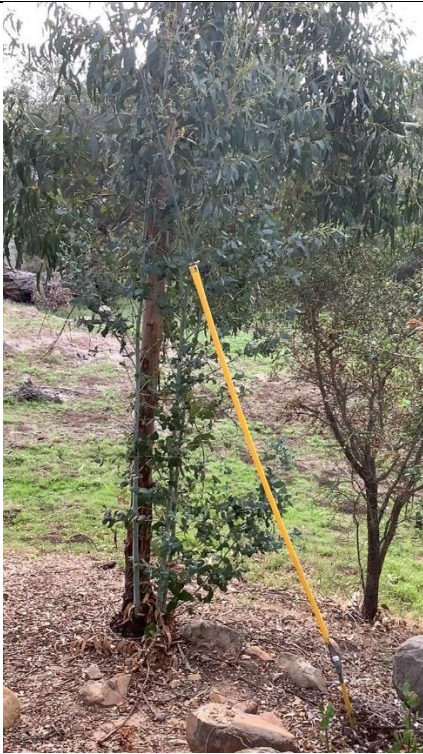
**Item1GW1img1:** Loose guy wire

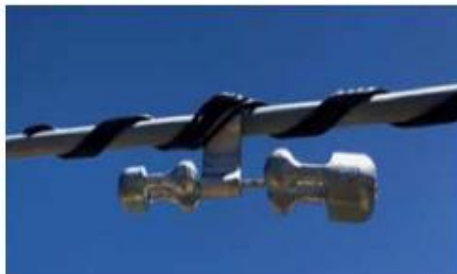
Figure 1: Stockbridge Damper

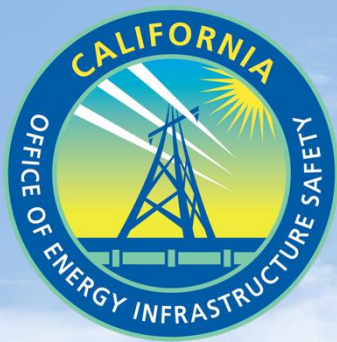
*regulated entity is noncompliant with its duties and responsibilities or has otherwise committed violations of any laws, regulations, or guidelines within the authority of the office.*

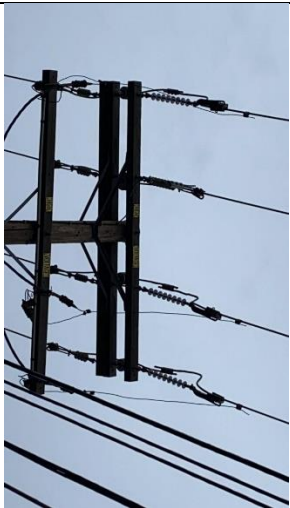
A close-up photograph of the cross-arms of a utility pole. The conductors are visible, and some appear to be bare, which is noted as a discrepancy in the caption.	
<p><b>Item3IA1img1:</b> Bare conductor when data indicates that there should be covered conductor</p>

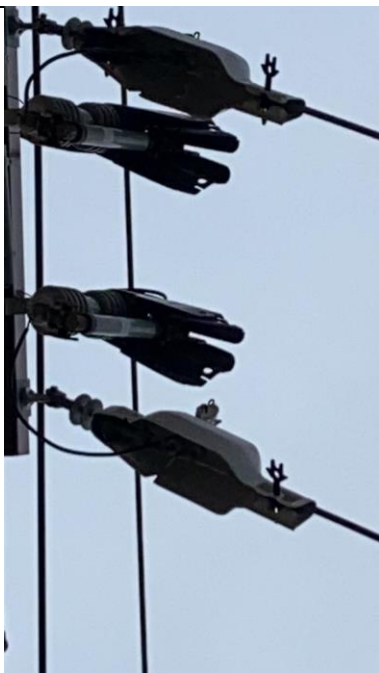
**Item16IA4Img1:** Loose dead-end clamp

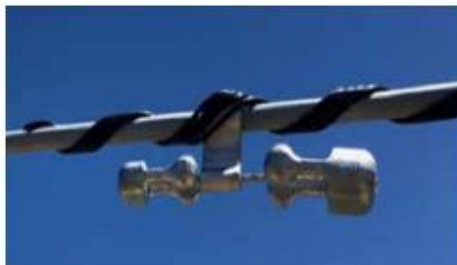
Figure 1: Stockbridge Damper

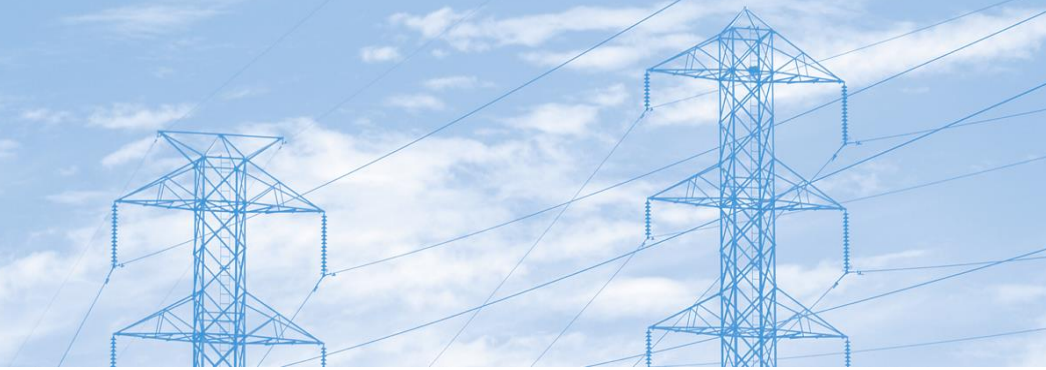
*regulated entity is noncompliant with its duties and responsibilities or has otherwise committed violations of any laws, regulations, or guidelines within the authority of the office.*

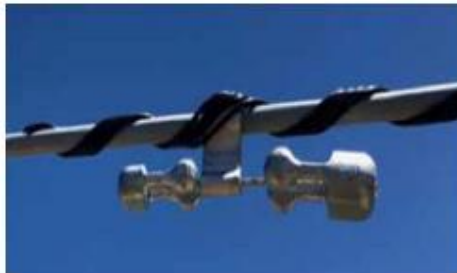
Figure 1: Stockbridge Damper

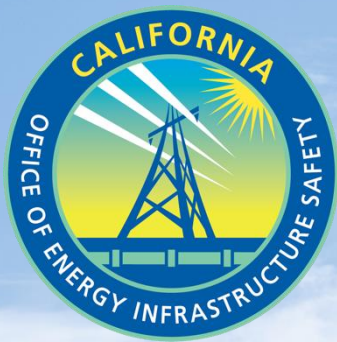
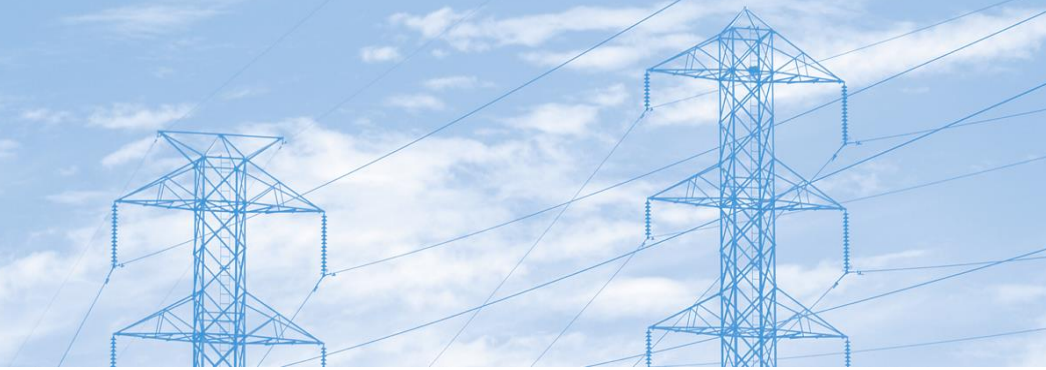
**Table 1. Risk Category and Correction Timelines**

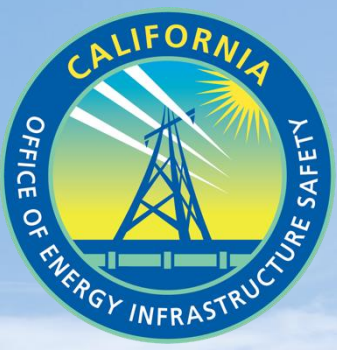
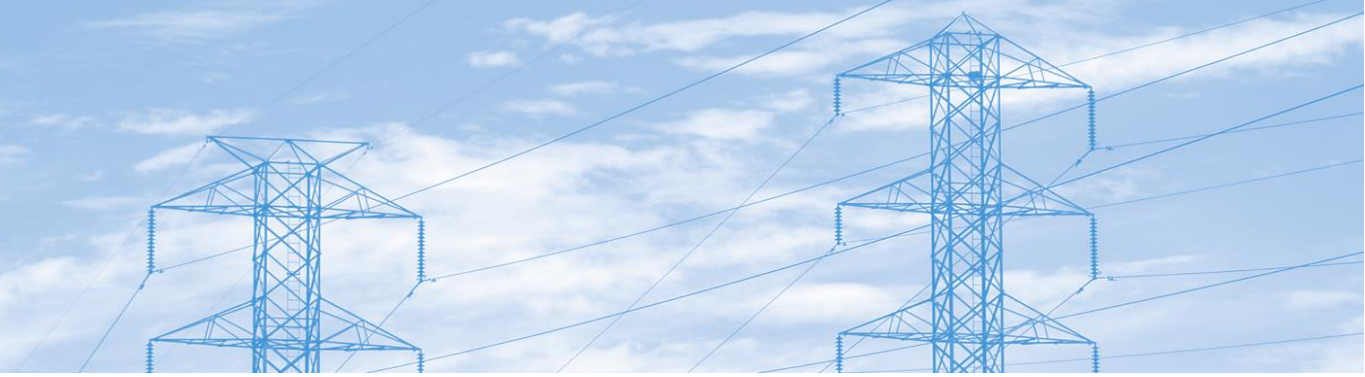
## Table 2. WMP Initiative Inspections

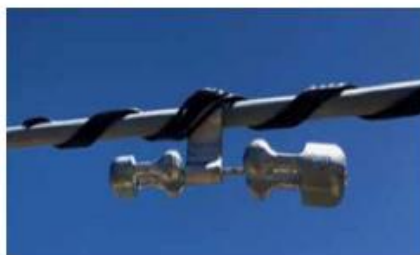
Figure 1: Stockbridge Damper

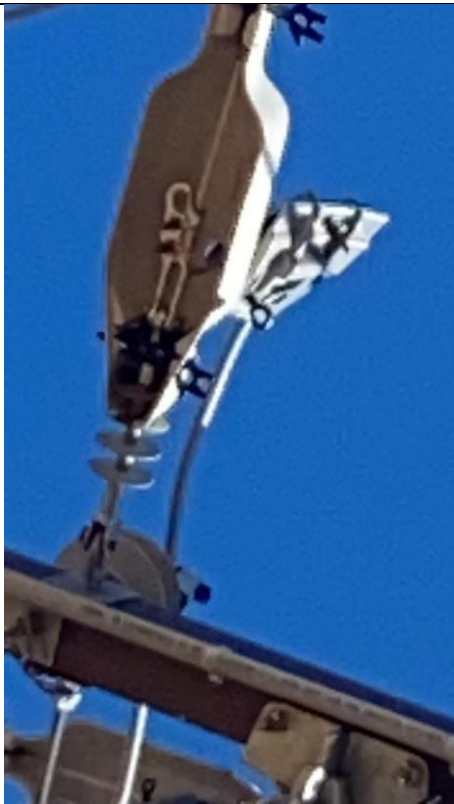
**Item16IA2Img1:** Loose center phase bolted wedge connector

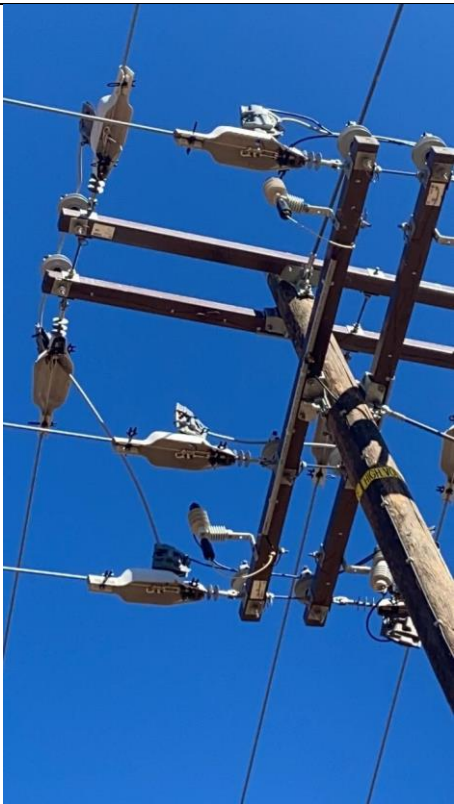
**Item16IA2Img2:** Overall loose center phase bolted wedge connector

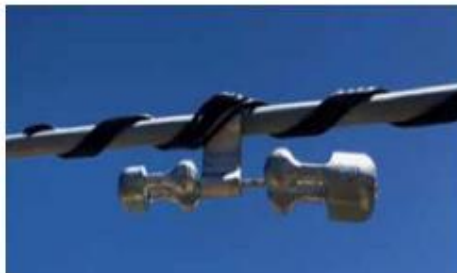
Figure 1: Stockbridge Damper

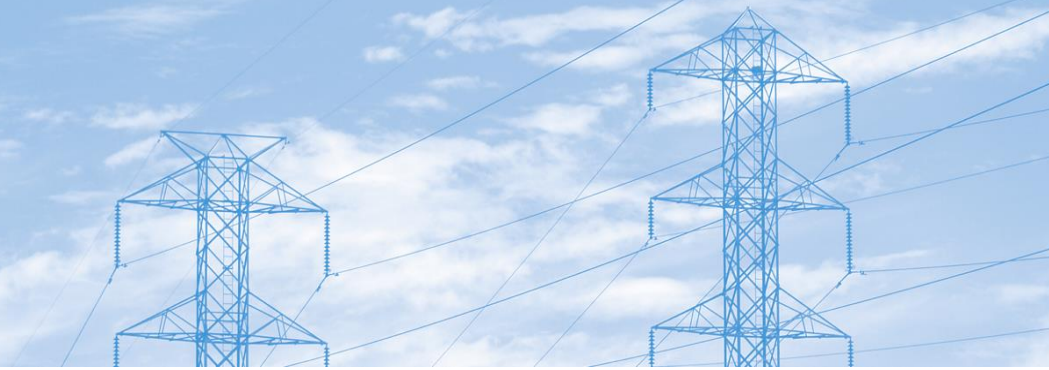
*regulated entity is noncompliant with its duties and responsibilities or has otherwise committed violations of any laws, regulations, or guidelines within the authority of the office.*

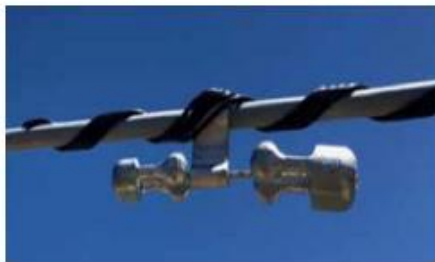
Figure 1: Stockbridge Damper

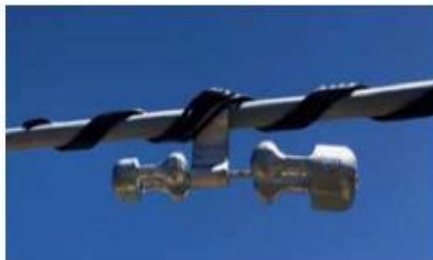
Figure 1: Stockbridge Damper

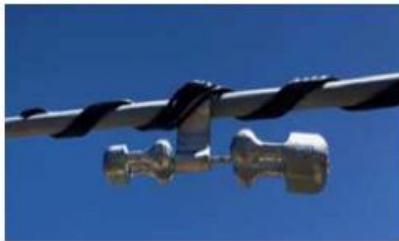
Figure 1: Stockbridge Damper

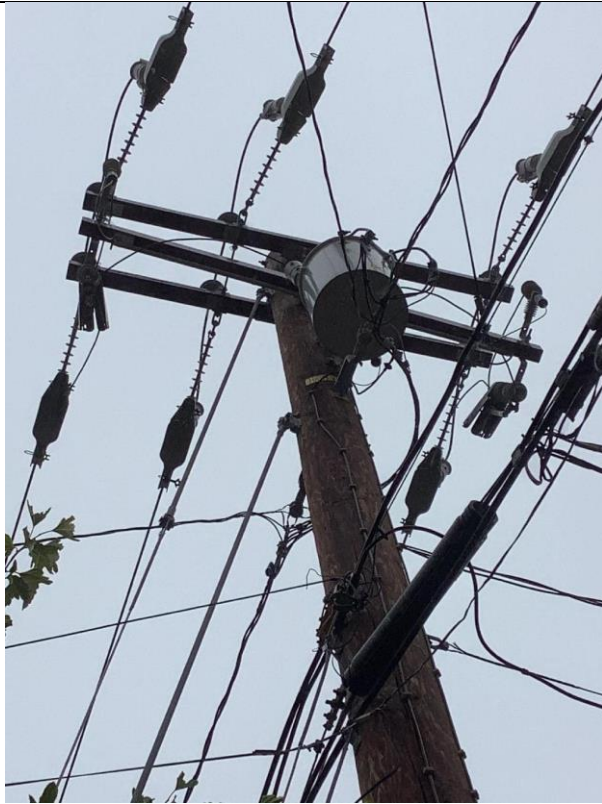
**Item1IA1Img1:** Vibration dampers are missing

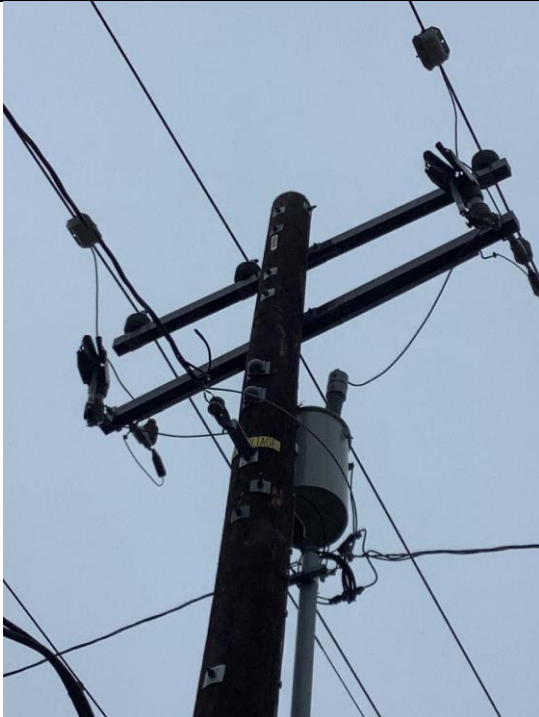
Item2IA1Img1: Vibration dampers are missing

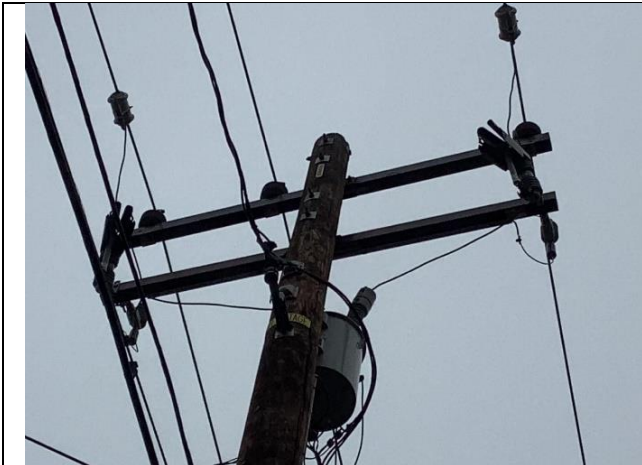
Item3IA1Img1: Vibration dampers are missing

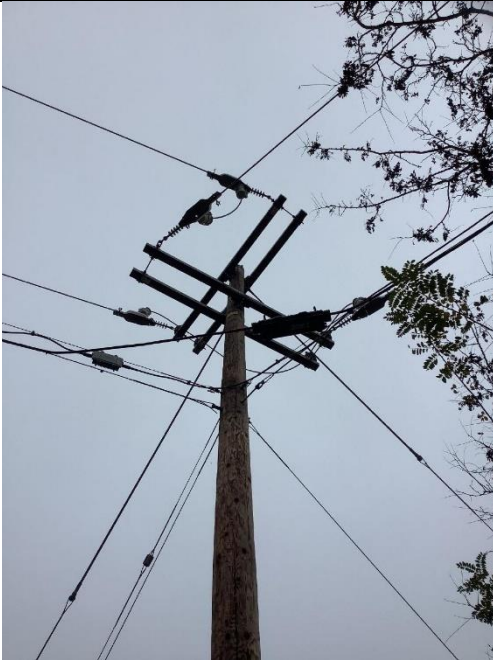
Item4IA1Img1: Vibration dampers are missing

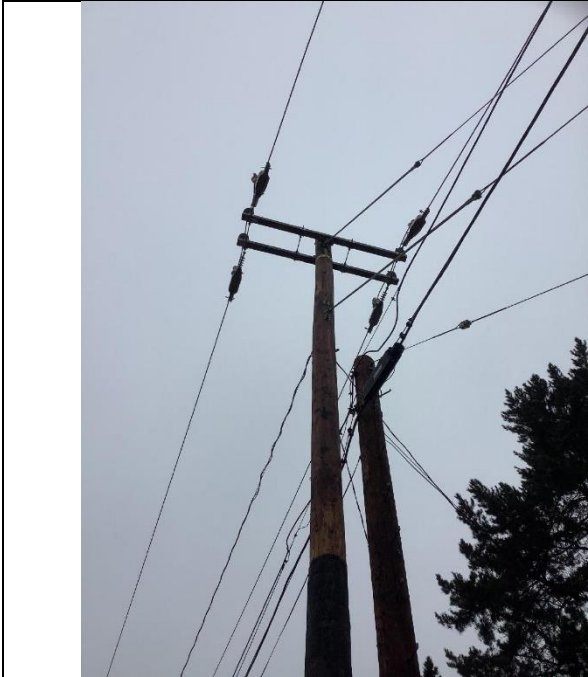
Item5IA1img1: Vibration dampers are missing

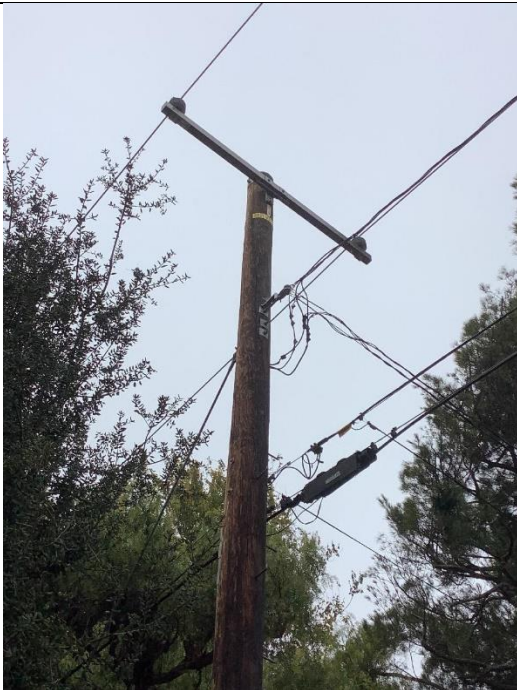
Item6IA1img1: Vibration dampers are missing

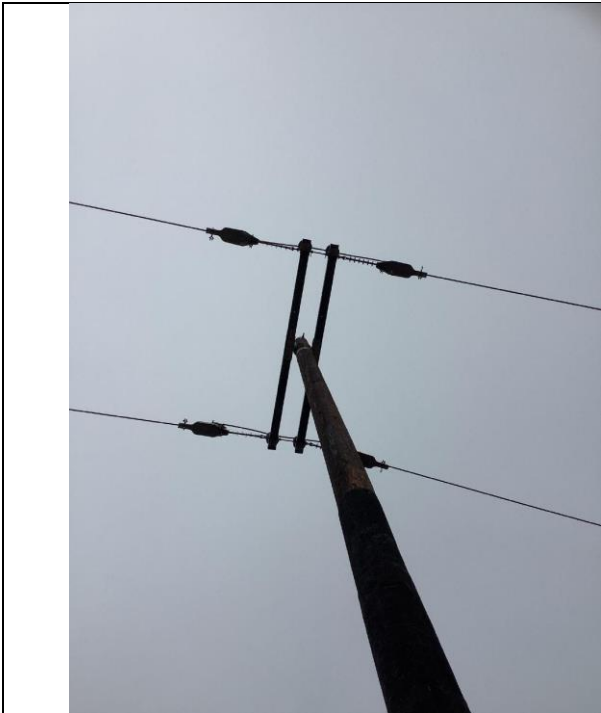
Item7IA1Img1: Vibration dampers are missing

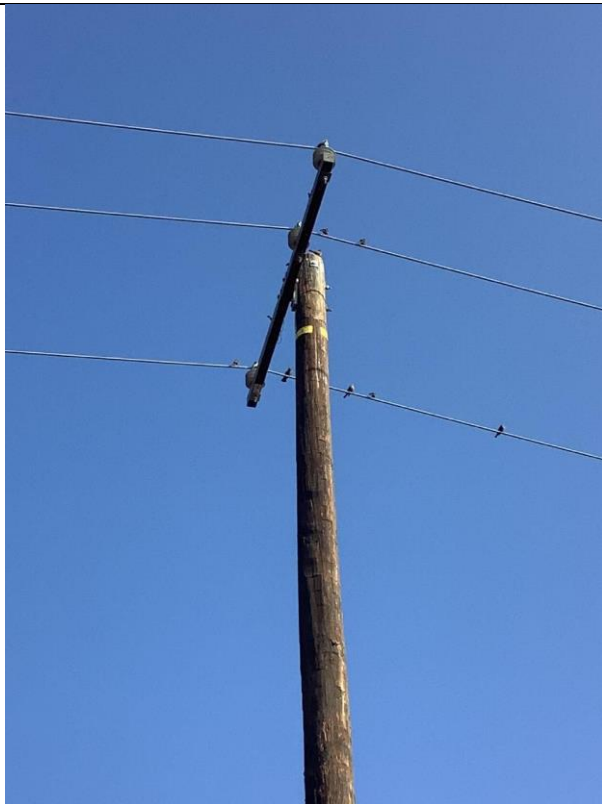
Item10IA1mg1: Vibration dampers are missing

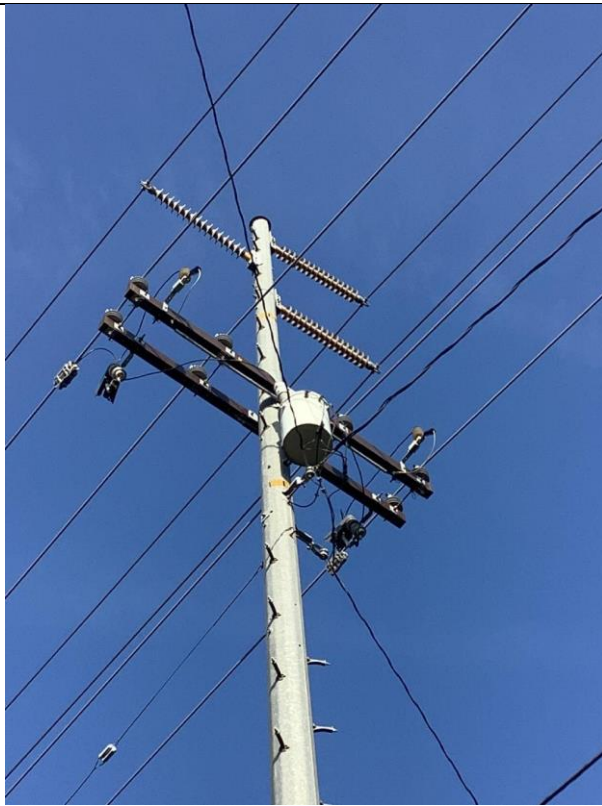
**Item12IA1mg1:** Vibration dampers are missing

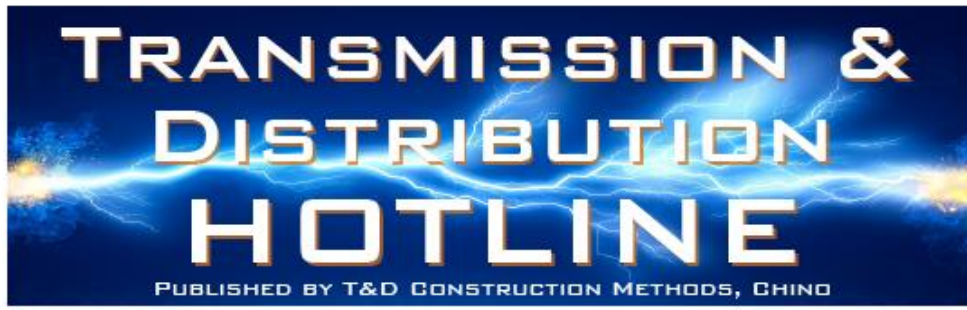
**Interim Deviation from Standards on Vibration Damper for Covered Conductor**

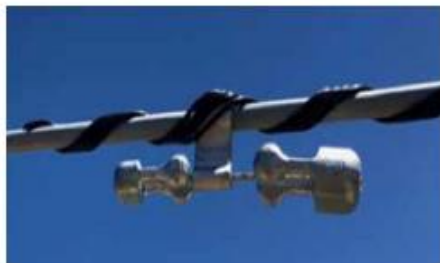
Figure 1: Stockbridge Damper

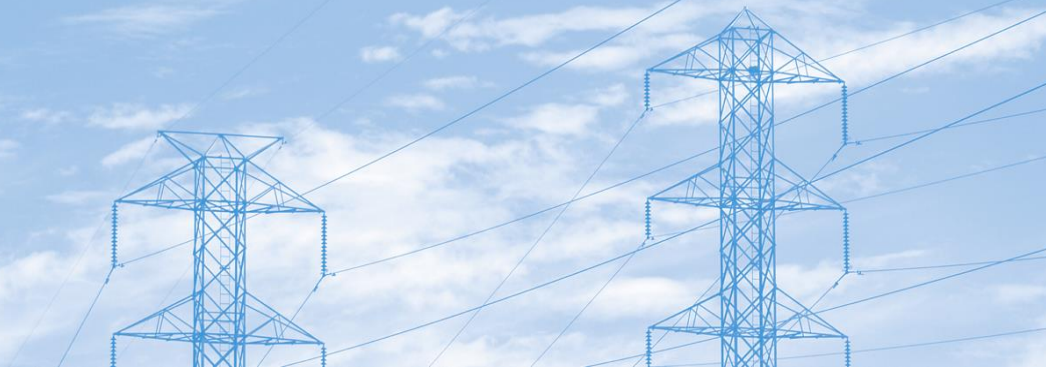
*regulated entity is noncompliant with its duties and responsibilities or has otherwise committed violations of any laws, regulations, or guidelines within the authority of the office.*

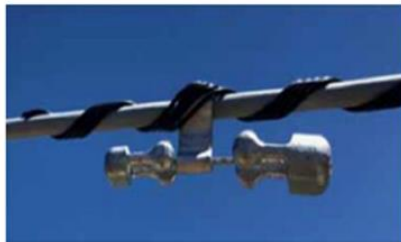
Figure 1: Stockbridge Damper

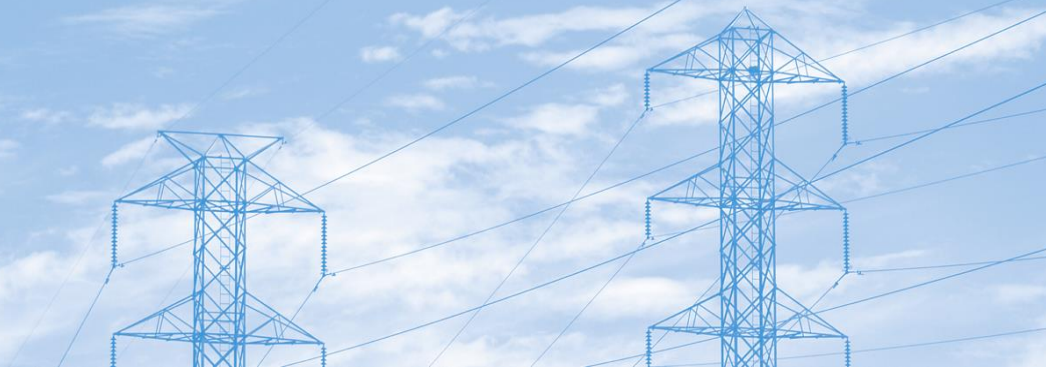
*regulated entity is noncompliant with its duties and responsibilities or has otherwise committed violations of any laws, regulations, or guidelines within the authority of the office.*

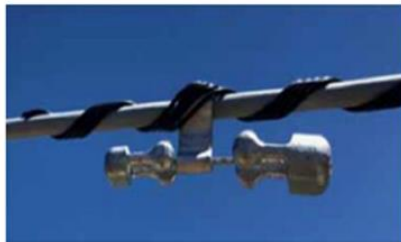
Figure 1: Stockbridge Damper

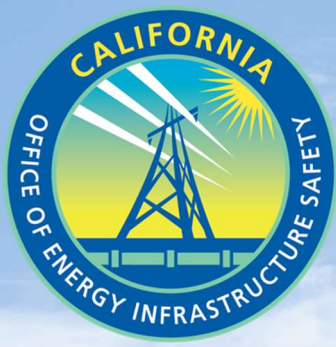
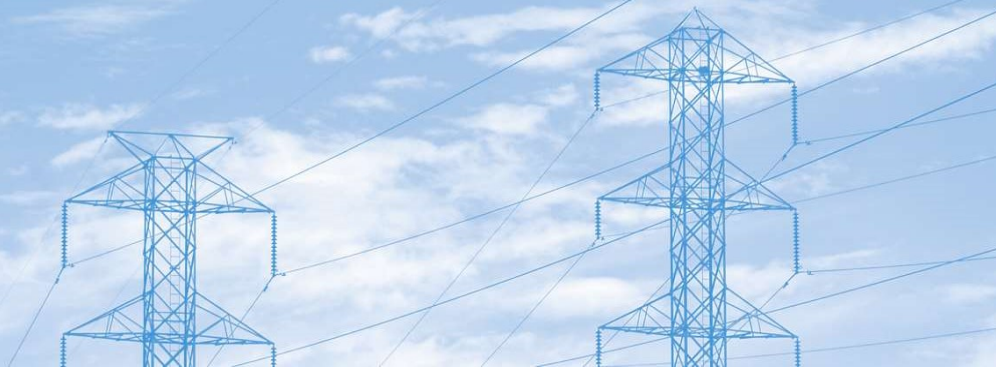
*regulated entity is noncompliant with its duties and responsibilities or has otherwise committed violations of any laws, regulations, or guidelines within the authority of the office.*

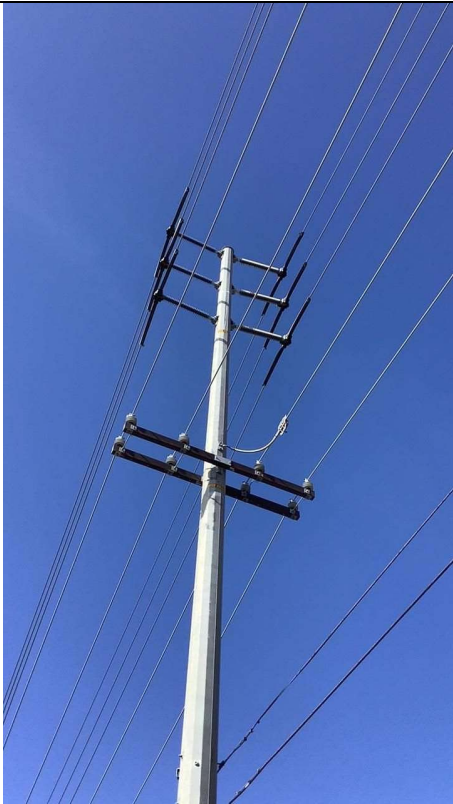
**Item4IA1img1:** Steel pole observed in the field and no vibration dampers installed

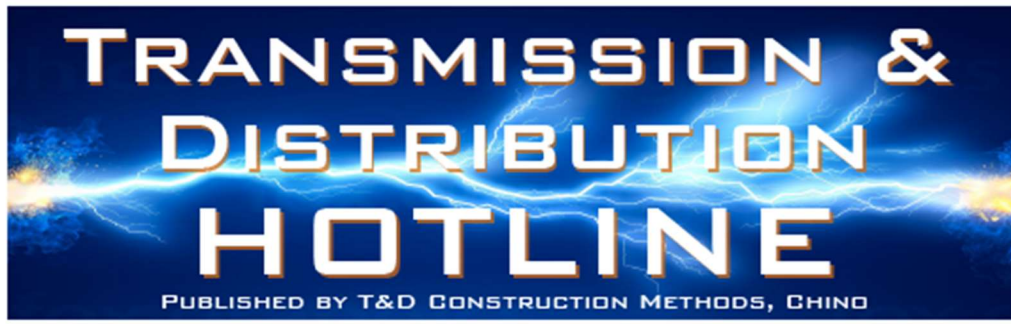
Interim Deviation from Standards on Vibration Damper for Covered Conductor

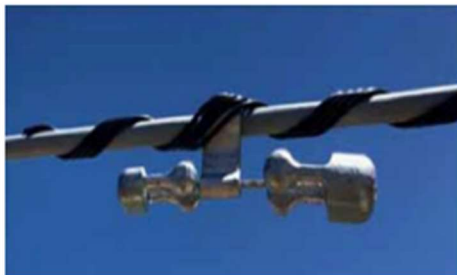
Figure 1: Stockbridge Damper

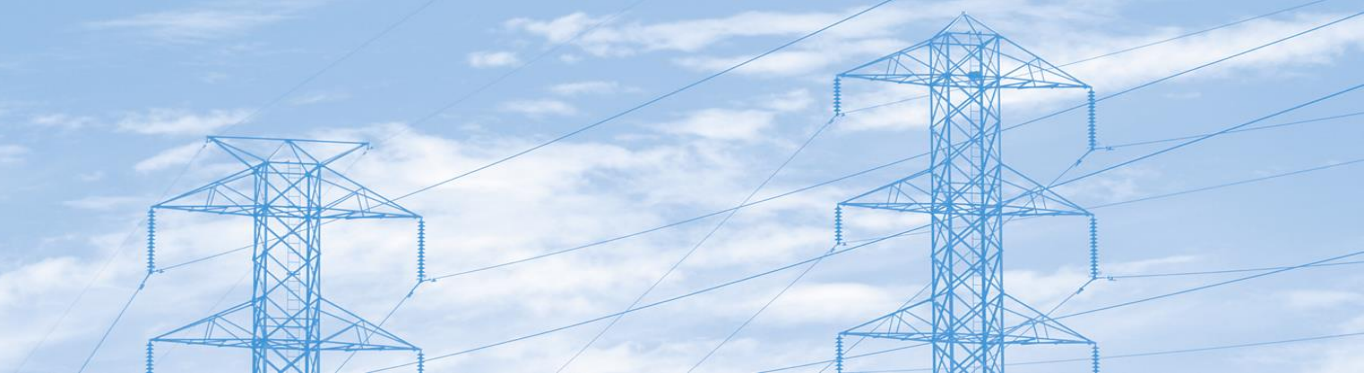
**Table 2. WMP Initiative Inspections**

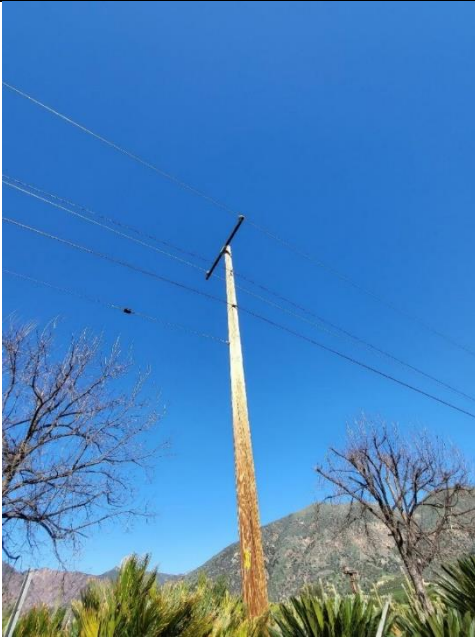
Item2IA1img1: Missing vibration dampers

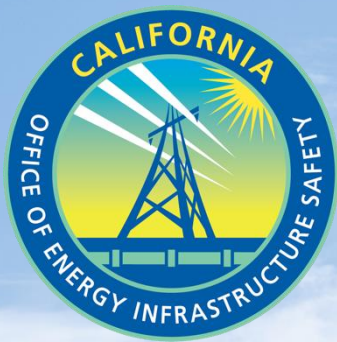
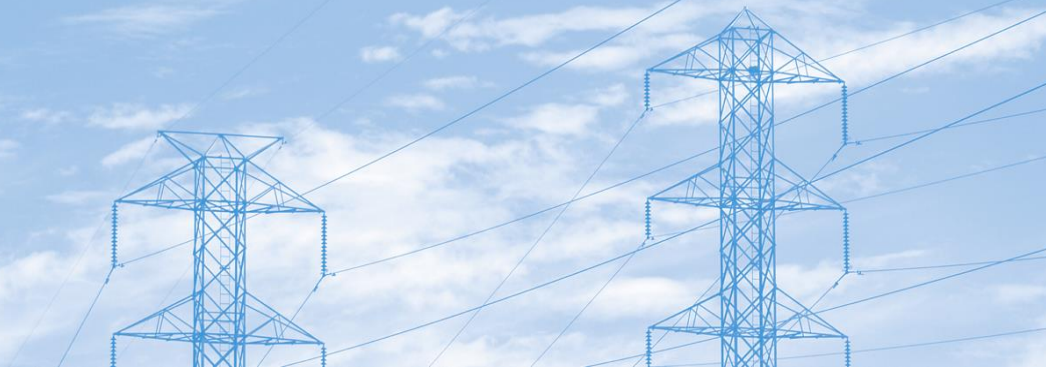
**Table 1. Risk Category and Correction Timelines**

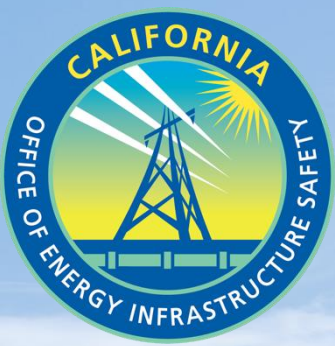
**Table 2. WMP Initiative Inspections**

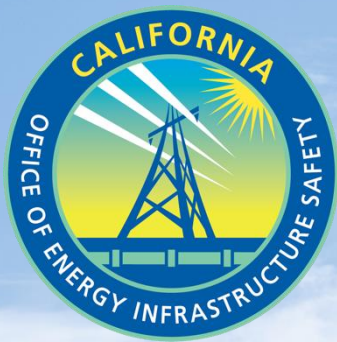
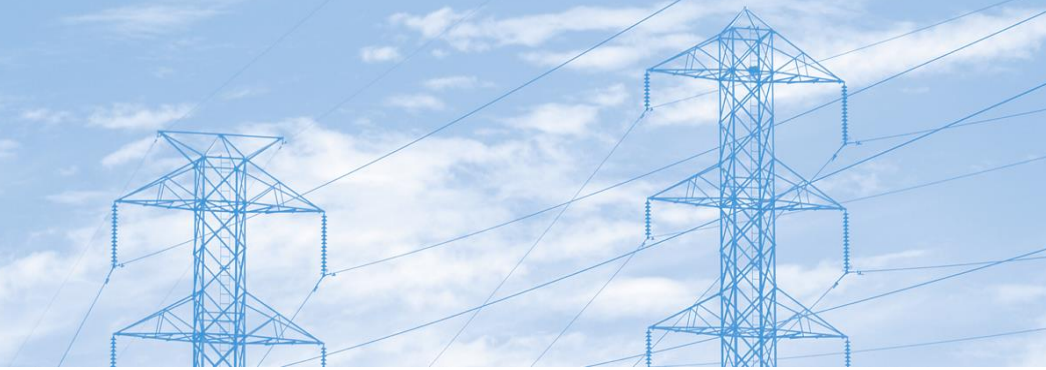
**Table 1. Risk Category and Correction Timelines**

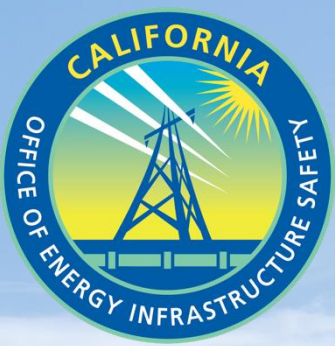
**Table 2. WMP Initiative Inspections**

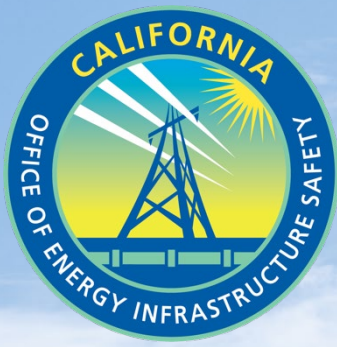
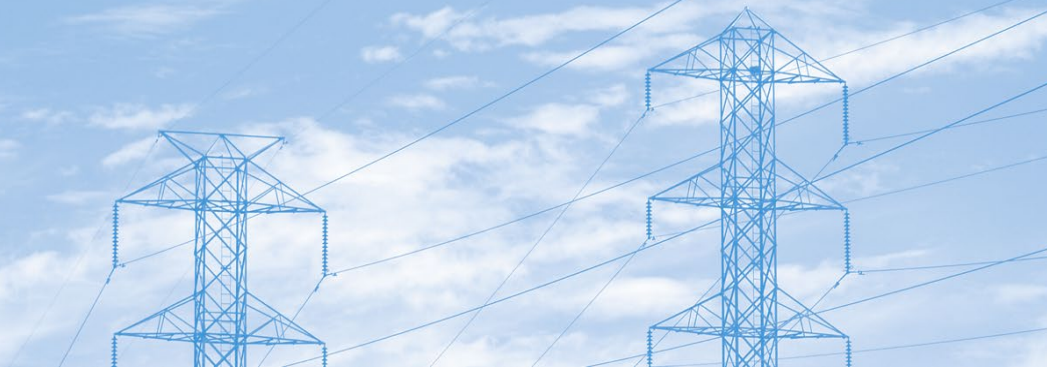
**Table 1. Risk Category and Correction Timelines**

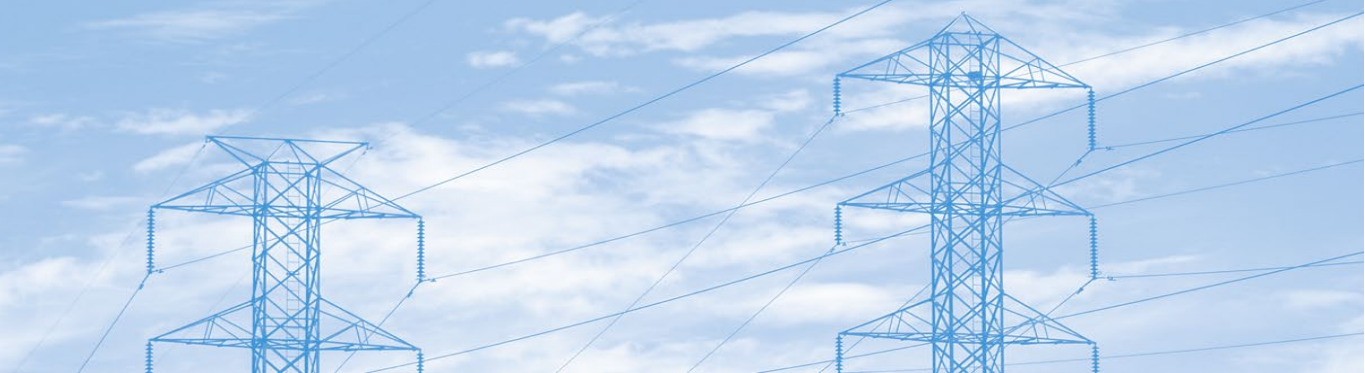
**Table 2. WMP Initiative Inspections**

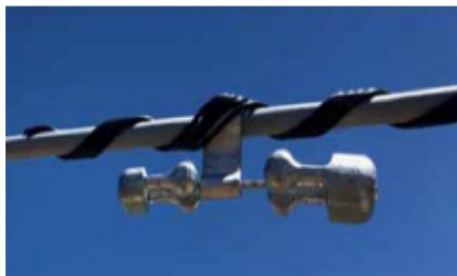
Figure 1: Stockbridge Damper
