8  
9 BEFORE THE OFFICE OF ADMINISTRATIVE HEARINGS  
10 OF THE STATE OF CALIFORNIA

11 In the Matter of the Notices of  
12 Violation Against,

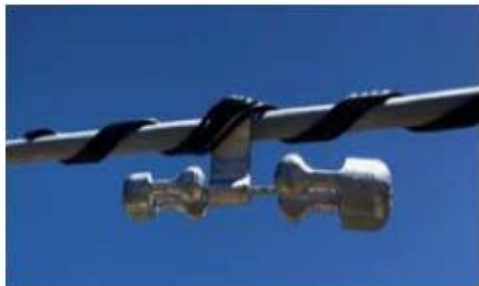
Figure 1: Stockbridge Damper

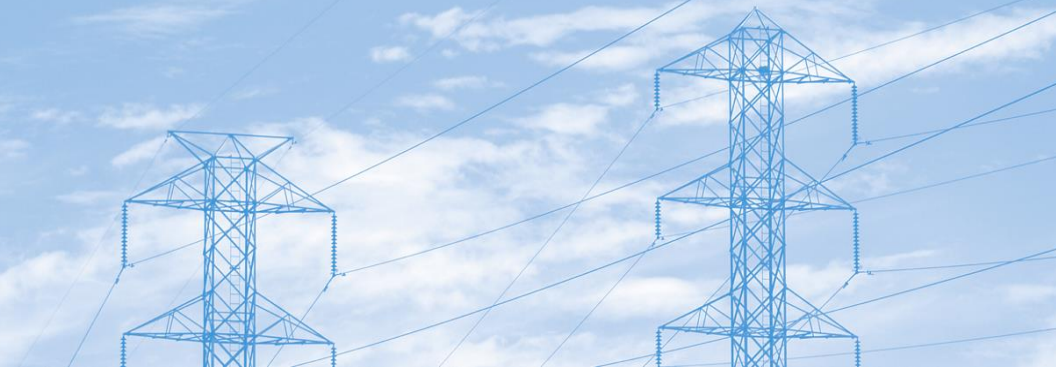
3 below. Issues discovered during these inspections are categorized as defects and are accompanied by a notice of defect (NOD).

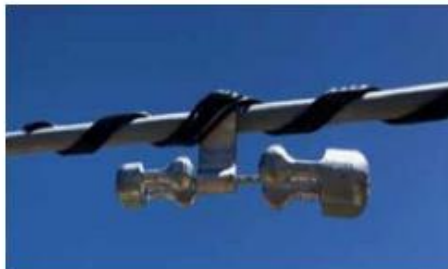
Figure 1: Stockbridge Damper

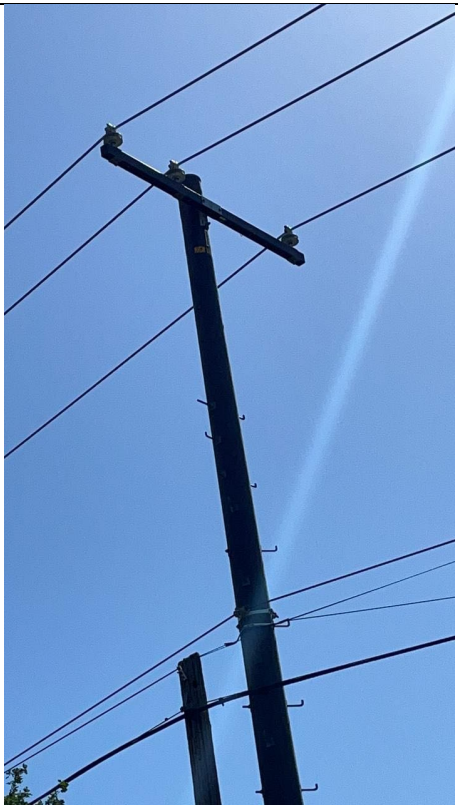
**Item1IA1Img1:** Missing vibration dampers

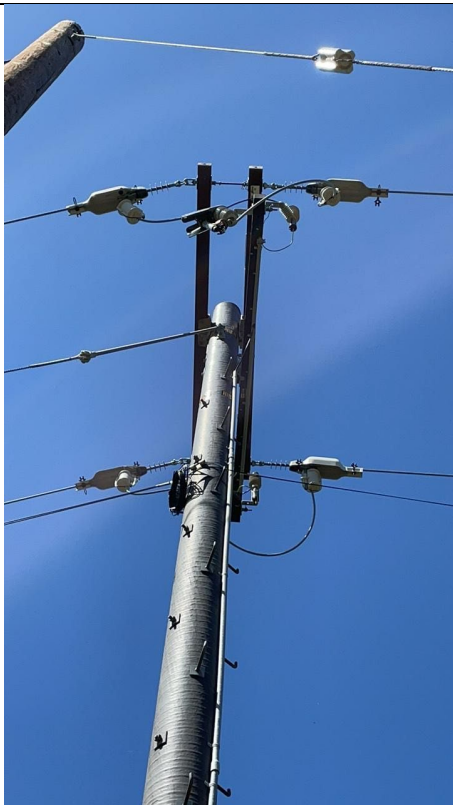
Item2IA1Img1: Missing vibration damper

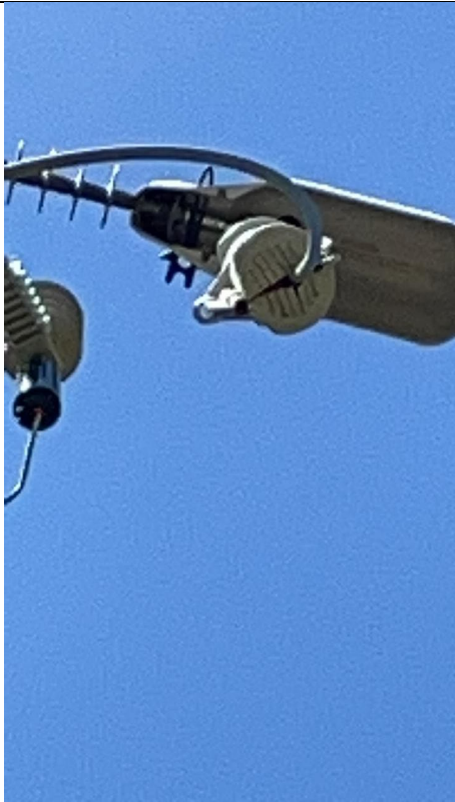
**Item2IA2Img1:** Missing anti-rotational device at outer notch under dead uncover

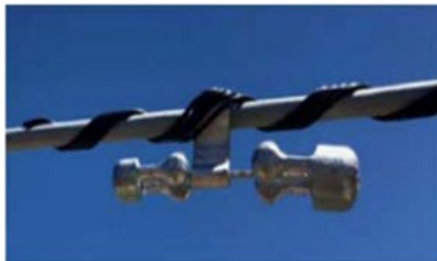
Figure 1: Stockbridge Damper

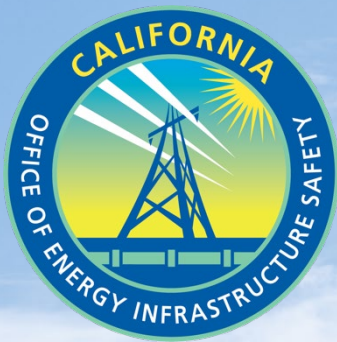
*(a) The office may determine that a regulated entity is not in compliance with any matter under the authority of the office. If necessary, the office may undertake an investigation into whether the regulated entity is noncompliant with its duties and responsibilities or has otherwise committed violations of any laws, regulations, or guidelines within the authority of the office.*

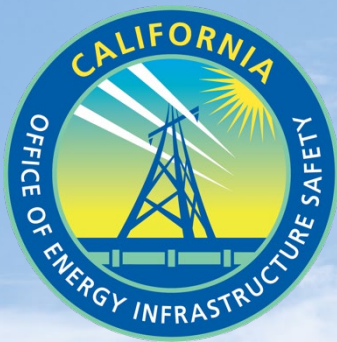
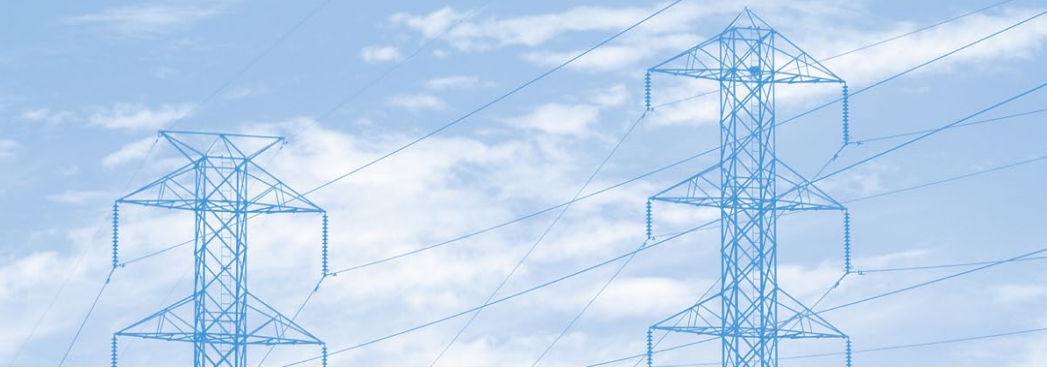
<b>Risk Category</b>	<b>Violation and defect correction timeline</b>
Moderate	<ul style="list-style-type: none"><li>• 2 months (in HFTD Tier 3)</li><li>• 6 months (in HFTD Tier 2)</li><li>• 6 months (if relevant to worker safety; not in HFTD Tier 3)</li></ul>
Minor	<ul style="list-style-type: none"><li>• 12 months or resolution scheduled in WMP update</li></ul>

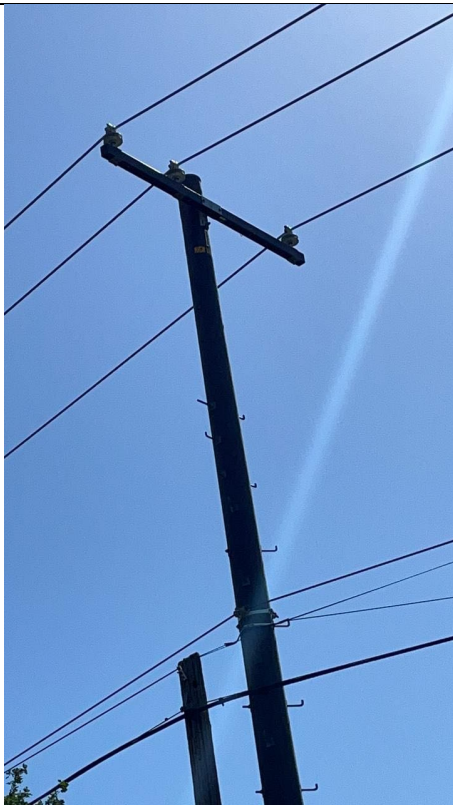
**Item1IA1Img1:** Missing vibration dampers

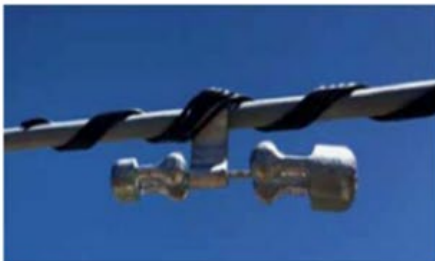
Figure 1: Stockbridge Damper
