Subject: Bear Valley Electric Service, Inc. Response to Notice of Violation- NOV_BVES_CAC15_20231025_1031 (No Written Hearing Requested)

Notice of Violation: NOV_BVES_CAC15_20231025_1031

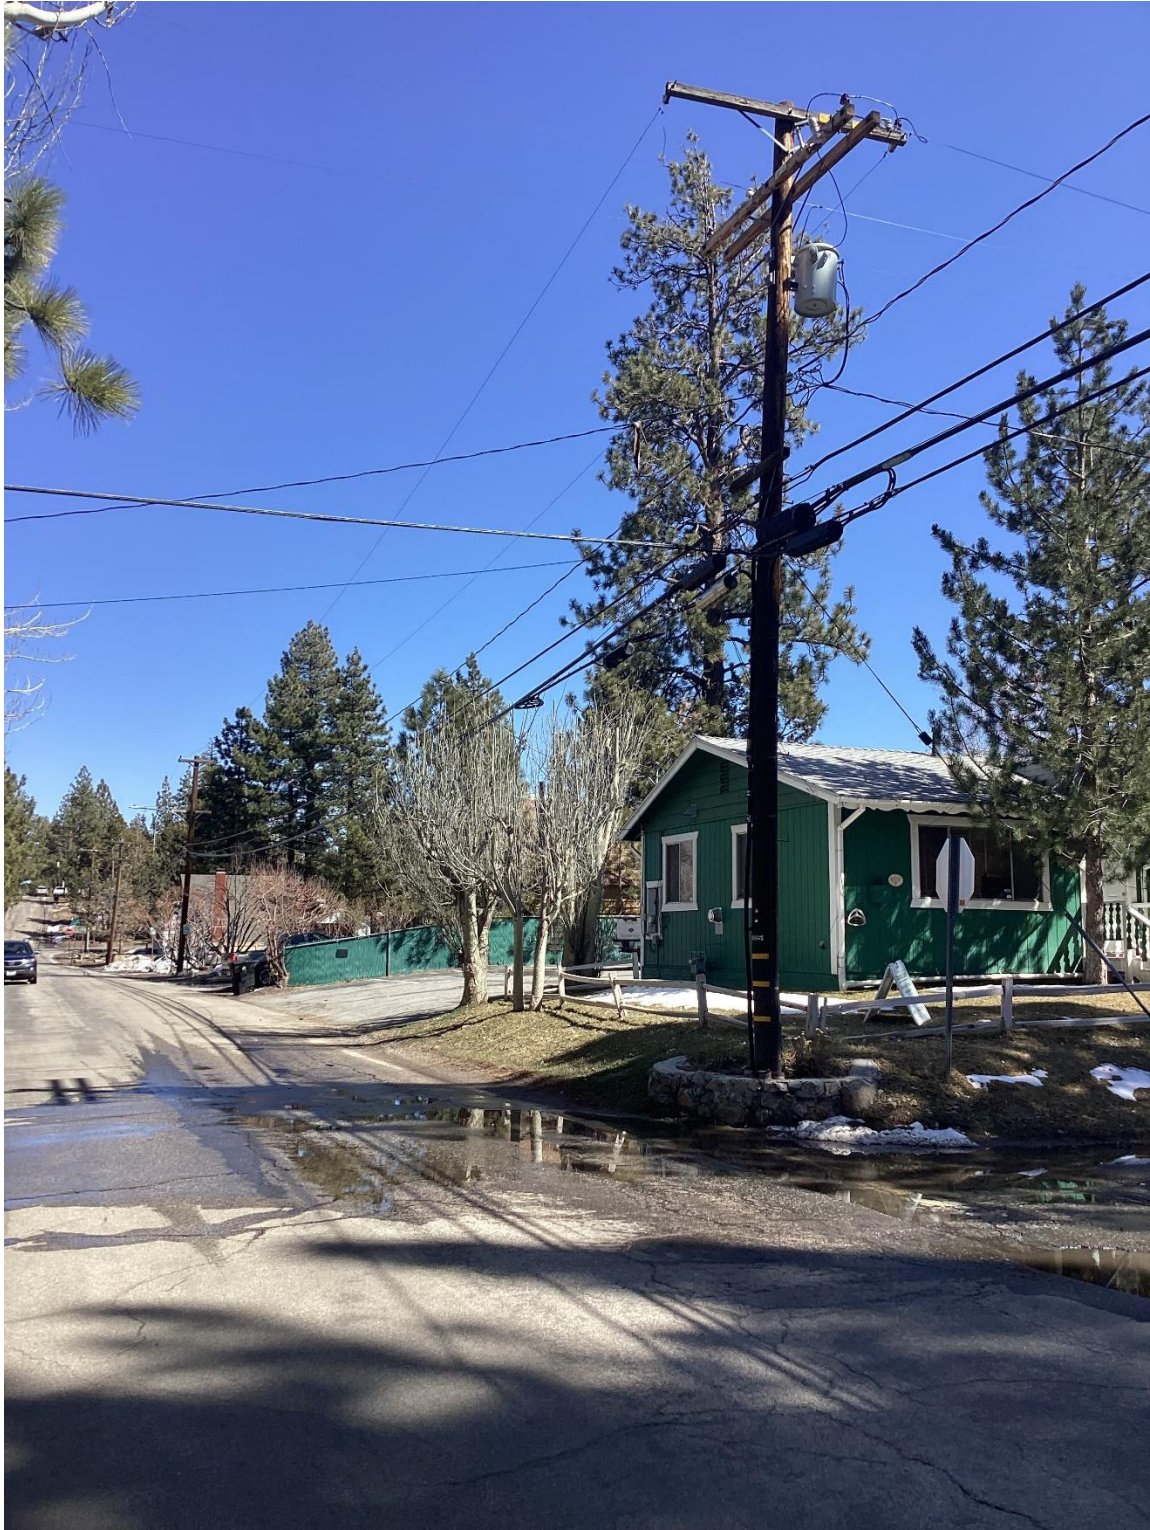
After Trimming on January 25, 2024

Response: BVES was made aware of the violation on March 15, 2024. Crews were dispatched to the location of pole number 1300BV located at (Lat/Long: 34.2617196240952, -116.847297778948). Vegetation crews made corrective trims to approximately 12 feet around the lines on March 21, 2024. See photos below.

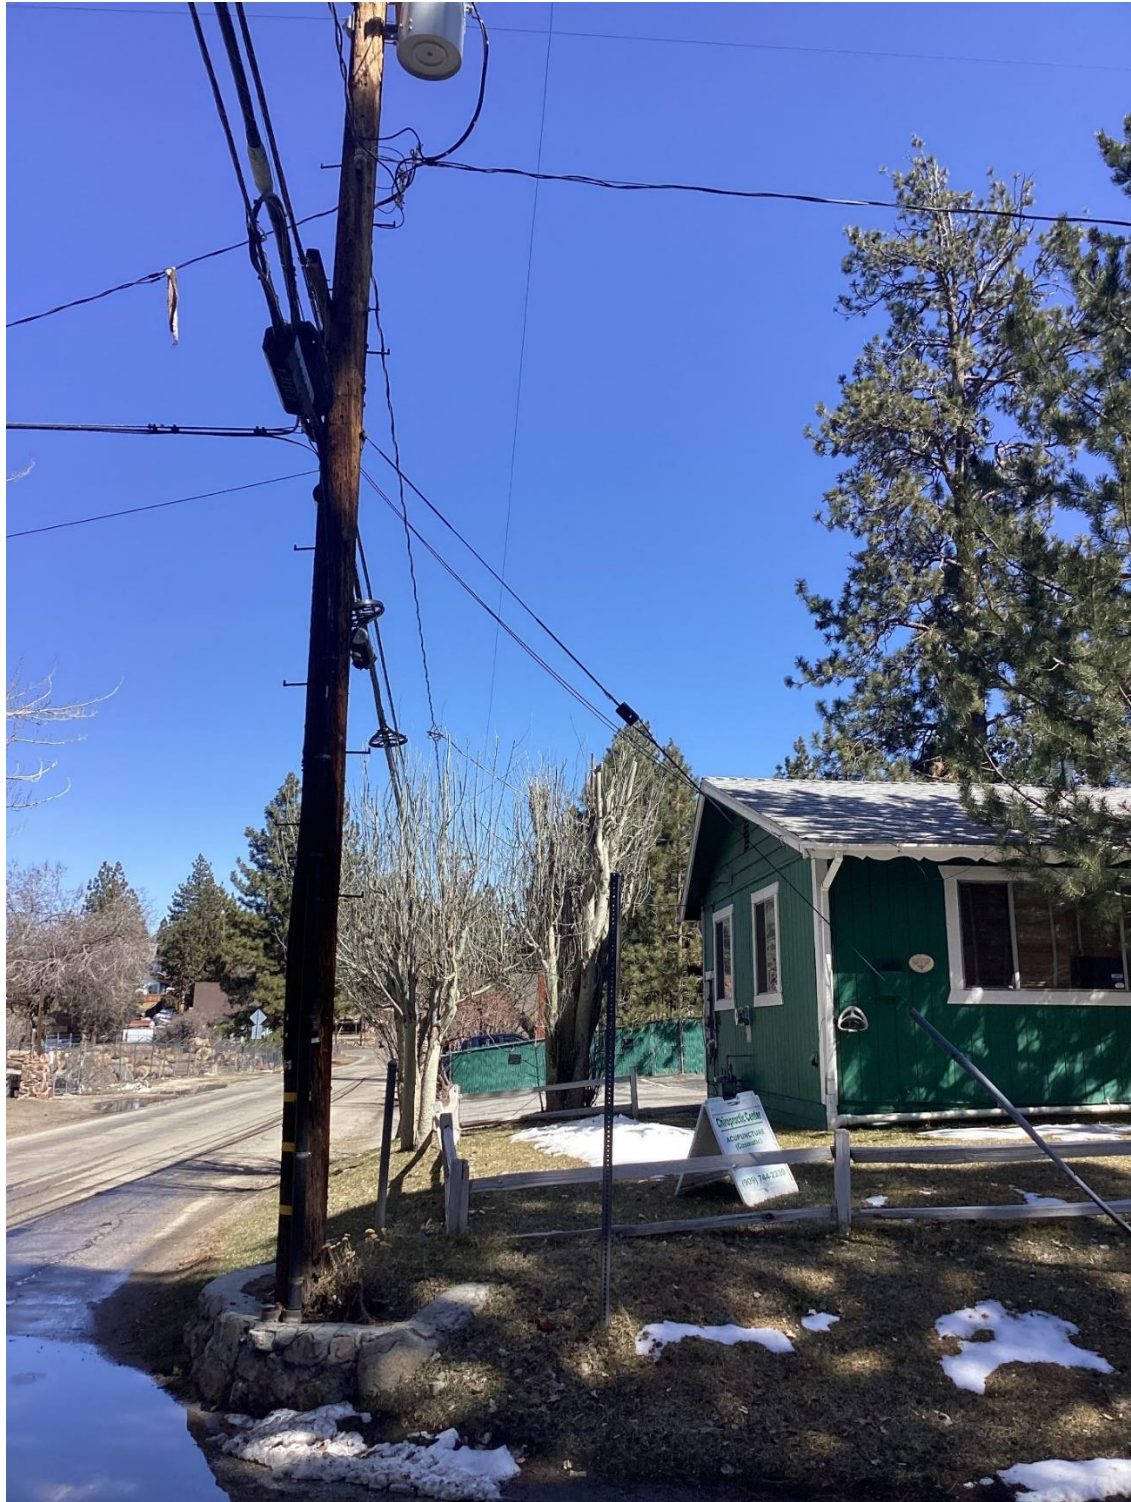
After Trimming on January 25, 2024
