Subject: Bear Valley Electric Service, Inc. Response to Notice of Violation- NOV_BVES_CAC15_20231026_1009 (No Written Hearing Requested)

Notice of Violation: NOV_BVES_CAC15_20231026_1009

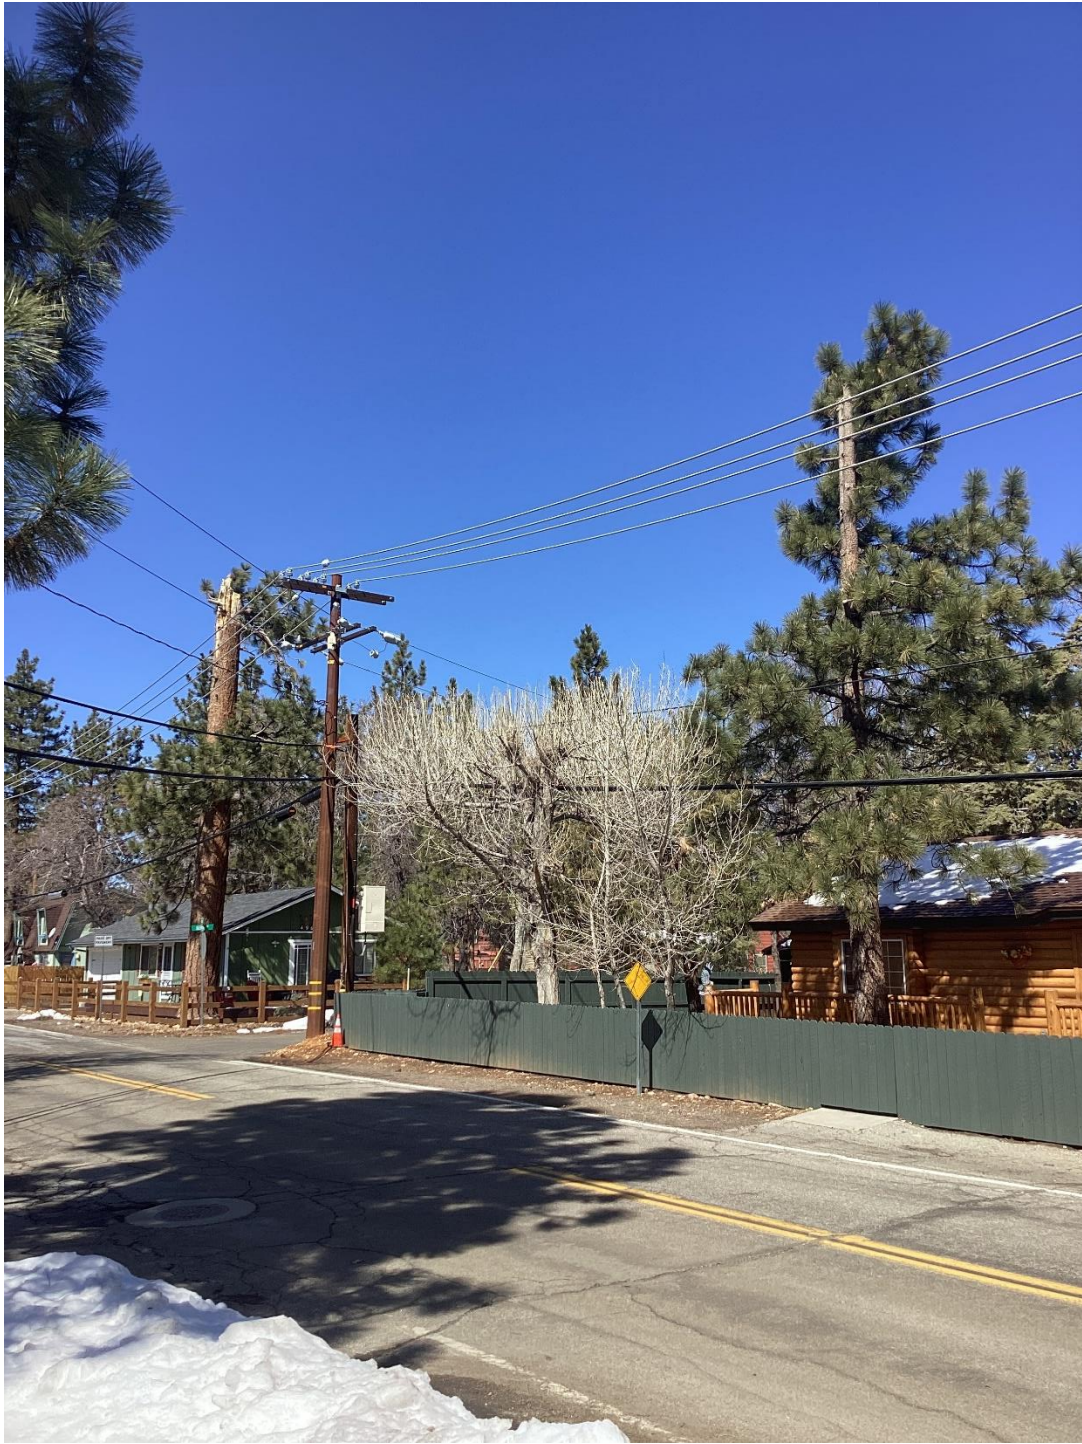
Finding: Near pole ID 15809 at 435-499 Kern Ave, Big Bear Lake, CA, 92386, USA, 34.2430496512049, -116.835088677895, the inspector observed a tulip tree in contact with the primary covered conductor. The inspector's observation is documented in Violation 1 photographs, which are attachments to this report. Photo numbers Item10IA1Img1 and Item10IA1Img2 depict a tulip tree in contact with electrical infrastructure (primary conductor) and within the minimum 72-inch safe clearance distance.

After picture of work completed on October 26, 2023

Response: BVES was made aware of the violation by a phone call on October 26, 2023. Crews were dispatched to the location of pole number 1509BV located at (Lat/Long: 34.2430496512049, -116.835088677895). Vegetation crews made corrective trims around the lines near the pole on October 26, 2023. Additionally, when this notice was sent to BVES on March 15, 2024, the lines were re-inspected on for any additional growth. See photos below.

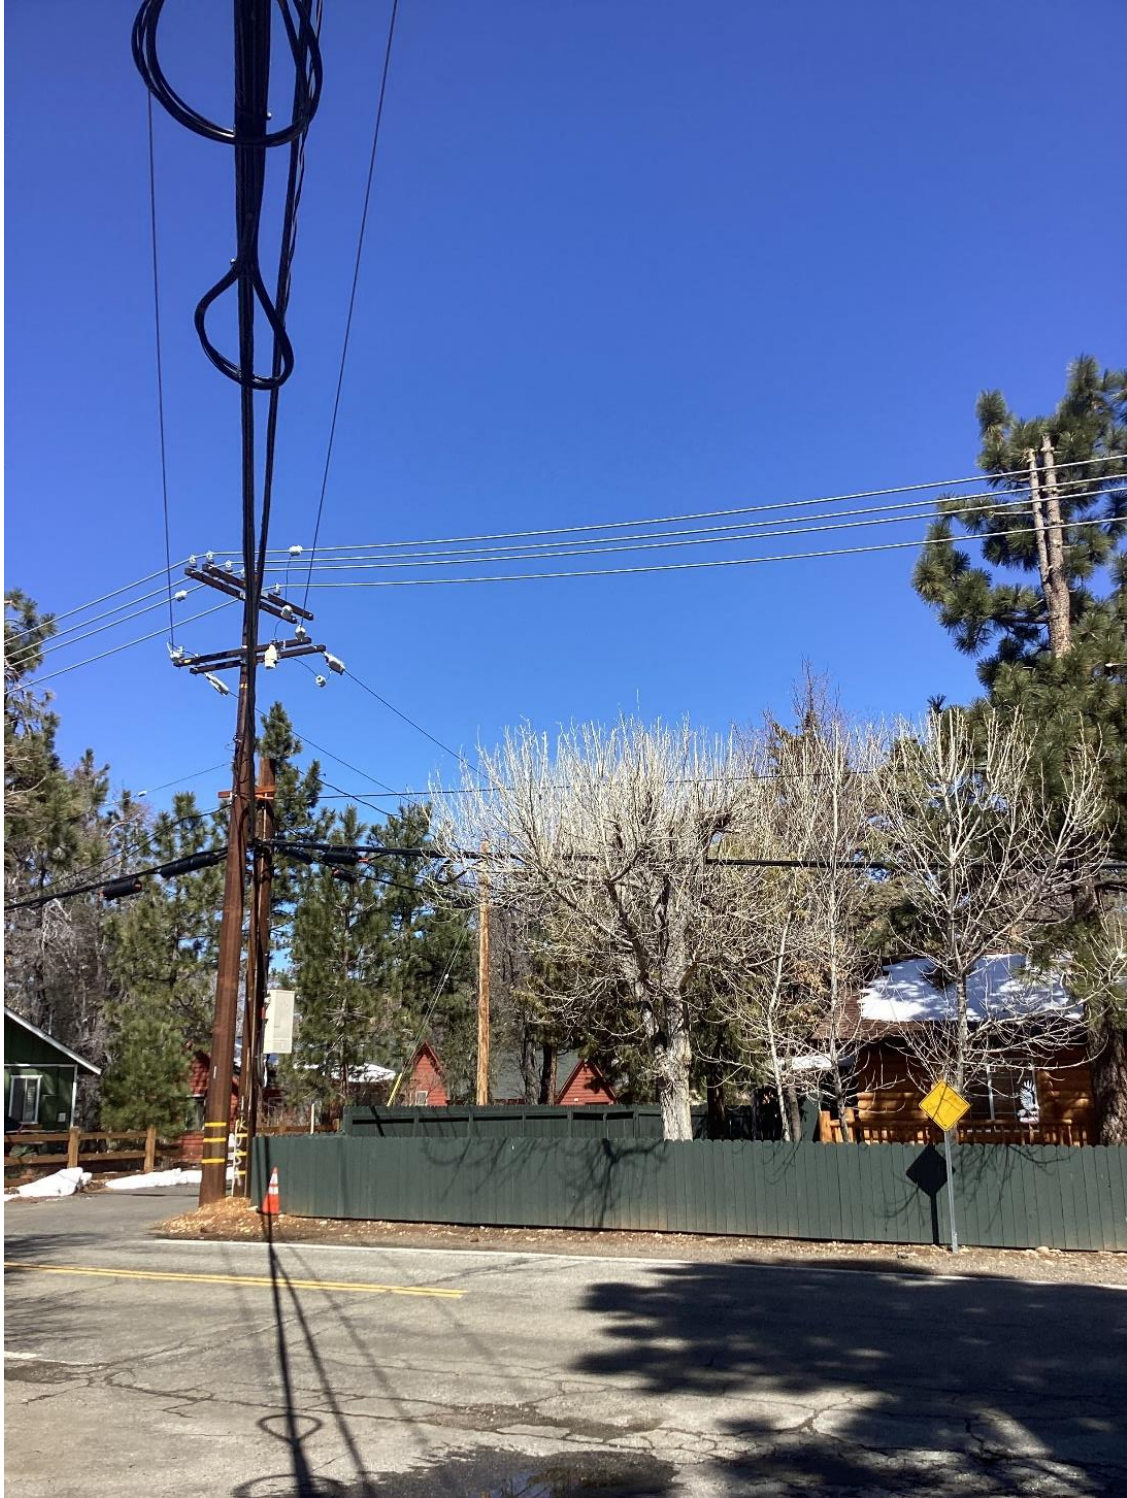
After picture of work completed on October 26, 2023
