## NOTICE OF VIOLATION

On April 27, 2023, Energy Safety conducted an inspection of SDG&E's WMP initiatives in the vicinity of the city of Alpine, California. The inspection report is enclosed herewith. Energy Safety found the following violation:

Violation 1. Energy Safety observed that in implementing 2022 WMP initiative 7.3.3.3 - Covered Conductor Installation, SDG&E failed to install covered conductor on pole ID P574883 at coordinates 32.8093471616653, -116.65015668652. Energy Safety considers this violation for failure to complete initiative to be in the Minor risk category.

# INSPECTION REPORT

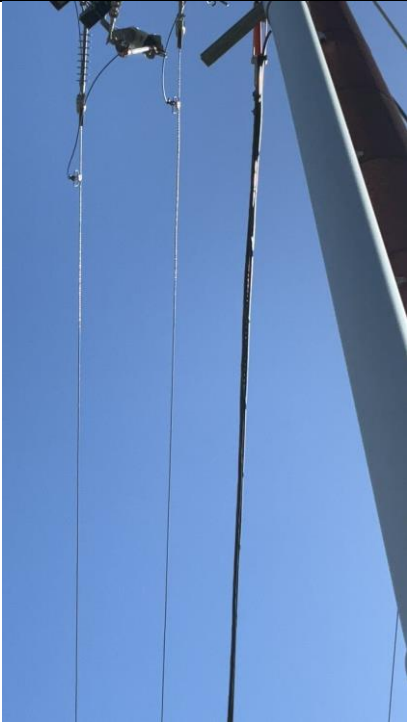
Energy Safety arrived at the provided pole ID P574883 at 23301-23567 Bell Bluff Truck Trail, Alpine, CA 91901, 32.8093471616653, -116.65015668652 and found bare wire. No covered conductor was observed where covered conductor installation was reported as completed by SDG&E. The inspector's observation is documented in Violation 1 photographs, which are attachments to this report. Photo numbers Item1GIimg1, Item1GIimg2 and Item1IA1img1 depict bare conductor where covered conductor installation was reported as completed.

1. SDG&E reported that WMP initiative number 7.3.3.3 – Covered Conductor installation as completed at this location.
2. Bare wire was observed at the provided location.
3. No covered conductor was not observed at the provided location.

**Item1IA1img1:** View of bare conductor where covered conductor installation was reported as completed.
