#### **NOTICE OF VIOLATION**

### **INSPECTION REPORT**

Electrical Corporation:	Liberty Utilities (LU)			
Report Number:	LU_CAC17_20231122_0834			
Inspector:	CAC17			
WMP Year Inspected:	2022			
Quarterly Data Report (QDR) Referenced:	Quarter 3 and Quarter 4 (Q3 & Q4)			
Inspection Selection:	Energy Safety viewed the contents of the Q3 & Q4 QDR and performed an analysis that resulted in the			
	selection of the WMP initiatives and locations referenced in this report.			
Relevant WMP Initiatives:	Expulsion fuse replacement (WMP initiative number 7.3.3.7).			
Date of inspection:	November 22, 2023			
City and County of Inspection:	Tahoe City, Placer County			
Inspection Purpose:	Assess the accuracy of Liberty Utilities' QDR data, completeness of its work, compliance with WMP			
	requirements, and compliance with its protocols.

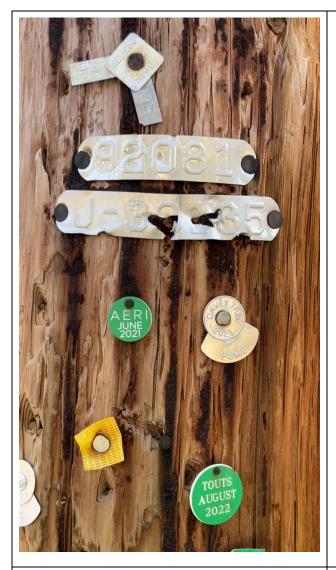
Item3GImg1: Pole ID.

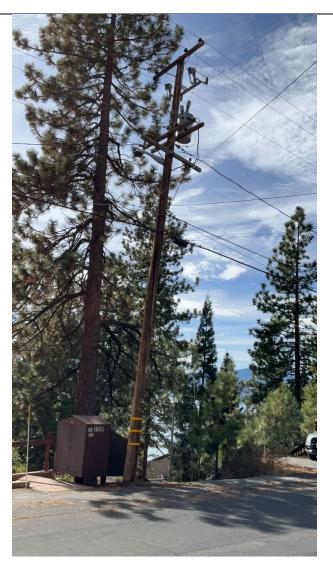
Item3Glmg2: Overall pole.

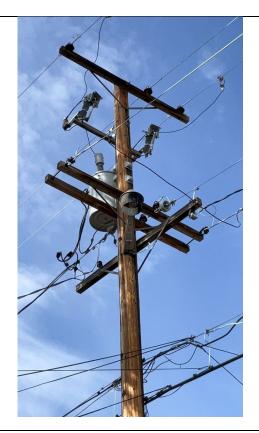
On pole ID 92081 at 3306 Edgewater Dr, Tahoe City, CA, 96145, USA, 39.1849205330682, -120.097887084118, the inspector observed both an expulsion fuse and a non-expulsion fuse on the pole. The inspector's observation is documented in Violation 1 photographs, which are attachments to this report. Photo numbers Item3Glmg1, Item3Glmg2, Item3IA1Img1, and Item3IA1Img2 depict the installation of an expulsion fuse and a non-expulsion fuse on this pole.

- 1. Liberty Utilities' WMP initiative number 7.3.3.7 Expulsion Fuse Replacement work was reported as complete at this location.
- 2. Liberty Utilities' WMP initiative number 7.3.3.7 Expulsion Fuse Replacement states expulsion fuses are replaced with non-expulsion fuse alternatives.
- 3. An expulsion fuse was observed on the pole.

**Item3IA1Img1**: View of one expulsion fuse (left) and one non-expulsion fuse (right).

Energy Safety may prescribe a timeframe for resolution of a violation associated with the assigned risk category. Within 30 days from the issuance date of this NOV, the electrical corporation must provide a response advising Energy Safety of corrective actions taken or planned to remedy the above identified violation and prevent recurrence. Alternatively, the electrical corporation must advise Energy Safety that it will not correct the violation, including the reasoning or justification for inaction and all supporting documentation.<sup>3</sup>

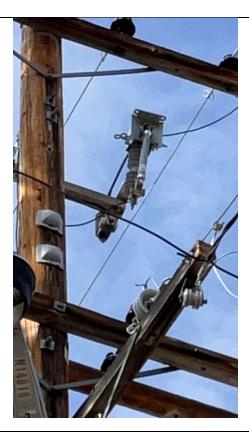
Violation 1. Energy Safety observed that in implementing 2022 WMP initiative 7.3.3.7 – Expulsion fuse replacement, Liberty Utilities failed to complete an expulsion fuse replacement with a non-expulsion fuse alternative on pole ID 92081 at coordinates 39.1849205330682, -120.097887084118. Energy Safety considers this violation for failure of completeness to be in the Minor risk category.

**Item3IA1Img2**: Close-up view of installed nonexpulsion fuse indicating half the reported initiative work was completed.
