NOTICE OF VIOLATION

INSPECTION REPORT

Electrical Corporation:	PacifiCorp (PC)
Report Number:	PC_CAC9_20230809_1346
Inspector:	CAC9
WMP Year Inspected:	2022
Quarterly Data Report (QDR) Referenced:	Quarter 3 and Quarter 4 (Q3 & Q4)
Inspection Selection:	Energy Safety viewed the contents of the Q3 & Q4 QDR and performed an analysis that resulted in the selection of the WMP initiatives and locations referenced in this report.
Relevant WMP Initiative(s):	Expulsion Fuse Replacement (2022 WMP initiative number 7.3.3.7)
Date of inspection:	August 9, 2023
City and/or County of Inspection:	Happy Camp, Siskiyou County
Inspection Purpose:	Assess the accuracy of PacifiCorp’s QDR data, completeness of its work, compliance with WMP requirements, and compliance with its protocols.

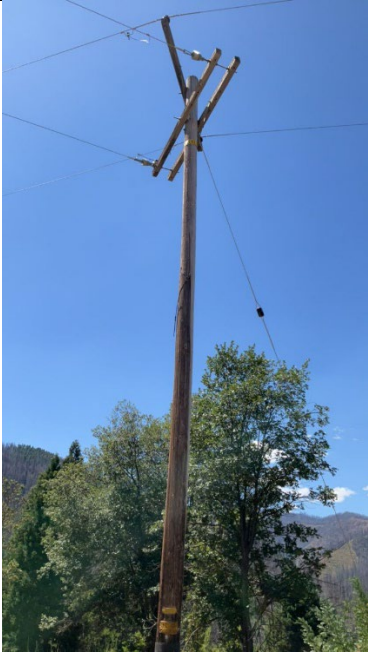
Energy Safety arrived at the provided location at pole ID 7116007.00233 at 840 Indian Creek Rd, Happy Camp, CA, 96039, USA, 41.8038176882994, -123.378034851249 and observed a utility pole with no fuses or cutouts. The inspector's observation is documented in Violation 1 photographs, which are attachments to this report. Photo numbers Item2GImg1, Item2GImg2, and Item2IA1Img1 depict a utility pole with no fuses or cutouts where PacifiCorp reported installing new and CAL FIRE-approved fuses.

Item2G1mg1: Overall pole.

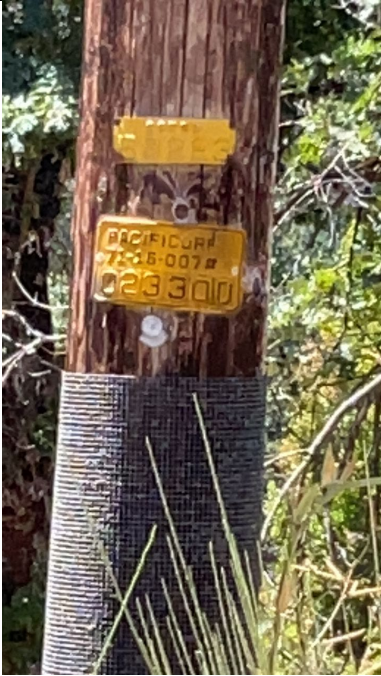
Item2G1mg2: Pole ID.

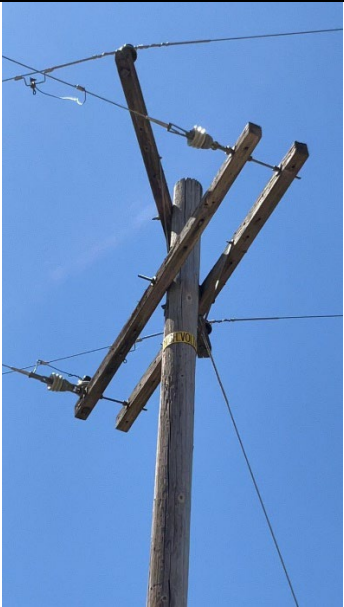
1. PacifiCorp's WMP expulsion fuse replacement work was identified as complete at this location.
2. The subject pole is in HFTD Tier 2.
3. There were no fuses or cutouts on the subject pole.

Item2IA1mg1: View of subject pole with no fuses.

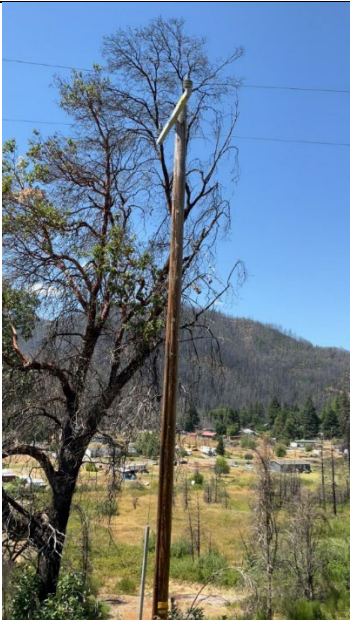
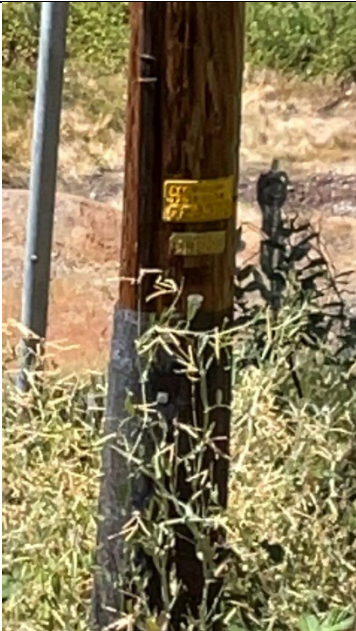
Energy Safety arrived at the provided location at pole ID 7116007.0023302 at 846 Indian Creek Rd, Happy Camp, CA, 96039, USA, 41.8041489207657, -123.377730520978 and found no fuses or cutouts on the pole. The inspector's observation is documented in Violation 2 photographs, which are attachments to this report. Photo numbers Item3GIimg1, Item3GIimg2, and Item3IA1img1 depict a utility pole with no fuses where PacifiCorp reported installing new and CAL FIRE-approved fuses.

<p>Item3GImg1: Overall pole.</p>	<p>Item3GImg2: Pole ID.</p>

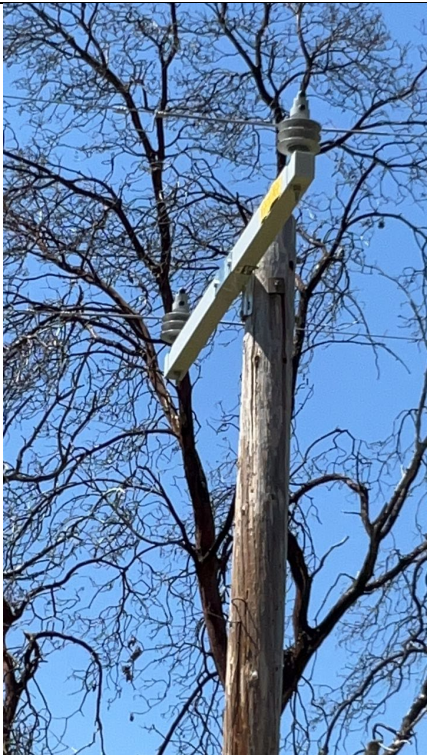
1. PacifiCorp's WMP expulsion fuse replacement work was identified as complete at this location.
2. The subject pole is in HFTD Tier 2.
3. There were no fuses or cutouts on the subject pole.

<p>Item3IA1Img1: View of subject pole with no fuses.</p>

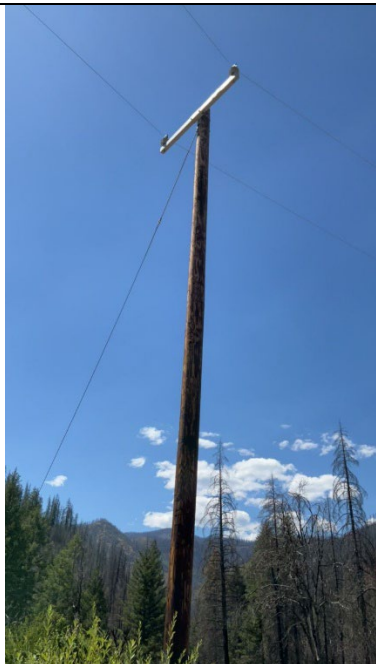
On pole ID 7116007.0020401 at 237 Indian Meadows Dr, Happy Camp, CA, 96039, USA, 41.8070274149862, -123.383514648978, the inspector observed a utility pole with no fuses or cutouts on the pole. The inspector's observation is documented in Violation 3 photographs, which are attachments to this report. Photo numbers Item7G1mg1, Item7G1mg2, and Item7IA11mg1 depict a utility pole with no fuses where PacifiCorp reported installing new and CAL FIRE-approved fuses.

Item7GImg1: Overall pole.

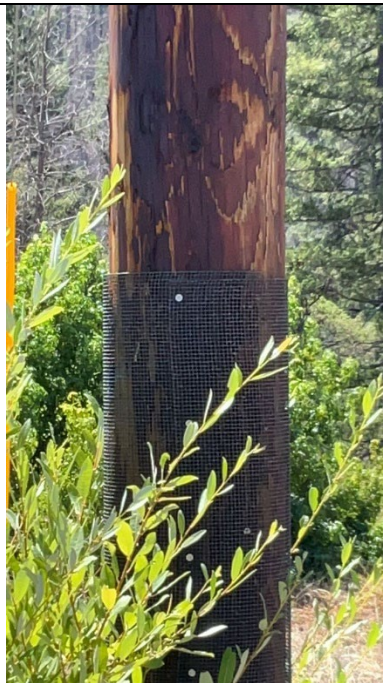
Item7GImg2: Pole ID is absent.

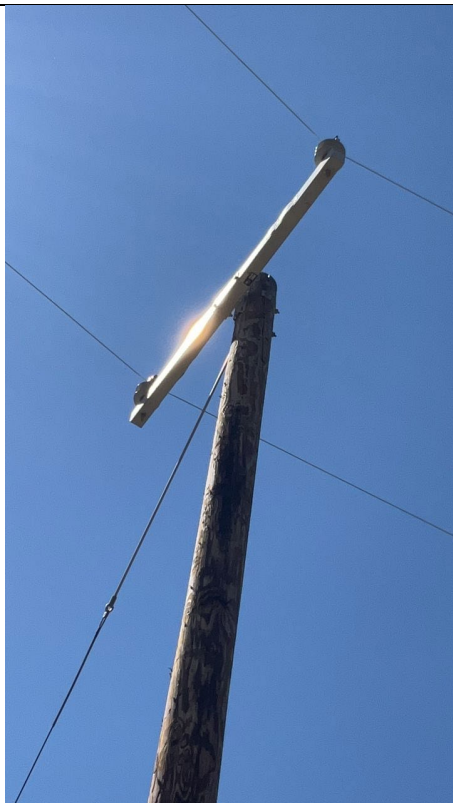
1. PacifiCorp's WMP 7.3.3.7 - Expulsion Fuse Replacement work was identified as complete at this location.
2. The subject pole is in HFTD Tier 2.
3. There were no fuses or cutouts on the subject pole.

Item7IA1Img1: View of subject pole with no fuses.
