SUBJECT: Southern California Edison Company's Response to Notice of Violation
- SCE_CAC15_20231219_0851

Finding: Failure to achieve required clearance

Notice	Finding #	Structures
SCE_CAC15_20231219_0851	1	1248323E

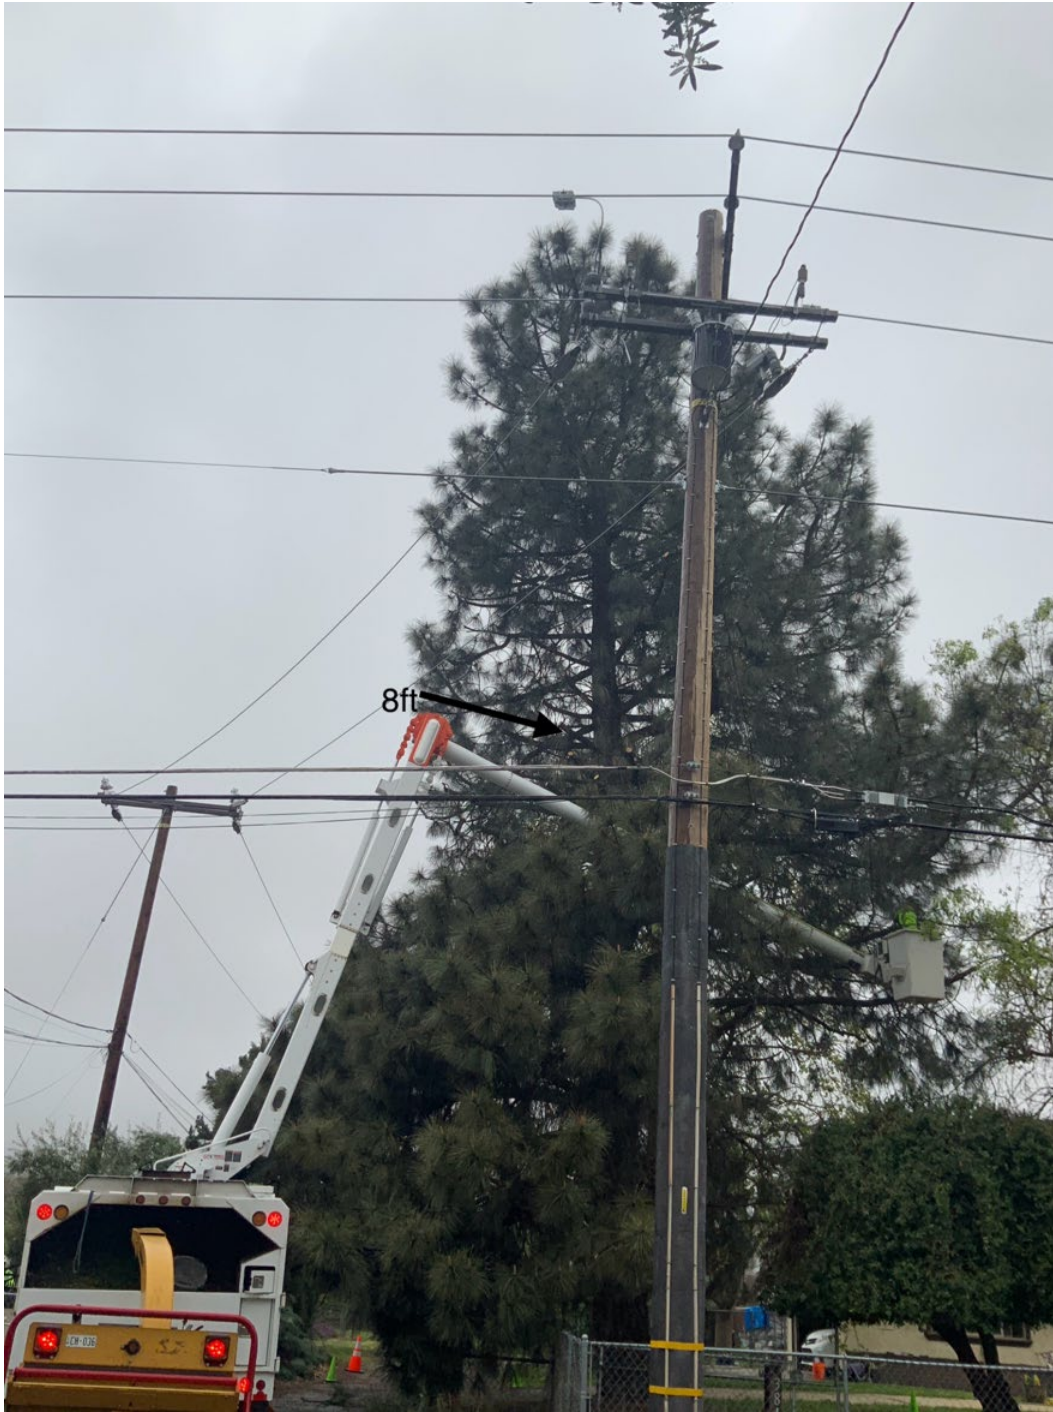
Tree Trimming Crews Performing Trimming on 4/26/24

On 4/26/24, trimming was performed and achieved a clearance of 8 feet to the conductors. Please see photographs of tree trimming crews performing trimming on 4/26/24.

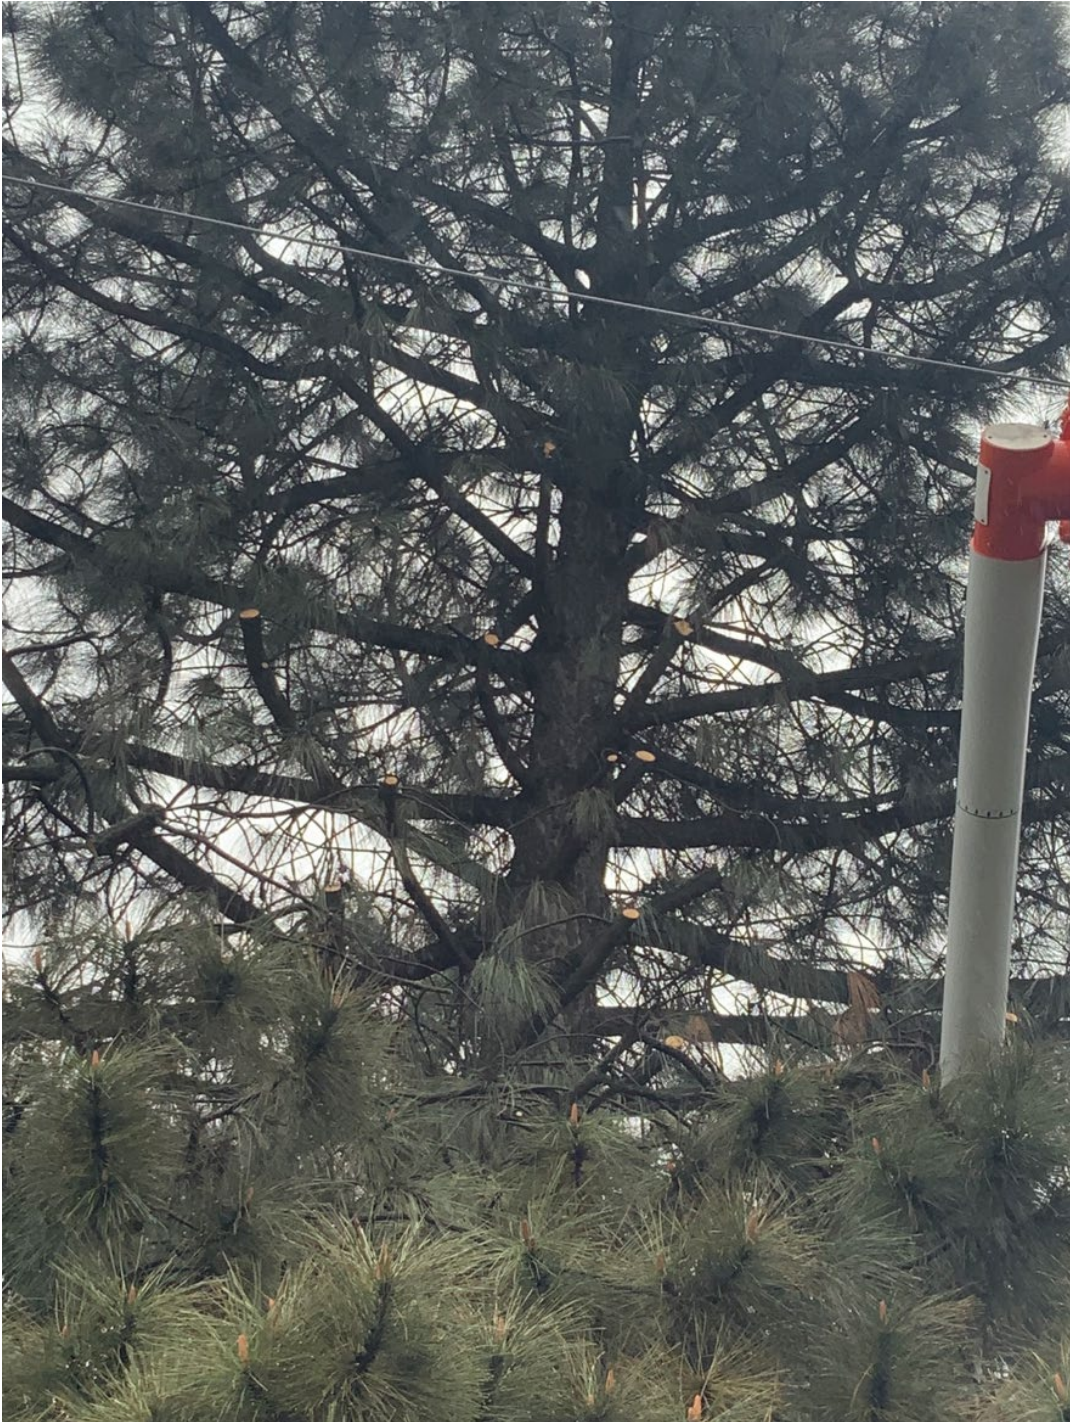
Photograph showing tree limbs removed on 4/26/24

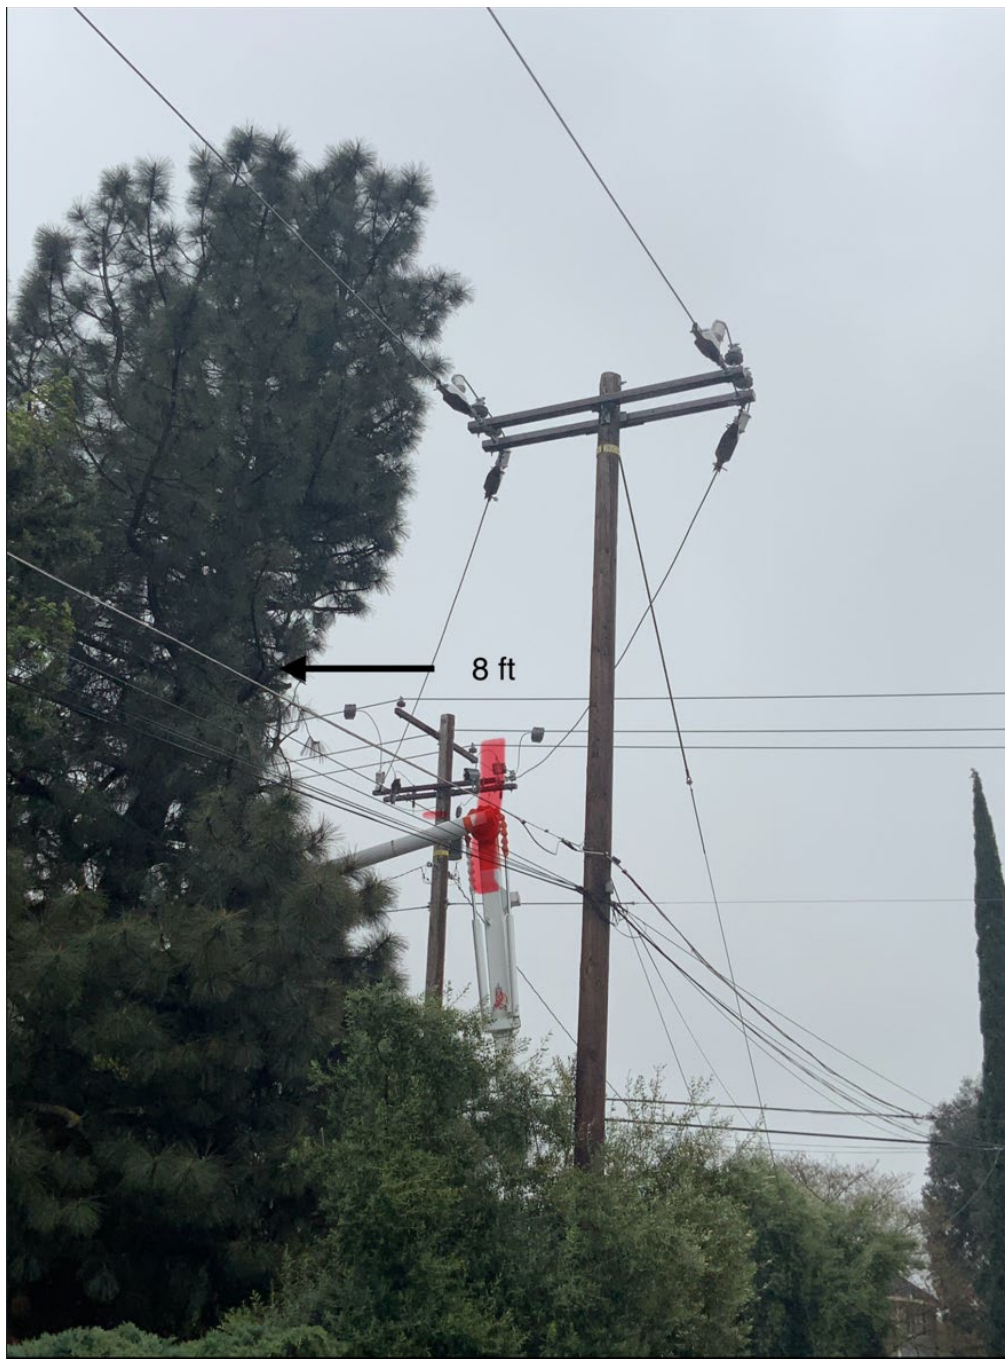
Post trim clearance established at 8 ft

On 4/24/24, the SCE SSP met with the homeowner and received approval to trim the tree to an enhanced clearance of 8 feet beyond the conductors. Customer would not allow additional clearance. The minimum clearance required per regulation is 4 feet.
