Subject: Liberty's Response to Notice of Violation – NOV_LU_CAC17_20231116

Liberty Response

Finding: Failure to replace expulsion fuses with non-expulsion fuse alternatives / Failure to remove tree attachment(s).

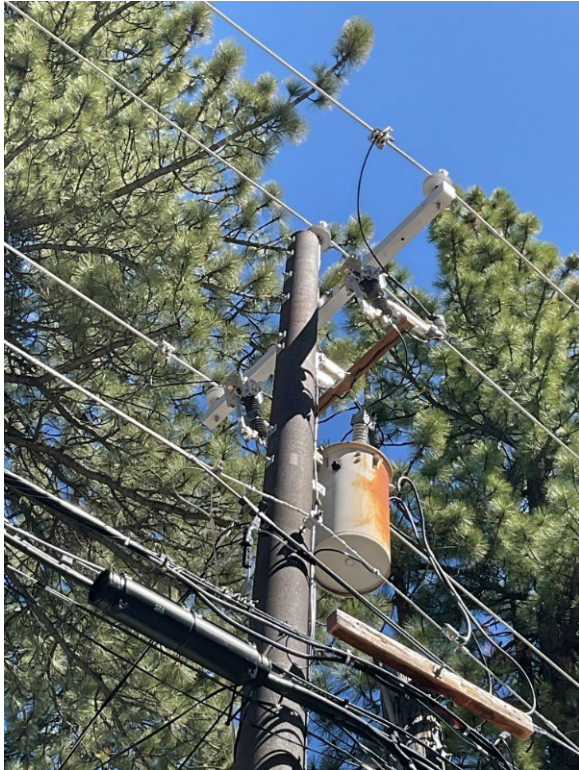
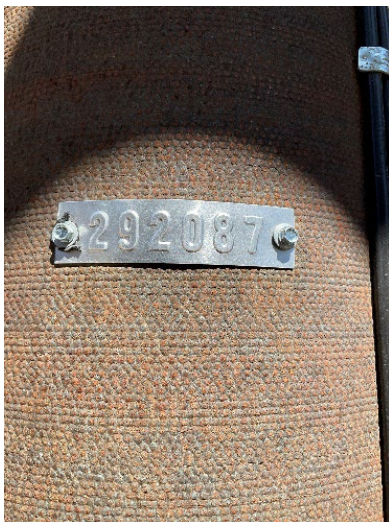
Violation 1. Energy Safety observed that in implementing 2022 WMP initiative 7.3.3.7 – Expulsion Fuse Replacement, Liberty Utilities failed to complete the replacement of expulsion fuses with non-expulsion fuse alternatives on pole ID 292087 at coordinates 39.2426041412934, -120.048456796215. Energy Safety considers this violation for failure of completeness to be in the Minor risk category.

Liberty Response 1 - Liberty disagrees with Energy Safety's observation that it failed to complete the replacement of expulsion fuses with non-expulsion fuse alternatives on pole ID 292087 because Liberty did not report that work as completed in its Quarter 3 2023 spatial data report. Additionally, at the time of this response, Liberty has replaced the expulsion fuse on pole ID 292087 with a non-expulsion fuse alternative to reduce wildfire risk. The following photos show the completed work at this location:

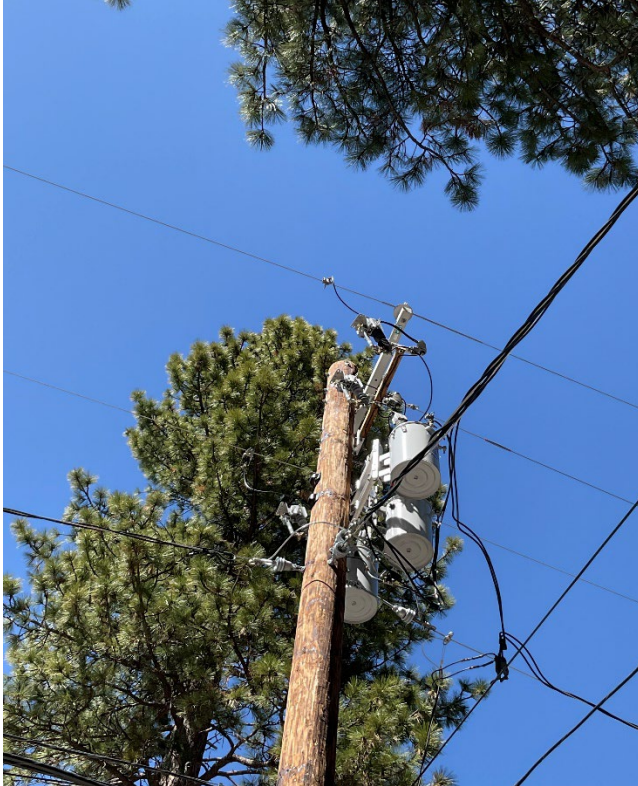
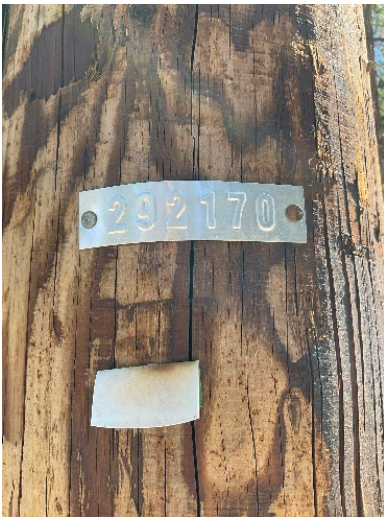
Violation 2. Energy Safety observed that in implementing 2022 WMP initiative 7.3.3.7 – Expulsion Fuse Replacement, Liberty Utilities failed to complete the replacement of expulsion fuses with non-expulsion fuse alternatives on pole ID 292170 at coordinates 39.2384877574962, -120.027669287579. Energy Safety considers this violation for failure of completeness to be in the Minor risk category.

Liberty Response 2 - Liberty disagrees with Energy Safety's observation that it failed to complete the replacement of expulsion fuses with non-expulsion fuse alternatives on pole ID 292170 because Liberty did not report that work as completed in its Quarter 3 2023 spatial data report. Additionally, at the time of this response, Liberty has replaced the expulsion fuse on pole ID 292170 with a non-expulsion fuse alternative to reduce wildfire risk. The following photos show the completed work at this location:

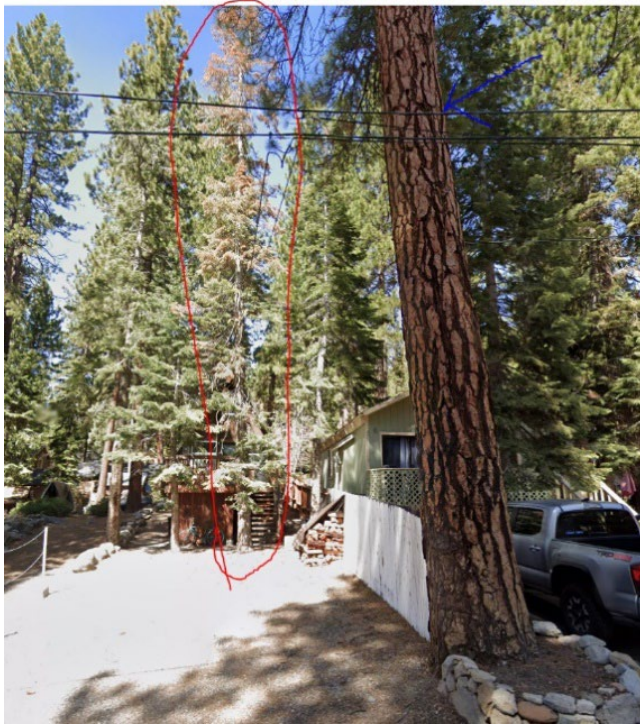
Violation 3. Energy Safety observed that in implementing 2022 WMP initiative 7.3.3.12 - Tree Attachment Removal, Liberty Utilities failed to complete a tree attachment removal on pole ID 291897 at coordinates 39.2361242144599, -120.016292223114. Energy Safety considers this violation for failure of completeness to be in the Minor risk category.

Photo showing dead tree and related tree attachment prior to removal:

Liberty Response 3 - Liberty disagrees with Energy Safety's observation that it failed to complete the removal of a tree attachment on pole ID 291897 because Liberty did complete that tree attachment removal as reported in its Quarter 3 2023 spatial data report. It is possible that Energy Safety's observation was of other tree attachments in the vicinity. The following photos identify the completed work at the pole ID 291897 location:

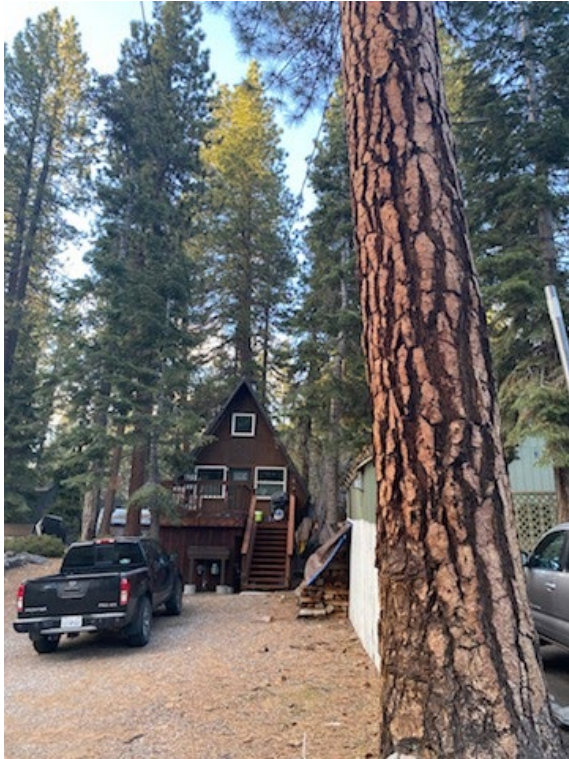
Photo showing that tree attachment and dead tree have been removed:

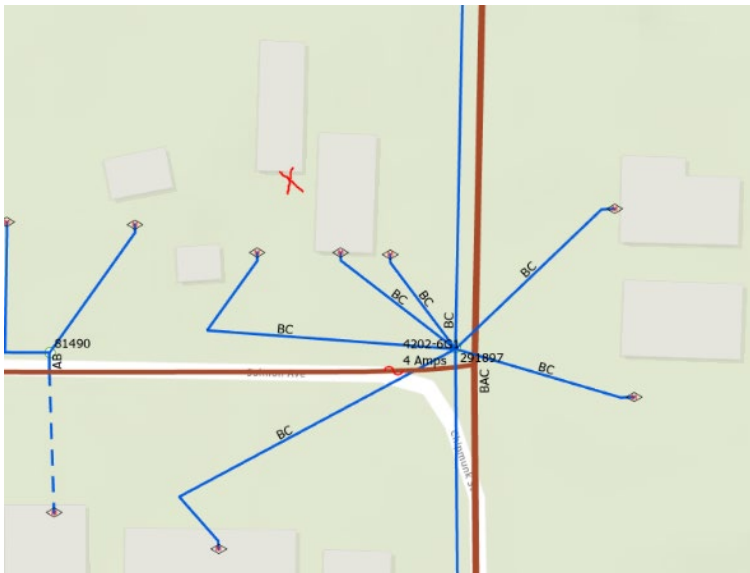
Map depicting location of removed tree and tree attachment:

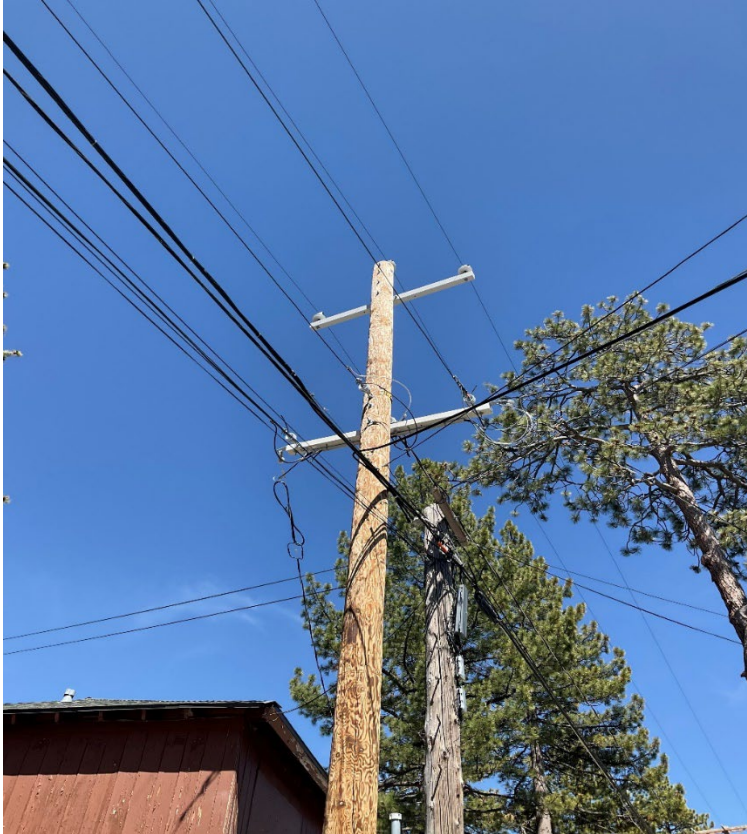
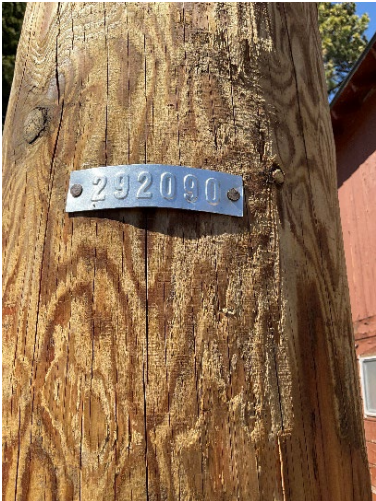
Violation 4. Energy Safety observed that in implementing 2022 WMP initiative 7.3.3.7 – Expulsion Fuse Replacement, Liberty Utilities failed to complete the replacement of existing expulsion fuses with non-expulsion fuse alternatives on pole ID 292090 at coordinates 39.2369406983482, -120.027923542717. Energy Safety considers this violation for failure of completeness to be in the Minor risk category.

Liberty Response 4 - Liberty disagrees with Energy Safety's observation that it failed to complete the replacement of expulsion fuses with non-expulsion fuse alternatives on pole ID 292090 because Liberty did not report that work as completed in its Quarter 3 2023 spatial data report. Additionally, at the time of this response, Liberty has replaced the expulsion fuse on pole ID 292090 with a non-expulsion fuse alternative to reduce wildfire risk. The following photos show the completed work at this location:

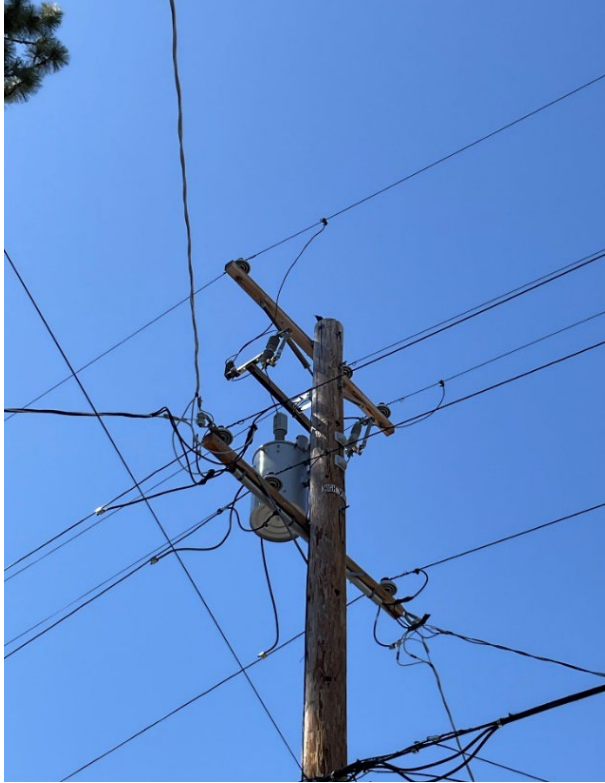
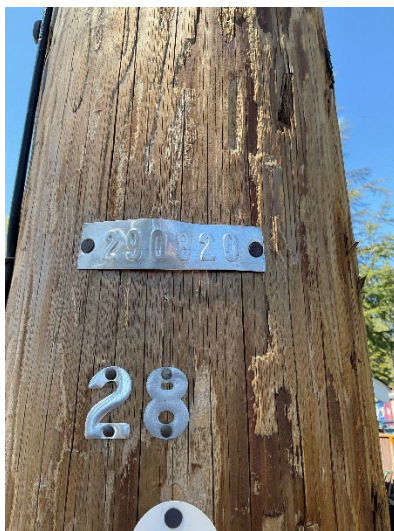
Violation 5. Energy Safety observed that in implementing 2022 WMP initiative 7.3.3.7 – Expulsion Fuse Replacement, Liberty Utilities failed to complete the replacement of existing expulsion fuses with non-expulsion fuse alternatives on pole ID 290820 at coordinates 39.2371603131986, -120.028928803064. Energy Safety considers this violation for failure of completeness to be in the Minor risk category.

Liberty Response 5 - Liberty disagrees with Energy Safety's observation that it failed to complete the replacement of expulsion fuses with non-expulsion fuse alternatives on pole ID 290820 because Liberty did not report that work as completed in its Quarter 3 2023 spatial data report. Additionally, at the time of this response, Liberty has replaced the expulsion fuse on pole ID 290820 with a non-expulsion fuse alternative to reduce wildfire risk. The following photos show the completed work at this location:
