Docket # 2022 NOV

**RE: PacifiCorp's Response to Notice of Violation – NOV\_PC\_CAC9\_20230809\_1346**

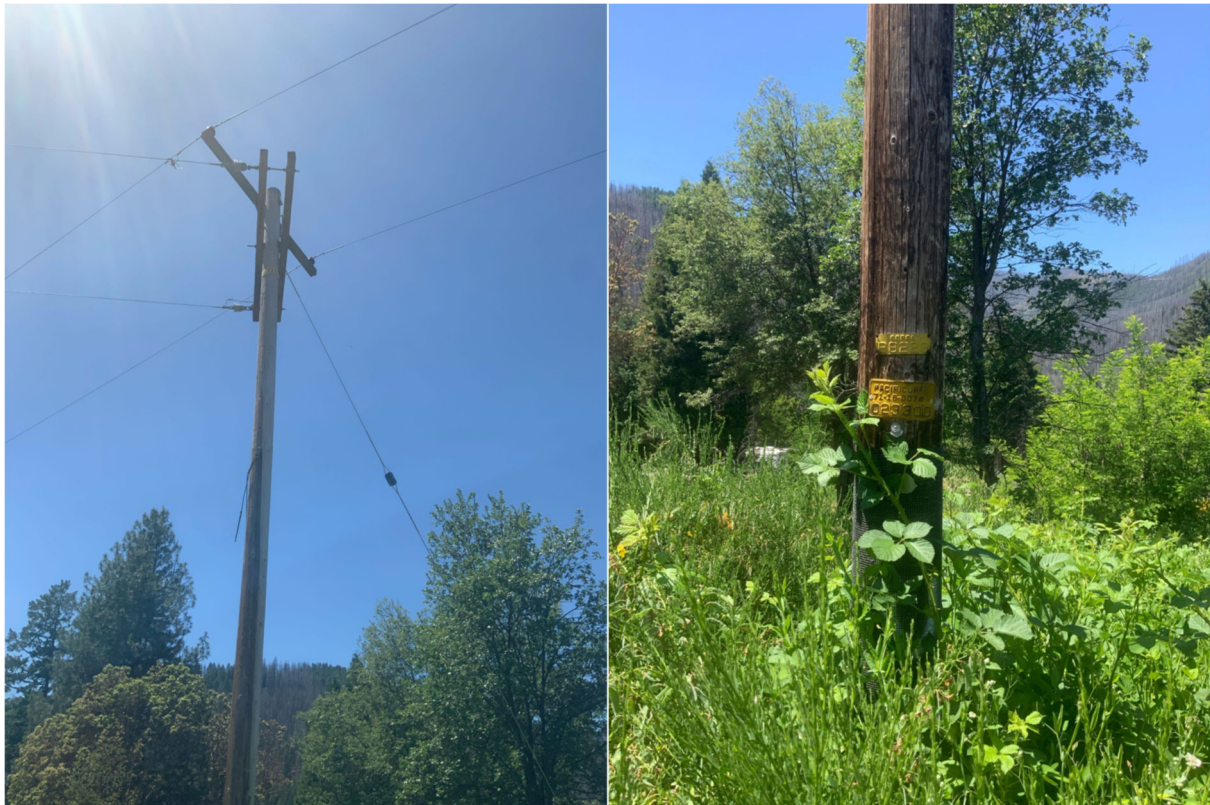
**Violation 1.** Energy Safety observed that in implementing 2022 WMP initiative 7.3.3.7 – Expulsion Fuse Replacement, PacifiCorp failed to provide accurate data for pole ID 7116007.00233 at coordinates 41.8038176882994, -123.378034851249. Energy Safety considers this violation for failure to provide accurate data to be in the Minor risk category.

PacifiCorp records show that the facility was inspected on October 8, 2022 and found to be exempt. In response to the notice of violation, the company conducted a field inspection on May 20, 2024, and found that all non-exempt equipment was previously removed. A request to the company's geographical information system (GIS) team was made to remove the equipment that is no longer in the field. There are no further corrective actions required. Please see below images of the pole from a field inspection on May 20, 2024.

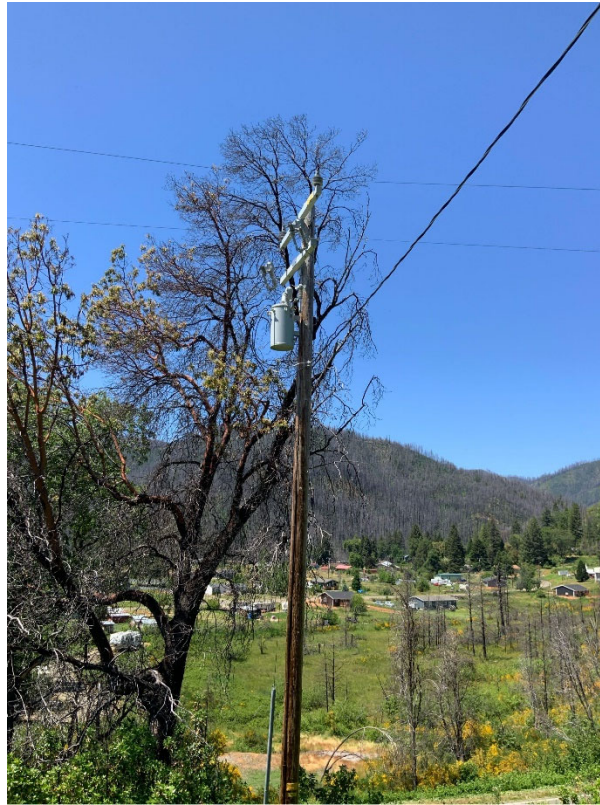
**Violation 2.** Energy Safety observed that in implementing 2022 WMP initiative 7.3.3.7 – Expulsion Fuse Replacement, PacifiCorp failed to provide accurate data for pole ID 7116007.0023302 at coordinates 41.8041489207657, -123.377730520978. Energy Safety considers this violation for failure to provide accurate data to be in the Minor risk category.

PacifiCorp records show that the transformer, fuses, and other non-exempt equipment were removed on October 15, 2022 and the cross arm was replaced on the same date. In response to the notice of violation, the company conducted a field inspection on May 14, 2024, and current pole conditions show that new overhead transformer with non-expulsion arrester and ELF type fuse were installed on March 26, 2024. There are no further corrective actions required. Please see below an image of the pole from a field inspection on May 14, 2024.

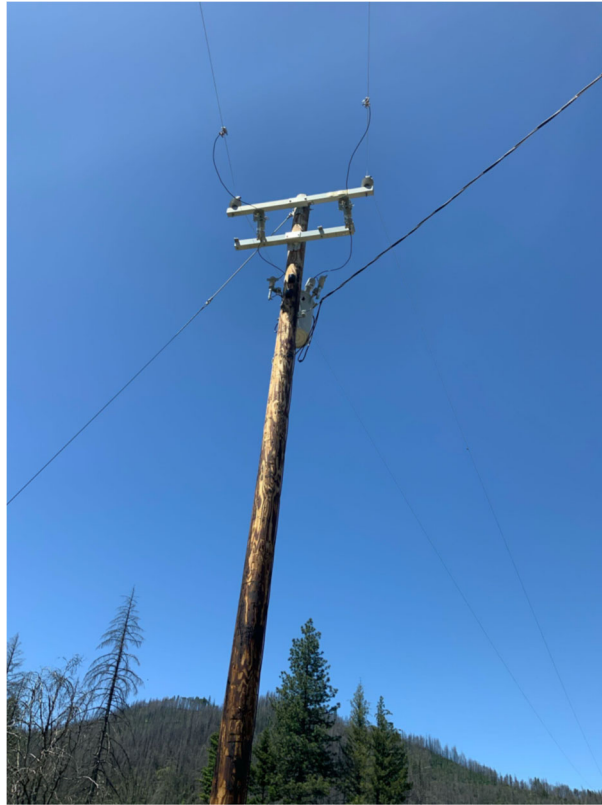
**Violation 3.** Energy Safety observed that in implementing 2022 WMP initiative 7.3.3.7 – Expulsion Fuse Replacement, PacifiCorp failed to provide accurate data for pole ID 7116007.0020401 at coordinates 41.8070274149862, -123.383514648978. Energy Safety considers this violation for failure to provide accurate data to be in the Minor risk category.

PacifiCorp records show that the facility was inspected on October 8, 2022 and found to be exempt (transformer and fuses were previously removed but are still included in PacifiCorp’s geographical information system). In response to the notice of violation, the company conducted a field inspection on May 14, 2024, and current pole conditions show that new overhead transformer with non-expulsion arrester and ELF type fuse were installed on February 16, 2024. There are no further corrective actions required. Please see below an image of the pole from a field inspection on May 14, 2024.
