### NOTICE OF VIOLATION

## **INSPECTION REPORT**

Electrical Corporation:	PacifiCorp			
Report Number:	PC_SIS_20240523_0916			
Inspector:	Samuel Isaiah			
WMP Year Inspected:	2023			
Quarterly Data Report (QDR) Referenced:	Quarter 4 (Q4)			
Inspection Selection:	Energy Safety viewed the contents of the Q4 QDR and performed an analysis that resulted in the selection of			
	the WMP initiatives and locations referenced in this report.			
Relevant WMP Initiative(s):	Expulsion Fuse Replacements (2023 WMP initiative number 8.1.2.12)			
Date of inspection:	May 23, 2024			
City and/or County of Inspection:	Fort Jones, Siskiyou County			
Inspection Purpose:	Assess the accuracy of PacifiCorp's QDR data, completeness of its work, compliance with WMP requirements,			
	and compliance with its protocols.

Exhibit A: Photo Log Structure ID: 06243009.0028303

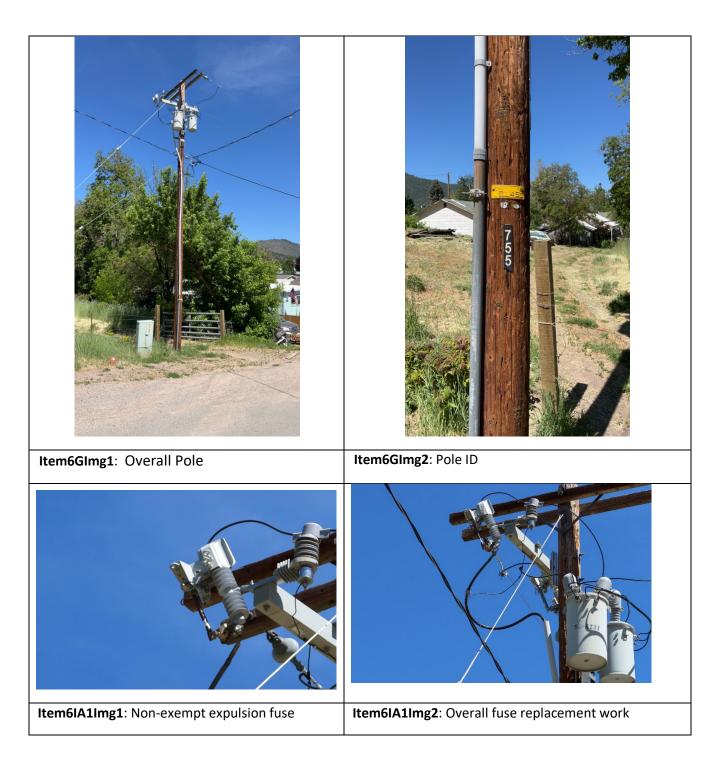
122.841787587528, the inspector observed that one of the fuses in place is a non-exempt expulsion fuse. The inspector's observation is documented in Violation 1 photographs, which are attachments to this report. Photo numbers Item6IA1Img1 and Item6IA1Img2 depict a non-exempt expulsion fuse.

- 1. PacifiCorp's WMP 8.1.2.12 Expulsion Fuse Replacement work was identified as complete at this location.
- 2. Energy Safety observed a non-exempt expulsion fuse.
