## NOTICE OF VIOLATION

# INSPECTION REPORT

Electrical Corporation:	PacifiCorp
Report Number:	PC_SIS_20240509_0914
Inspector:	Samuel Isaiah
WMP Year Inspected:	2023
Quarterly Data Report (QDR) Referenced:	Quarter 3 (Q3)
Inspection Selection:	Energy Safety viewed the contents of the Q3 QDR and performed an analysis that resulted in the selection of the WMP initiatives and locations referenced in this report.
Relevant WMP Initiative(s):	Expulsion Fuse Replacements (2023 WMP initiative number 8.1.2.12)
Date of inspection:	May 9, 2024
City and/or County of Inspection:	Mount Shasta, Siskiyou County
Inspection Purpose:	Assess the accuracy of PacifiCorp’s QDR data, completeness of its work, compliance with WMP requirements, and compliance with its protocols.

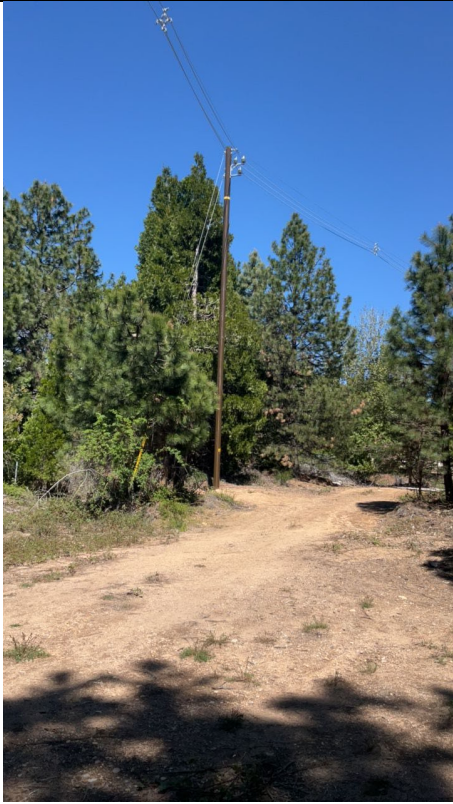
A photograph showing a utility pole standing in a wooded area with a dirt path leading towards it. The sky is clear and blue.

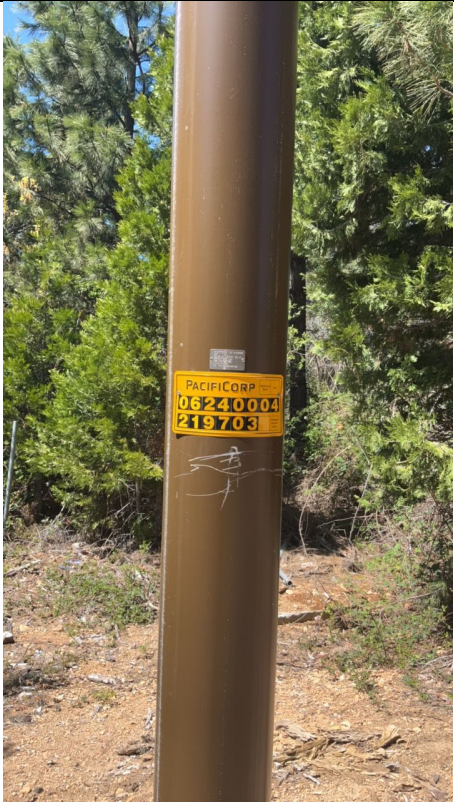
A close-up photograph of a utility pole. A yellow identification tag is attached to the pole, displaying the text: PACIFICORP, 06240004, and 0219703. There are some white markings on the pole below the tag.
<p><b>Item9GImg1:</b> Overall Pole</p>	<p><b>Item9GImg2:</b> Pole ID</p>

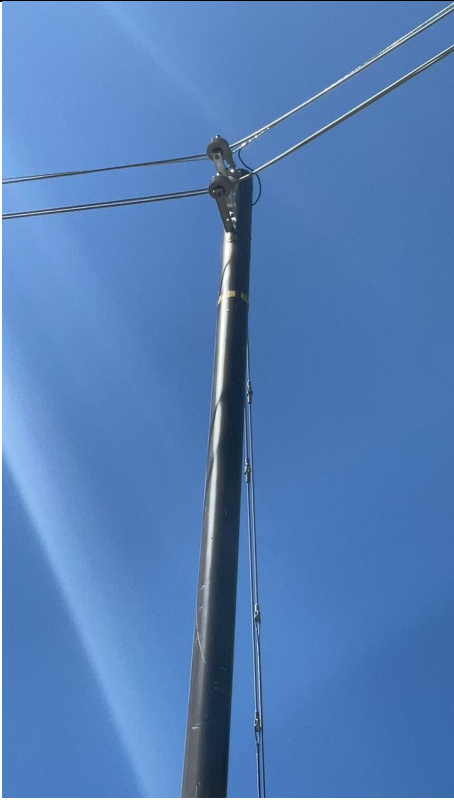
**Item9IA3Img1: No Fuse Installed**

Energy Safety arrived at the provided pole ID 06240004.0219703 at 1305-1399 S Mount Shasta Blvd, Mount Shasta, CA, 96067, USA, 41.3009857032377, -122.307145186836 and observed that the pole did not have fuses installed where Expulsion Fuse Replacement was reported as completed. The inspector's observation is documented in Violation 1 photographs, which are attachments to this report. Photo number Item9IA3Img1 depicts no fuses on the pole.

1. The reported location provided by PacificCorp indicated that work on the Expulsion Fuse Replacements initiative (8.1.2.12) was reported as completed.
2. No fuses were observed on the indicated pole.
