NOTICE OF VIOLATION

INSPECTION REPORT

Electrical Corporation:	PacifiCorp (PC)
Report Number:	PC_CAC17_20240501_1051
Inspector:	CAC17
WMP Year Inspected:	2023
Quarterly Data Report (QDR) Referenced:	Quarter 4 (Q4)
Inspection Selection:	Energy Safety viewed the contents of the Q4 QDR and performed an analysis that resulted in the selection of the WMP initiatives and locations referenced in this report.
Relevant WMP Initiative(s):	Distribution Pole Replacements and Reinforcements (2023 WMP initiative number 8.1.2.3)
Date of inspection:	May 1, 2024
City and/or County of Inspection:	Weed, Siskiyou County
Inspection Purpose:	Assess the accuracy of PacifiCorp’s QDR data, completeness of its work, compliance with WMP requirements, and compliance with its protocols.

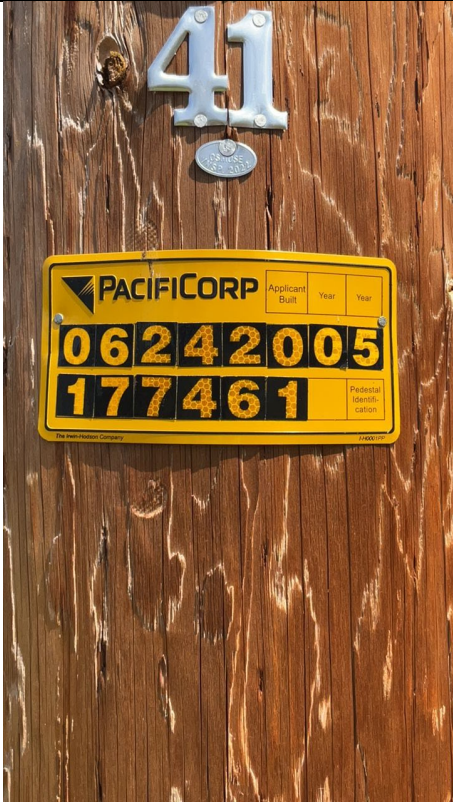
On pole ID 06242005.0177461 at 22602 Slough Rd, Weed, CA, 96094, USA, 41.4857664462249, -122.442510294584, the inspector observed that the subject pole was a wood pole, manufactured in the year 2006. The inspector's observation is documented in Violation 1 photographs, which are attachments to this report. Photo numbers Item13GImg1, Item13GImg2, Item13IA1Img3, and Item13IA1Img4 depict that the pole was not replaced.

<p>A close-up photograph of a wooden utility pole. At the top, a blue metal number '41' is mounted. Below it is a small circular metal tag. A large yellow identification tag is affixed to the wood. The tag features the 'PACIFICORP' logo and a table with columns for 'Applicant', 'Built', 'Year', and 'Year'. The identification number '06242005' and '177461' is printed in large black digits on a yellow background. A small 'Pacelocal Identification' label is also visible on the tag.</p>

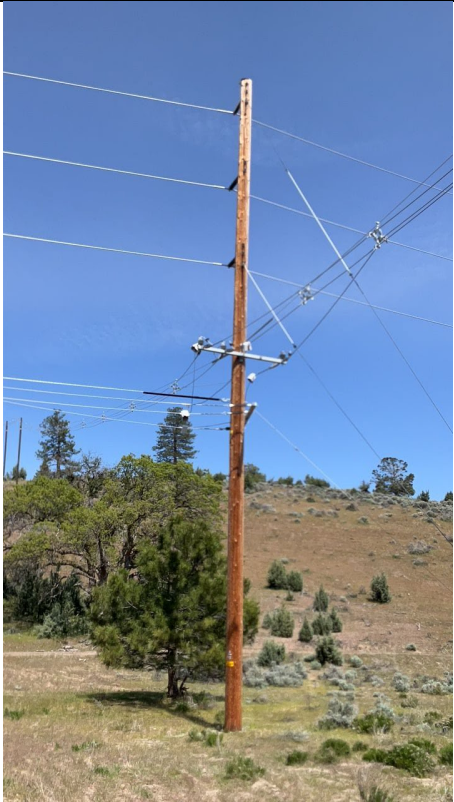
<p>A photograph showing a wooden utility pole in its entirety, standing in a rural landscape. The pole is supported by cross-arms and carries several power lines. The background consists of a clear blue sky, green trees, and a grassy hillside.</p>
<p>Item13GImg1: Pole ID.</p>	<p>Item13GImg2: Overall pole.</p>

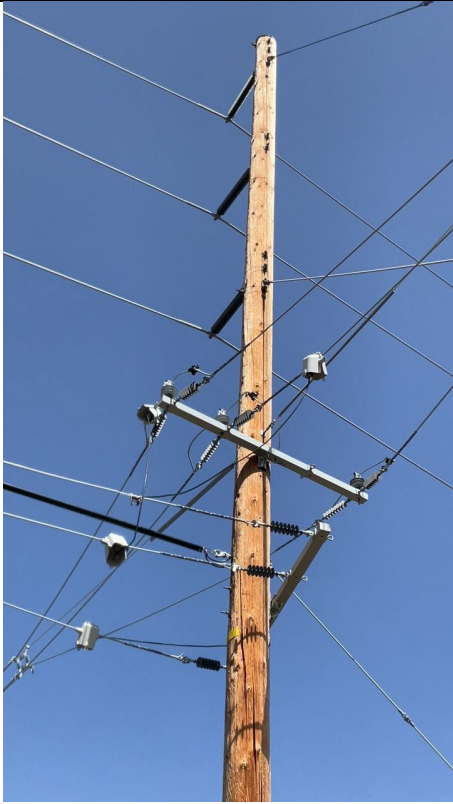
Item13IA1img3: View of pole top.

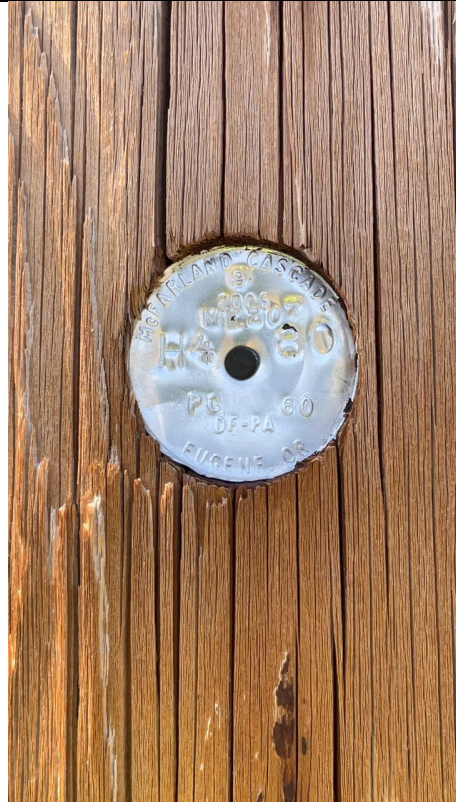
1. PacifiCorp's WMP Distribution Pole Replacement initiative (8.1.2.3) work was identified as complete at this location.
2. The subject pole was not recently replaced.

Item13IA1img4: View of pole brand showing a manufacture date of September 2006.
