NOTICE OF VIOLATION

INSPECTION REPORT

Electrical Corporation:	Liberty Utilities (LU)
Report Number:	LU_CAC17_20231116_0839
Inspector:	CAC17
WMP Year Inspected:	2022
Quarterly Data Report (QDR) Referenced:	Quarter 3 and Quarter 4 (Q3 and Q4)
Inspection Selection:	Energy Safety viewed the contents of the Q3 & Q4 QDR and performed an analysis that resulted in the selection of the WMP initiatives and locations referenced in this report.
Relevant WMP Initiatives:	Other corrective action/Tree attachments (WMP 7.3.3.12)
Date of inspection:	November 16, 2023
City and County of Inspection:	Kings Beach, Placer County
Inspection Purpose:	Assess the accuracy of Liberty Utilities' QDR data, completeness of its work, compliance with WMP requirements, and compliance with its protocols.

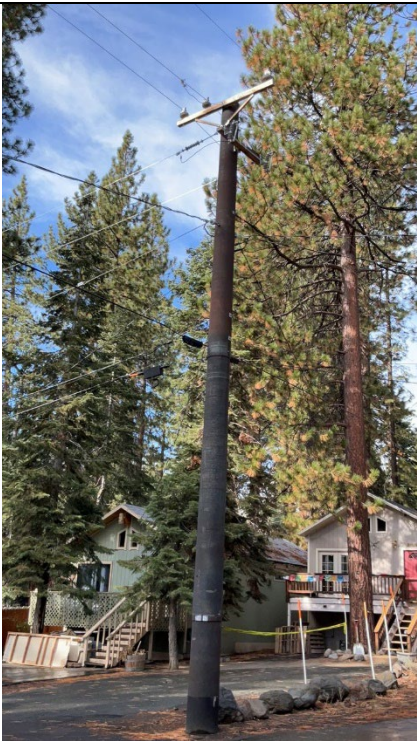
On pole ID 291897 at 8899 Salmon Ave, Kings Beach, CA, 96143, USA, 39.2361242144599, -120.016292223114, the inspector observed a tree attachment. The inspector's observation is documented in Violation 1 photographs, which are attachments to this report. Photo numbers Item8GIimg1, Item8GIimg2, and Item8GIimg3 depict a tree attachment where the attachment was reported as removed.

A photograph showing a tall, dark utility pole standing in a residential area. The pole is surrounded by trees and houses. A yellow caution tape is visible around the base of the pole.	  A close-up photograph of the utility pole, showing a white band with the ID number '291 97' in blue text. The pole appears to be made of metal and shows signs of rust and wear.
<p>Item8GImg1: Overall pole.</p>	<p>Item8GImg2: Pole ID (damaged).</p>

1. Liberty Utilities' WMP 7.3.3.12 - Other corrective action: Tree attachment work was identified as complete at this location.
2. Energy Safety understood Liberty Utilities' QDR submission to mean that all tree attachments would be removed from this location.
3. Liberty Utilities failed to remove the tree attachment and reroute the service line using a new pole.

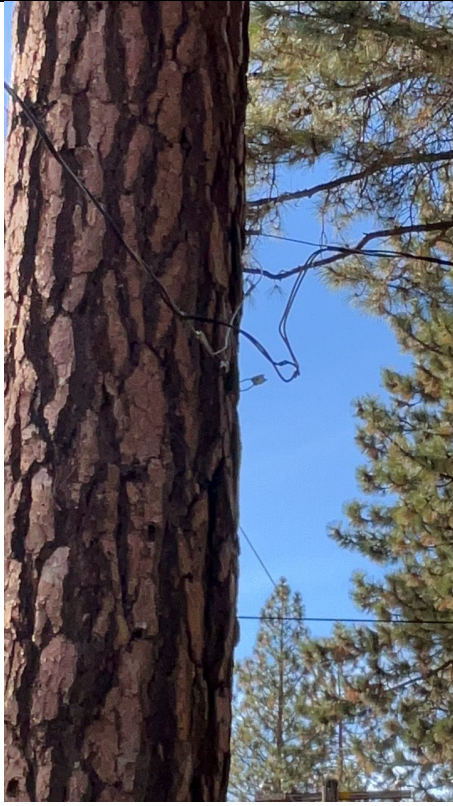
Item8GImg3: Close-up view of tree attachment.
