NOTICE OF VIOLATION

INSPECTION REPORT

Electrical Corporation:	San Diego Gas & Electric Company
Report Number:	SDGE_YLO_20240606_0812
Inspector:	Yana Loginova
WMP Year Inspected:	2023
Quarterly Data Report (QDR) Referenced:	Quarter 3 (Q3)
Inspection Selection:	Energy Safety viewed the contents of the Q3 QDR and performed an analysis that resulted in the selection of the WMP initiatives and locations referenced in this report.
Relevant WMP Initiative(s):	Avian Protection Program (2023 WMP initiative number 8.1.2.10.1, WMP.972)
Date of inspection:	June 6, 2024
City and/or County of Inspection:	Fallbrook, San Diego County
Inspection Purpose:	Assess the accuracy of San Diego Gas & Electric Company’s QDR data, completeness of its work, compliance with WMP requirements, and compliance with its protocols.

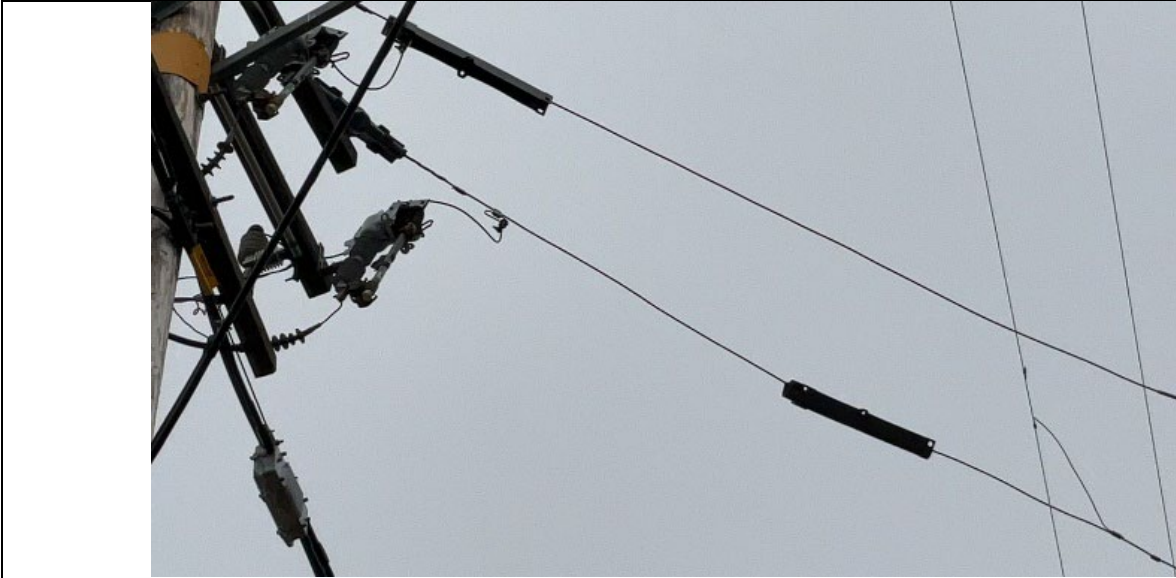
Energy Safety arrived at the pole ID P218236 at 887 Hillcrest Ter, Fallbrook, CA, 92028, USA, 33.3911329330061, -117.232570455604, and observed that one of the avian protection covers was missing. The inspector's observation is documented in Violation 1 photographs, which are attachments to this report. Photo number Item1IA1Img1 depicts that the avian protection cover is not covering clamps and instead it is loose and displaced.

1. The reported location provided by SDG&E indicated that work on the Avian Protection Program (WMP.972, 2023 WMP Initiative 8.1.2.10.1) was reported as completed.
2. The avian protection cover was missing on one side.

Item1IA1Img1: Dislodged avian protection cover

Energy Safety may prescribe a timeframe for resolution of a violation associated with the assigned risk category.² Within 30 days from the issuance date of this NOV, the electrical corporation must provide a response advising Energy Safety of corrective actions taken or planned to remedy the above identified violation(s) and prevent recurrence. Alternatively, the electrical corporation must advise Energy Safety that it will not correct the violation, including the reasoning or justification for inaction and all supporting documentation.³
