## NOTICE OF VIOLATION

Violation 1. Energy Safety observed that in implementing 2024 WMP initiative 8.2.3.1- Pole Clearing (WMP.512), SDG&E failed to adhere to its protocol of pole clearing around pole ID P510623 at coordinates 33.23763869901116, -117.2283849853278. Energy Safety considers this violation to be in the "Minor" risk category.

# INSPECTION REPORT

Electrical Corporation:	San Diego Gas and Electric Company
Report Number:	NOV_SDGE_CAC23_20240619_1251
Inspector:	CAC23
WMP Year Inspected:	2024
Quarterly Data Report (QDR) Referenced:	Quarter 1 (Q1)
Inspection Selection:	Energy Safety inspected the locations based on SDG&E's Q1 QDR
Relevant WMP Initiative(s):	8.2.3.1 Pole Clearing (WMP.512)
Date of inspection:	June 19, 2024
City and/or County of Inspection:	Vista, California
Inspection Purpose:	Assess the accuracy of San Diego Gas and Electric Company's QDR data, completeness of its work, compliance with WMP requirements, and compliance with its protocols.

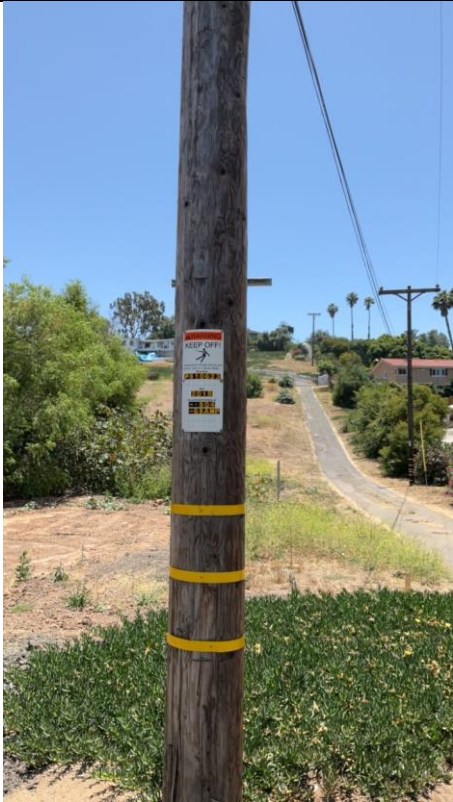
Item1Gimg1: Pole ID

The reported location provided by SDG&E indicated that work on the Pole Clearing Program (.512 WMP initiative number 8.2.3.1.2) was reported as completed. At pole ID P510623 at 1009 Osborne Street in Vista, at GPS coordinates 33.23763869901116, -117.2283849853278, the inspector observed that vegetation (ice plant, *Carpobrotus edulis*) was growing within a 10-foot radius from the subject pole. SDG&E's Q1 QDR data indicated the pole was mechanically cleared in March 2024. The inspector's observation is documented in Violation 1 photographs, which are attachments to this report. Photo numbers Item1GImg1, Item1GImg2, and Item1IA1Img1 depict ice plants contacting the base of the pole and growing within the clearance radius.

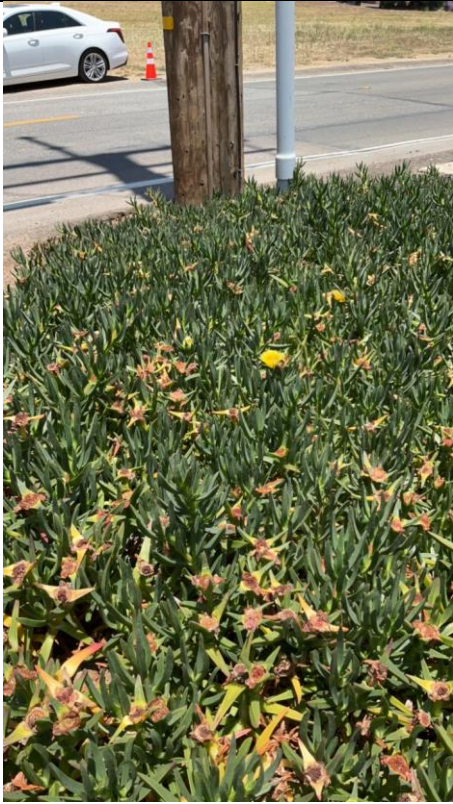
Energy Safety concludes that Violation 1 is “Minor” because the vegetation fuel bed does not consist of light flashy fuels.

**Item1IA1mg1:** View of vegetation at the base of the pole.
