NOTICE OF VIOLATION

On June 18, 2024, Energy Safety conducted an inspection of SCE's WMP initiatives in the vicinity of the city of Trabuco Canyon, California. The inspection report is enclosed herewith. Energy Safety found the following violation(s):

INSPECTION REPORT

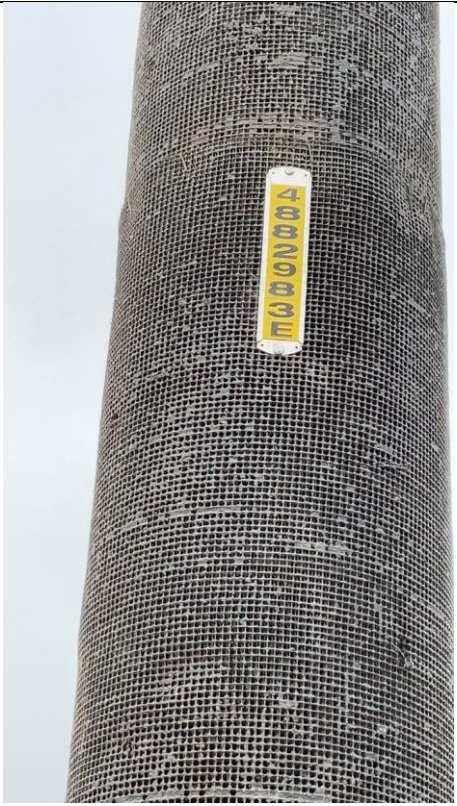
On pole ID 4882983E at 32187-32197 Trabuco Creek Rd, Trabuco Canyon, CA, 92679, USA, 33.66831158065607, -117.56514540812104, the inspector observed that no covered conductor was present. The inspector's observation is documented in Violation 1 photographs, which are attachments to this report. Photo numbers Item1IG1Img1, Item1IG1Img2 and Item1IA1Img1 depict that no covered conductor was installed at the location.

<p>Item1Gimg1: Pole ID</p>	<p>Item1Gimg2: Overall Pole</p>

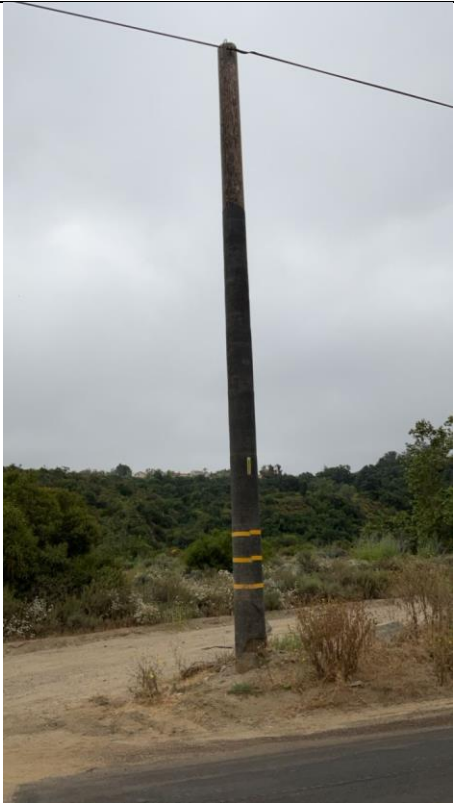
1. Southern California Edison Company's 2023 WMP Covered Conductor (8.1.2.1.1) work was identified as complete at this location.
2. Covered Conductor (8.1.2.1.1) was not installed.
3. Only communication cable was present on the pole.

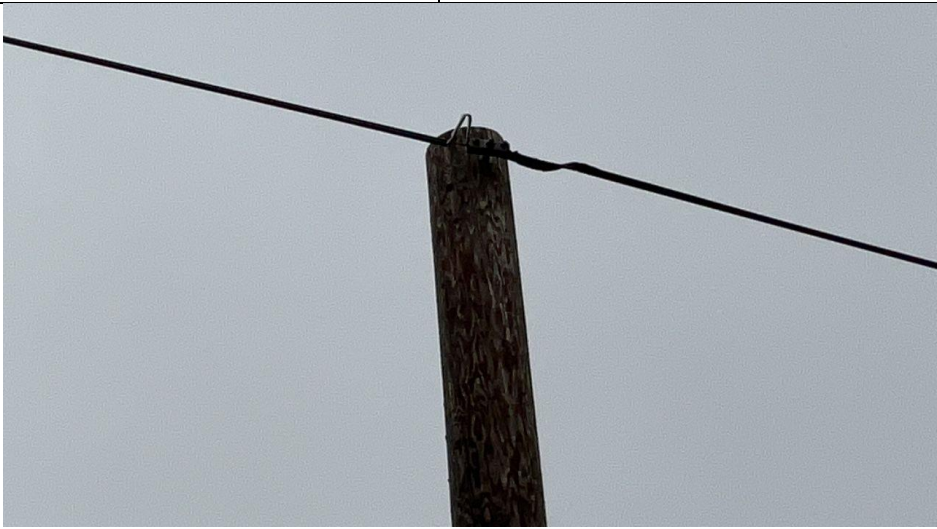
<p>Item1IA1img1: No covered conductor present</p>

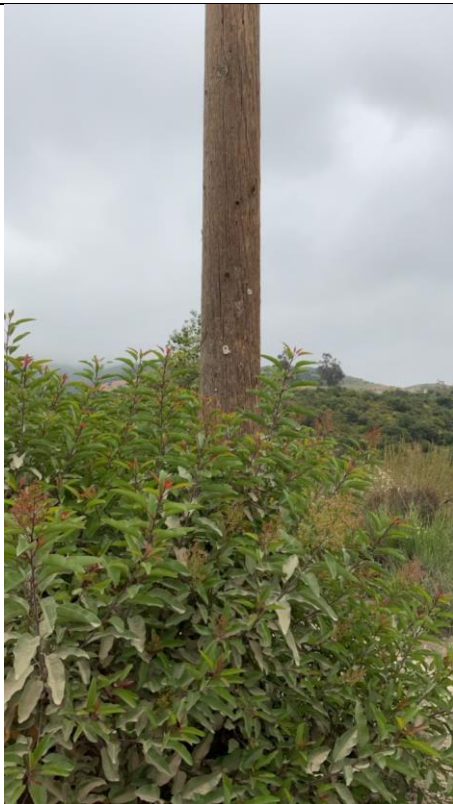
On pole ID X8485E at 32187-32197 Trabuco Creek Rd, Trabuco Canyon, CA, 92679, USA, 33.66801439418881, -117.56562608196106, the inspector observed that no covered conductor was present. The inspector's observation is documented in Violation 2 photographs, which are attachments to this report. Photo numbers Item2IG1Img1, Item2IG1Img2 and Item2IA1Img1 depict that no covered conductor was installed at the location.

Item2GImg1: Missing Pole ID

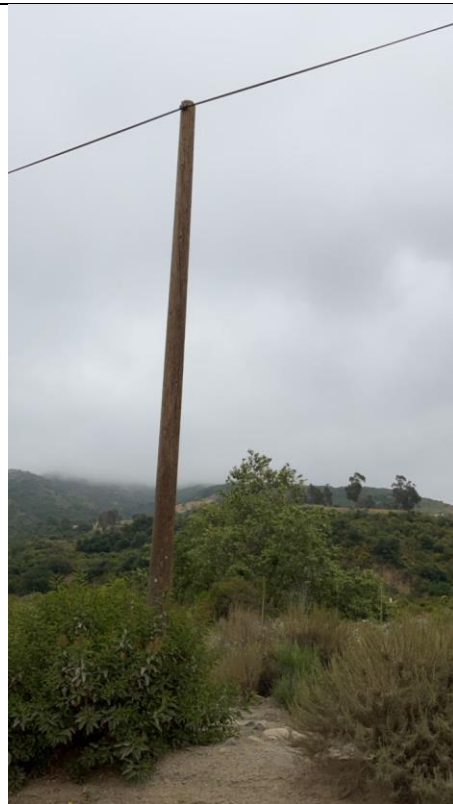
1. Southern California Edison Company's 2023 WMP Covered Conductor (8.1.2.1.1) work was identified as complete at this location.
2. Covered Conductor (8.1.2.1.1) was not installed.
3. Only communication cable was present on the pole.

Item2GImg2: Overall Pole

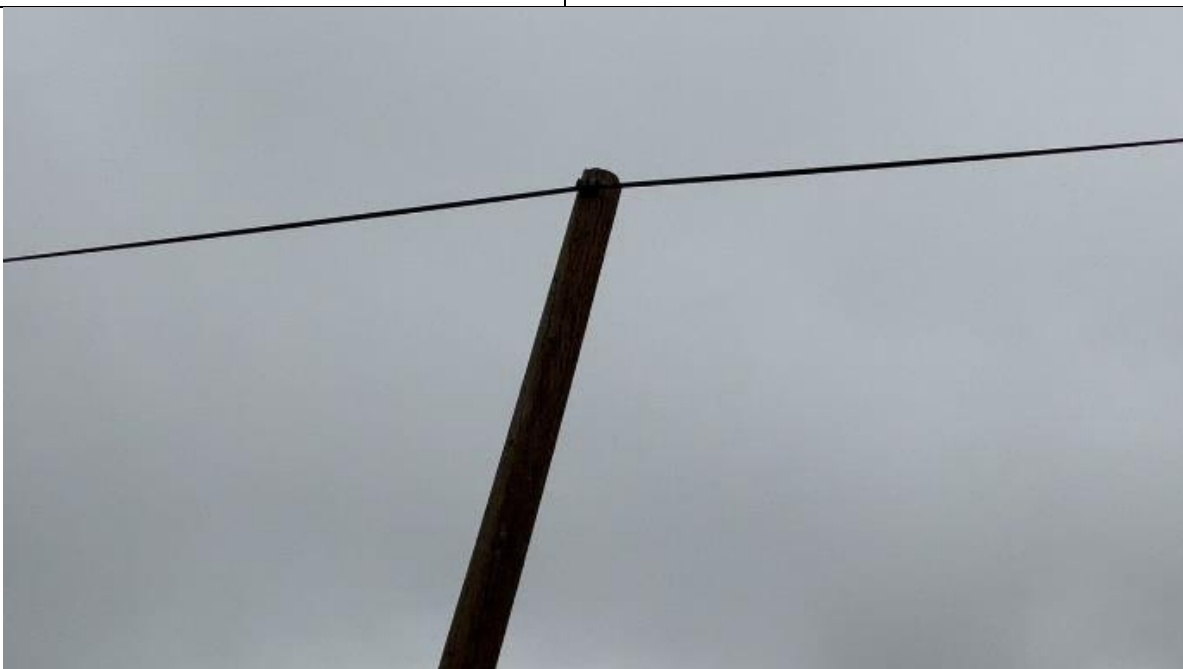
Item2IA1Img1: No covered conductor present

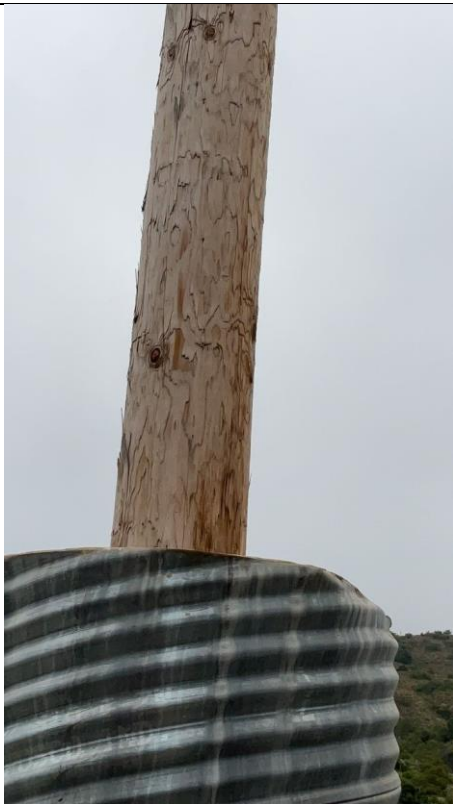
On pole ID 4617117E at 32170-32180 Trabuco Creek Rd, Trabuco Canyon, CA, 92679, USA, 33.667179818333864, -117.5669496338174, the inspector observed that no covered conductor was present. The inspector's observation is documented in Violation 3 photographs, which are attachments to this report. Photo numbers Item3IG1Img1, Item3IG1Img2 and Item3IA1Img1 depict that no covered conductor was installed at the location.

Item3GImg1: Missing Pole ID

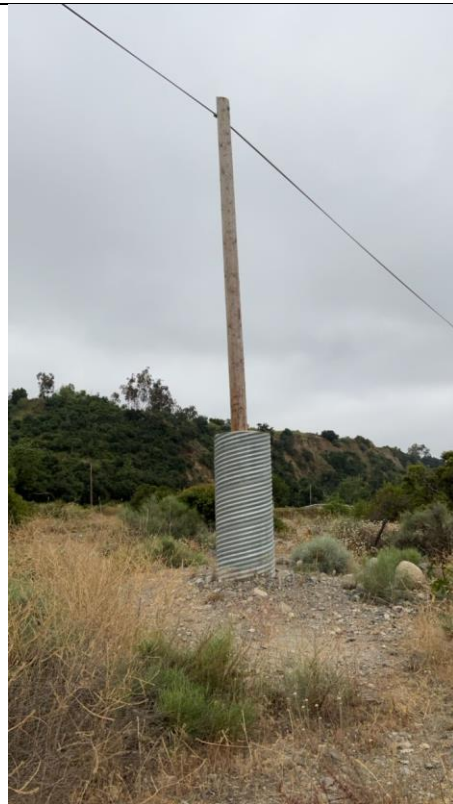
1. Southern California Edison Company's 2023 WMP Covered Conductor (8.1.2.1.1) work was identified as complete at this location.
2. Covered Conductor (8.1.2.1.1) was not installed.
3. Only communication cable was present on the pole.

Item3GImg2: Overall Pole

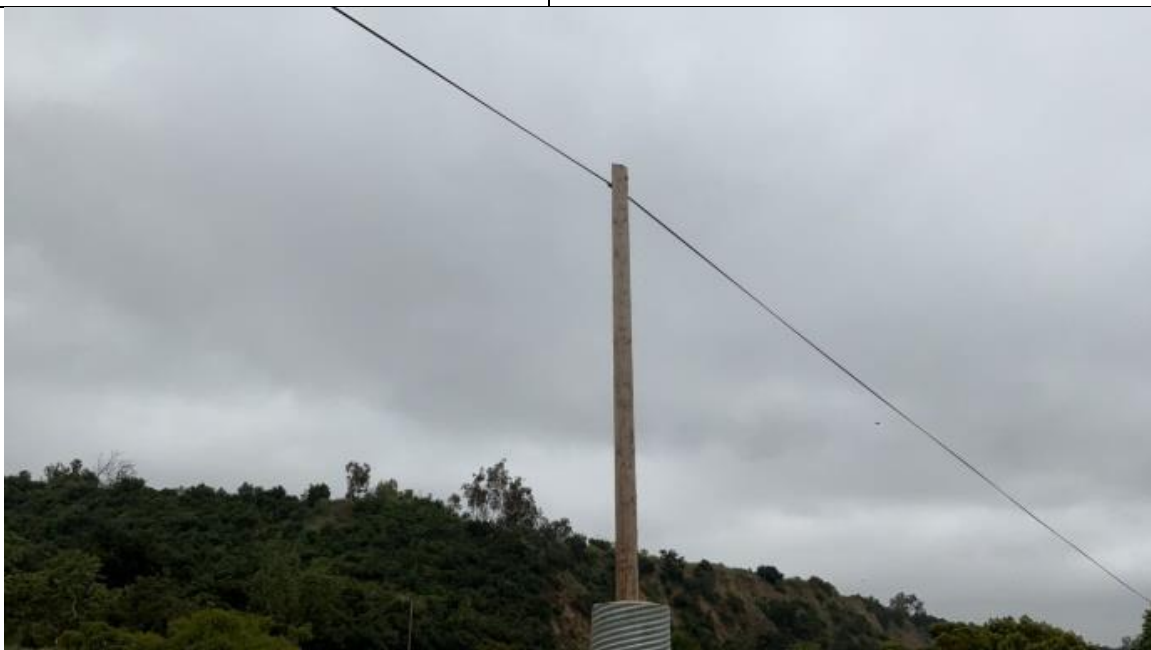
Item3IA1Img1: No covered conductor present
