NOTICE OF VIOLATION

INSPECTION REPORT

| Electrical Corporation: | Bear Valley Electric Service, Inc. | | | |
|---|---|--|--|--|
| Report Number: | CADBVES_ATJ_20240724_1031 | | | |
| Relevant WMP Initiative(s): | Covered Conductor Installation (2023 WMP initiative number 8.1.2.1) | | | |

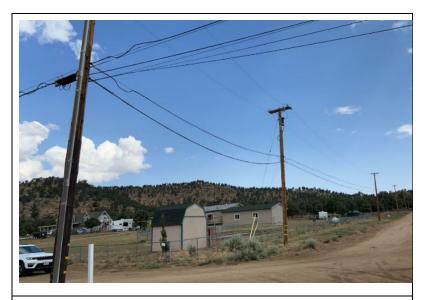
Energy Safety arrived at the provided pole ID 9473BV at 47200-47242 Lake View Dr, Big Bear City, CA, 92314, USA, 34.26679852652348, -116.77233773143737 and observed bare wire where covered conductor was reported as installed over five spans or between six poles. The inspector's observation is documented in Violation 1 photographs, which are attachments to this report. Photo numbers Item1Glmg1, Item1Glmg2, Item1IA1lmg1, Item1IA1lmg2, and Item1IA1lmg3 depict bare conductor on the five reported completed spans.

- 1. The reported location provided by BVES indicated that covered conductor work was completed on five spans.
- 2. No covered conductor work was observed on these five spans.

Item1IA1Img3: Overall photo showing five spans where covered conductor was reported as installed.
