## NOTICE OF VIOLATION

On July 2, 2024, Energy Safety conducted an inspection of Southern California Edison Company's WMP initiatives in the city of Valencia, California. The inspection report is enclosed herewith. Energy Safety found the following violation:

# INSPECTION REPORT

## Violation 1:

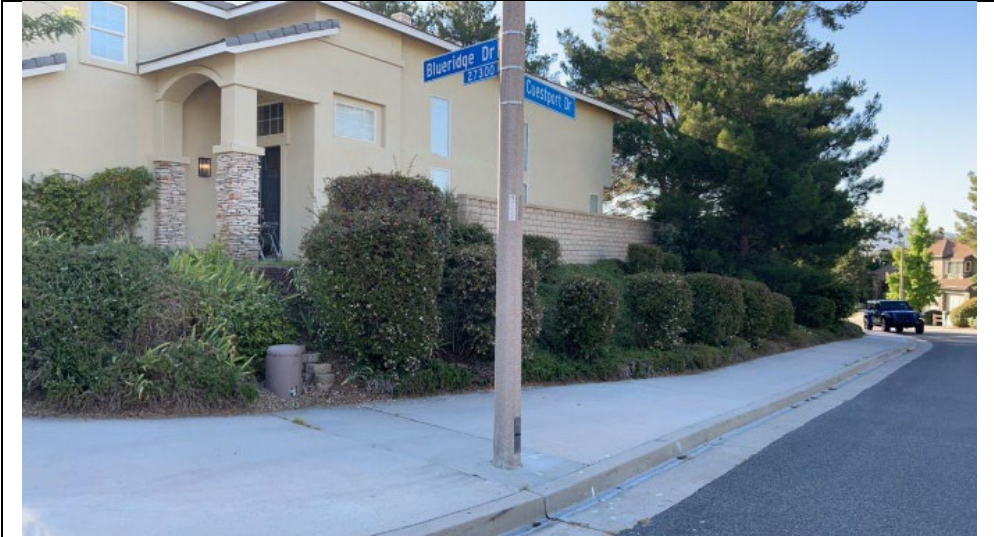
**Item1Gimg1:** Overall view of location showing a street light pole with no electrical equipment

On pole ID 4179230E, Grid Hardening ID TD2100529, at 27343 Blueridge Dr, Valencia, CA, 91354, USA, 34.44441856776136, -118.54160303972672, the inspector observed no overhead assets (poles) or pad mounted equipment. The inspector's observation is documented in Violation 1 photographs, which are attachments to this report. Photo numbers Item1GImg1 and Item1IA1Img1 depict a home lawn with no REFCL Ground Conversion equipment installed.

1. Southern California Edison Company's 2023 WMP REFCL Ground Conversion (8.1.2.6.2) work was identified as complete at this location.
2. A pad mounted isolation transformer or pole top transformer were not observed.
3. REFCL Ground Conversion (8.1.2.6.2) equipment was not observed.
