NOTICE OF VIOLATION

INSPECTION REPORT

Electrical Corporation:	Southern California Edison Company
Report Number:	CADSCE_SIS_20240725_1111
Inspector:	Samuel Isaiah
WMP Year Inspected:	2024
Quarterly Data Report (QDR) Referenced:	Quarter 1 (Q1)
Inspection Selection:	Energy Safety viewed the contents of the Q1 QDR and performed an analysis that resulted in the selection of the WMP initiatives and locations referenced in this report.
Relevant WMP Initiative(s):	8.1.2.1.1 Covered Conductor
Date of inspection:	July 25, 2024
City and/or County of Inspection:	Menifee, Riverside County
Inspection Purpose:	Assess the accuracy of Southern California Edison Company's QDR data, completeness of its work, compliance with WMP requirements, and compliance with its protocols.

Structure ID: 4057603E

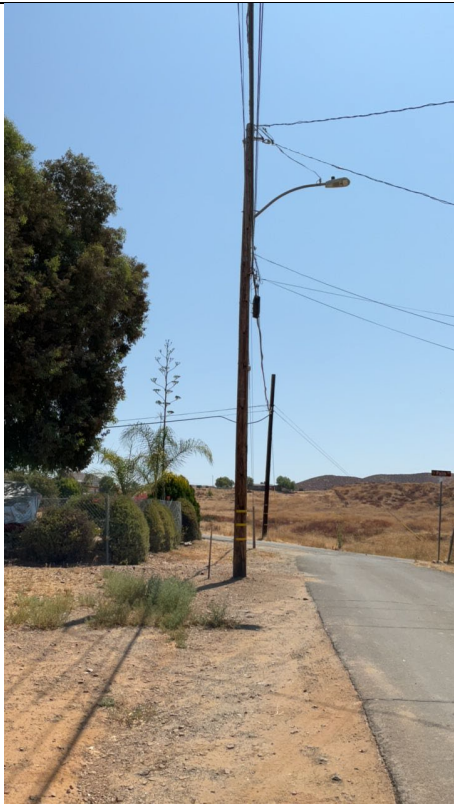
On Pole ID 4057603E, Grid Hardening ID TD2090512-4057603E, at 23998-23806 Johnson Ln, Manifee, CA, 92587, USA, 33.70991819829317, -117.24091850632244, the inspector observed that no covered conductor was present. The inspector's observation is documented in Violation 1 photographs, which are attachments to this report. Photo numbers Item1GImg1, Item1GImg2, Item1IA1Img1 depict that no covered conductor was installed at the location.

A photograph showing a utility pole on the side of a paved road. The pole is dark and has several power lines attached. The background shows a clear blue sky, some trees, and a dry, hilly landscape.

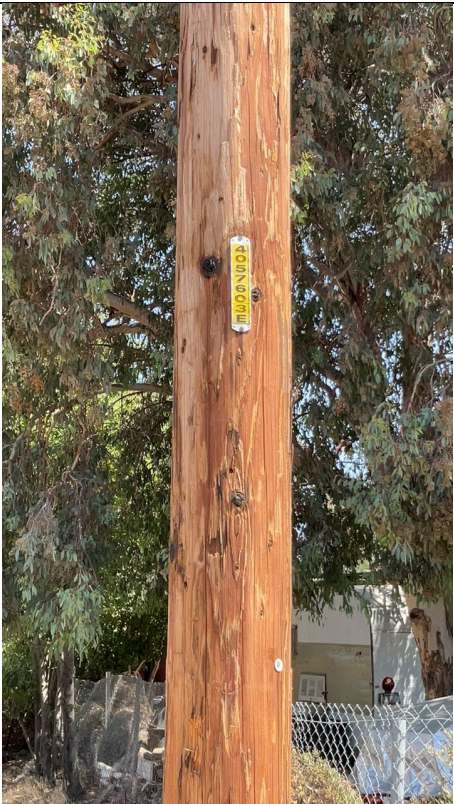
A close-up photograph of a wooden utility pole. A yellow tag with the number '4057603E' is attached to the pole. The pole is surrounded by green foliage and a chain-link fence is visible in the background.
<p>Item1GImg1: Overall Pole</p>	<p>Item1GImg2: Pole ID</p>

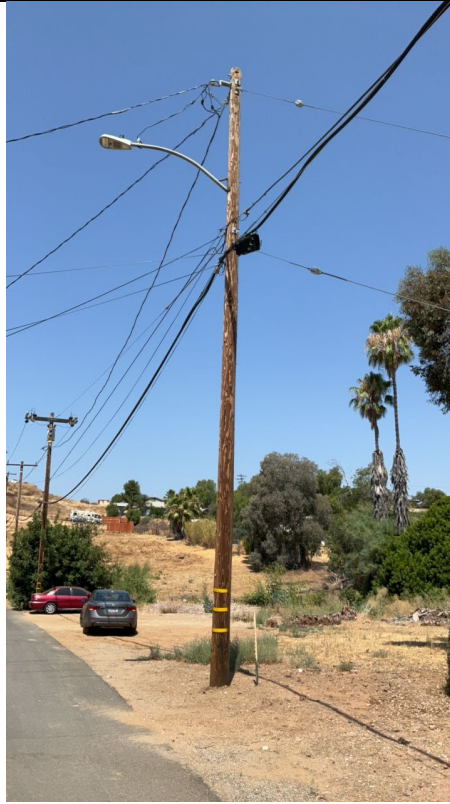
1. Southern California Edison Company's 2023 WMP Covered Conductor (8.1.2.1.1) work was identified as complete at this location.
2. Covered conductor was not installed.

Item1IA1img1: No covered conductor present
