NOTICE OF VIOLATION

On July 25, 2024, Energy Safety conducted an inspection of Southern California Edison Company's WMP initiatives in the vicinity of the city of Menifee, California. The inspection report is enclosed herewith. Energy Safety found the following violation(s):

INSPECTION REPORT

Electrical Corporation:	Southern California Edison Company
Report Number:	CADSCE_SIS_20240725_1017
Inspector:	Samuel Isaiah
WMP Year Inspected:	2024
Quarterly Data Report (QDR) Referenced:	Quarter 1 (Q1)
Inspection Selection:	Energy Safety viewed the contents of the Q1 QDR and performed an analysis that resulted in the selection of the WMP initiatives and locations referenced in this report.
Relevant WMP Initiative(s):	8.1.2.1.1 Covered Conductor
Date of inspection:	July 25, 2024
City and/or County of Inspection:	Menifee, Riverside County
Inspection Purpose:	Assess the accuracy of Southern California Edison Company's QDR data, completeness of its work, compliance with WMP requirements, and compliance with its protocols.

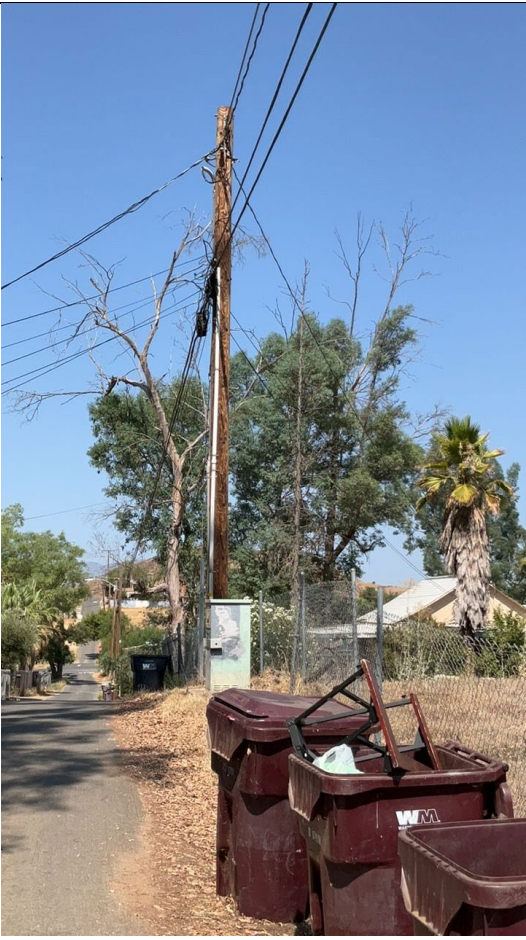
<p>A photograph showing a wooden utility pole standing on a residential street. In the foreground, there are several brown recycling bins. The background shows houses, trees, and a clear blue sky.</p>

<p>A close-up photograph of a wooden utility pole. A metal identification tag is attached to the pole, displaying the number '1610-6-114'. The tag is oriented vertically. The pole is surrounded by white pipes and other utility equipment.</p>
<p>Item1GImg1: Overall Pole</p>	<p>Item1GImg2: Pole ID</p>

On Pole ID 4791528E, Grid Hardening ID TD2090512-4791528E, at 23828 Mount Vernon Pl, Menifee, CA, 92587, USA, 33.7074437457038, -117.243448281104, the inspector observed that no covered conductor was present. The inspector's observation is documented in Violation 1 photographs, which are attachments to this report. Photo numbers Item1GImg1, Item1GImg2, Item1IA1Img1 depict that no covered conductor was installed at the location.

1. Southern California Edison Company's 2024 WMP Covered Conductor (8.1.2.1.1) work was identified as complete at this location.
2. Covered conductor was not installed.

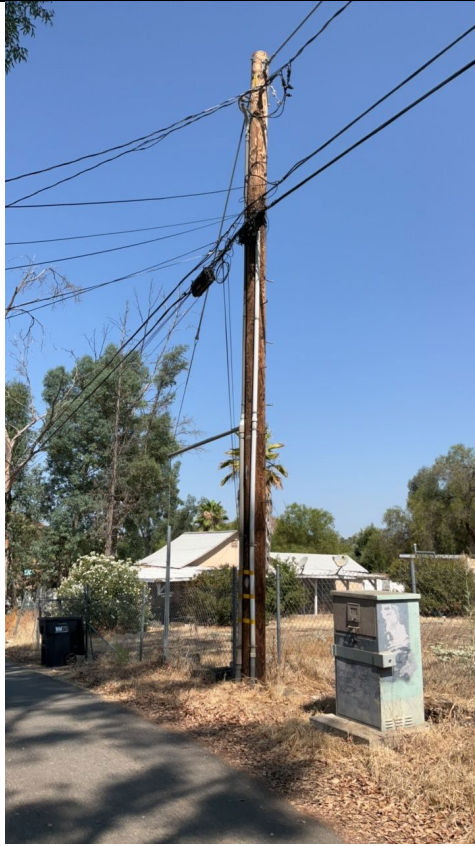
Item1IA1img1: No covered conductor present.
