NOTICE OF VIOLATION

On July 16, 2024, Energy Safety conducted an inspection of Southern California Edison Company's WMP initiatives in the vicinity of the city of Brea, California. The inspection report is enclosed herewith. Energy Safety found the following violation(s):

INSPECTION REPORT

Electrical Corporation:	Southern California Edison Company
Report Number:	CADSCE_SIS_20240716_1411
Inspector:	Samuel Isaiah
WMP Year Inspected:	2023
Quarterly Data Report (QDR) Referenced:	Quarter 4 (Q4)
Inspection Selection:	Energy Safety viewed the contents of the Q4 QDR and performed an analysis that resulted in the selection of the WMP initiatives and locations referenced in this report.
Relevant WMP Initiative(s):	8.1.2.1.1 Covered Conductor
Date of inspection:	July 16, 2024
City and/or County of Inspection:	Brea, Orange County
Inspection Purpose:	Assess the accuracy of Southern California Edison Company’s QDR data, completeness of its work, compliance with WMP requirements, and compliance with its protocols.

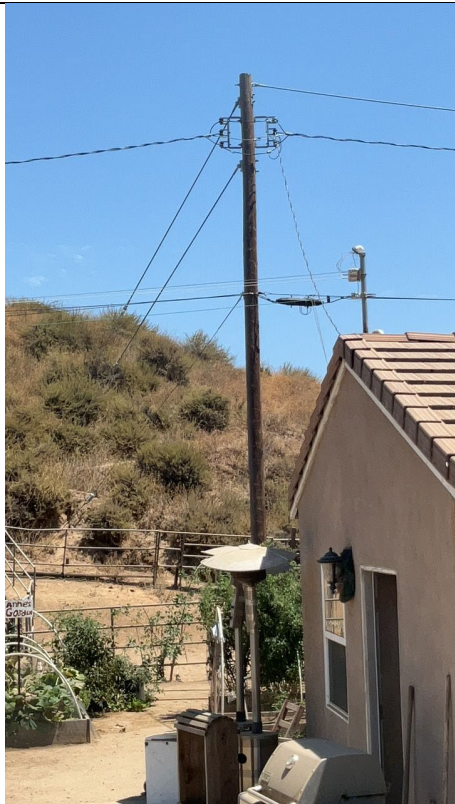
On pole ID 1314070E, Grid Hardening ID TD1817317-1314070E, at 4445 Carbon Canyon Rd, Brea, CA, 92823, USA, 33.92305484850949, -117.8295863630241, the inspector observed that no covered conductor was present. The inspector's observation is documented in Violation 1 photographs, which are attachments to this report. Photo numbers Item1Gimg1, Item1Gimg2, Item1IA1img1 depict that no covered conductor was installed at the location.

A photograph showing a wooden utility pole with multiple power lines. The pole is situated next to a light-colored house with a tiled roof. In the background, there is a dry, hilly landscape under a clear blue sky. A white utility box is visible at the base of the pole.

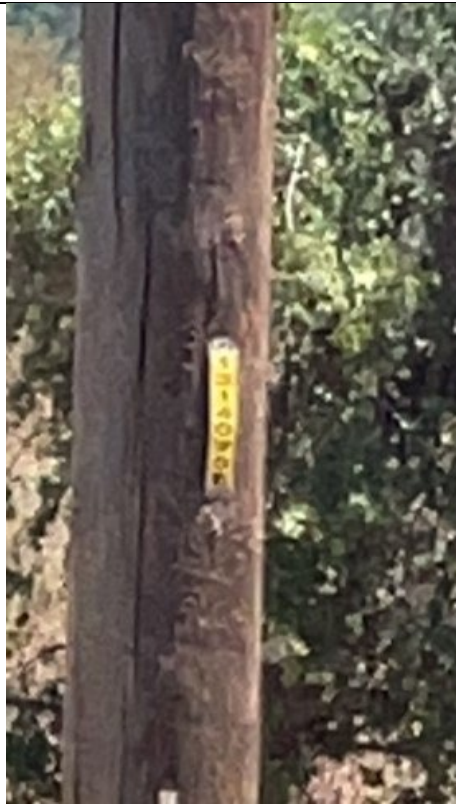
A close-up photograph of a yellow identification tag attached to a wooden utility pole. The tag has the number '1314070E' printed on it. The background shows green foliage.
<p>Item1GImg1: Overall Pole</p>	<p>Item1GImg2: Pole ID</p>

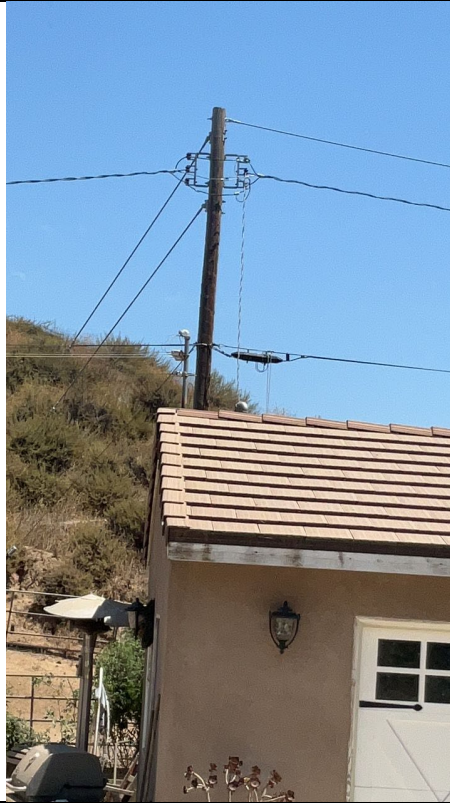
1. Southern California Edison Company's 2023 WMP Covered Conductor (8.1.2.1.1) work was identified as complete at this location.
2. Covered conductor was not installed.

Item1IA1Img1: No covered conductor installed.
