NOTICE OF VIOLATION

On July 23, 2024, Energy Safety conducted an inspection of Southern California Edison Company's WMP initiatives in the vicinity of the city of Lake Elsinore, California. The inspection report is enclosed herewith. Energy Safety found the following violation (s):

INSPECTION REPORT

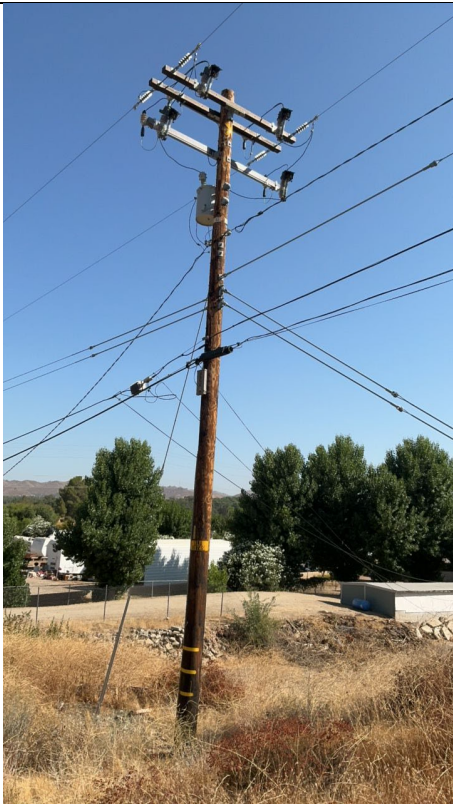
On Pole ID 1668407E, Grid Hardening ID TD2121976-1668407E, at 18962-18998 Dexter Ave, Lake Elsinore, CA, 92532, USA, 33.68649786411026, 117.32865556319356, the inspector observed that that the pole did not have covered conductors installed where covered conductor installation was reported as completed by SCE. The inspector's observation is documented in Violation 1 photographs, which are attachments to this report. Photo numbers Item1GIimg1, Item1GIimg2, and Item1IA1img1 depict bare conductor where covered conductor installation was reported as completed.

<p>Item1Gimg1: Overall pole.</p>	<p>Item1Gimg2: Pole ID.</p>

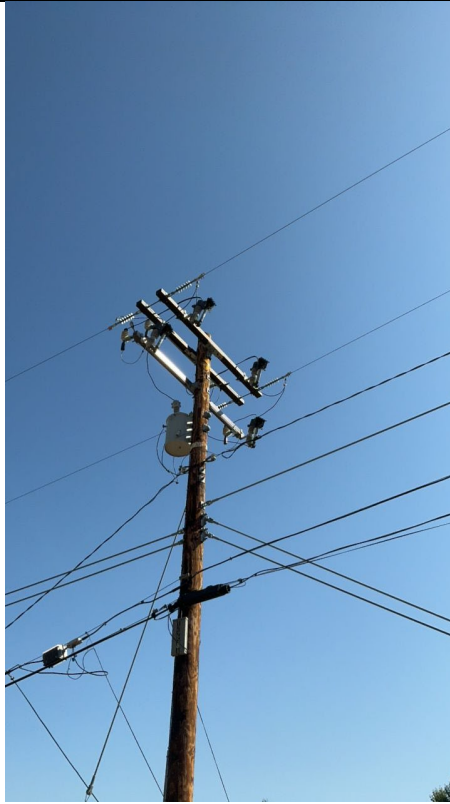
1. Southern California Edison Company's 2023 WMP Covered Conductor (8.1.2.1.1) work was identified as complete at this location.
2. A bare conductor was observed at this location.
3. No covered conductor was observed at the provided location.

Item1IA1img1: View of bare wire construction where covered conductor installation was reported as completed.
