Subject: Liberty's Response to Notice of Violation -
CAD_LU_CAC18_20231025_0916_Revision 1

Liberty Response

Finding: Failure to set the pole to protocol

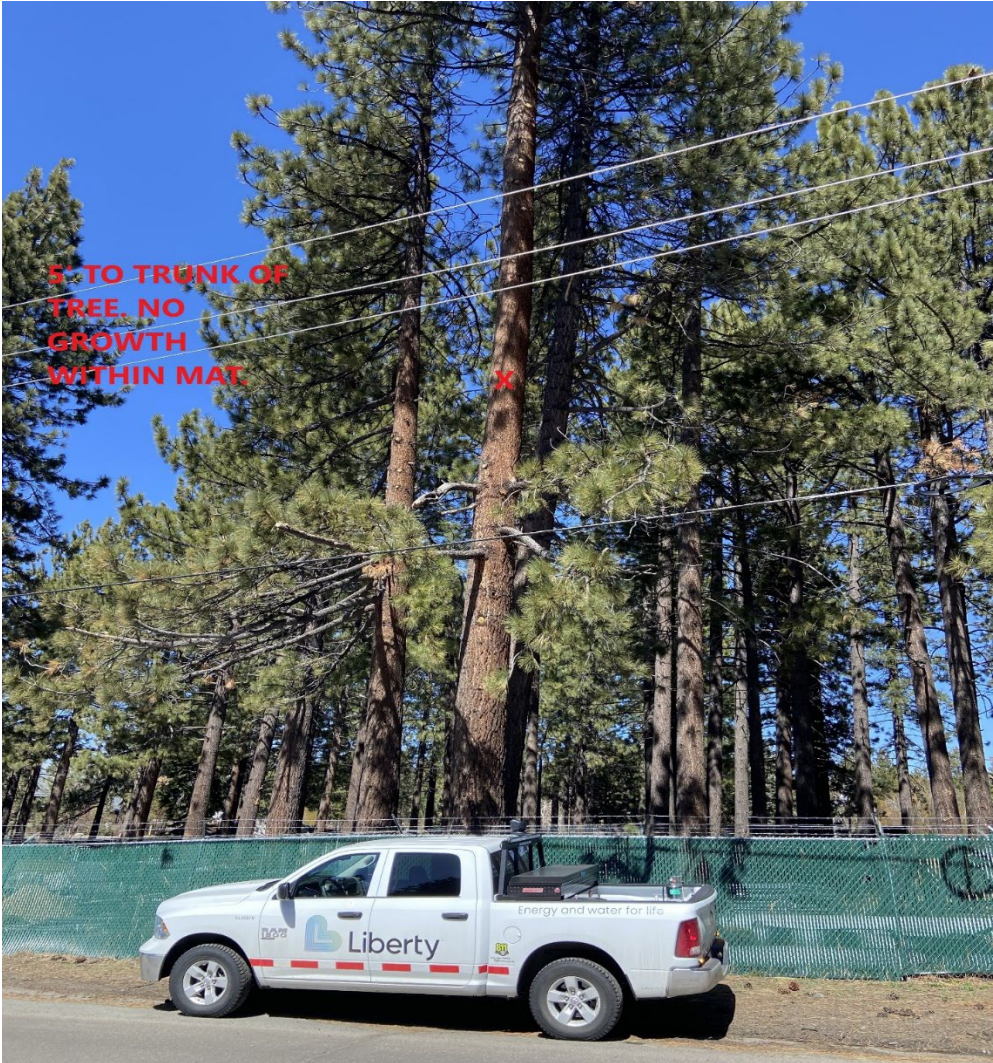
Summary of Energy Safety Finding:¹ Near pole ID 275568 at 920 Stateline Ave, South Lake Tahoe, CA, 96150, USA, 38.9609062307708, -119.944810162602, the inspector observed a Jeffrey pine within Liberty Utilities' clearance distance of six feet. The inspector's observations are documented in Violation 1 photographs. Photograph numbers Item1IA1Img3 and Item1IA1Img4 depict a Jeffrey pine that is approximately five feet from primary conductors. The radial clearance requirement from these primary conductors (12kV-25kV) is six feet, and Liberty Utilities failed to trim back to 12-15 feet, per Liberty Utilities' MAT.

Response: Regarding the tree displayed in 'Item1IA1Img3' and 'Item1IA1Img4,' no vegetation is within regulated clearance requirements. Bole wood is at 5' to conductors. There is no vegetative growth within Liberty maintenance action thresholds. No work is required by Liberty at this time.
