NOTICE OF VIOLATION

On June 18, 2024, Energy Safety conducted an inspection of SCE's WMP initiatives in the vicinity of the city of Trabuco Canyon, California. The inspection report is enclosed herewith. Energy Safety found the following violation(s):

INSPECTION REPORT

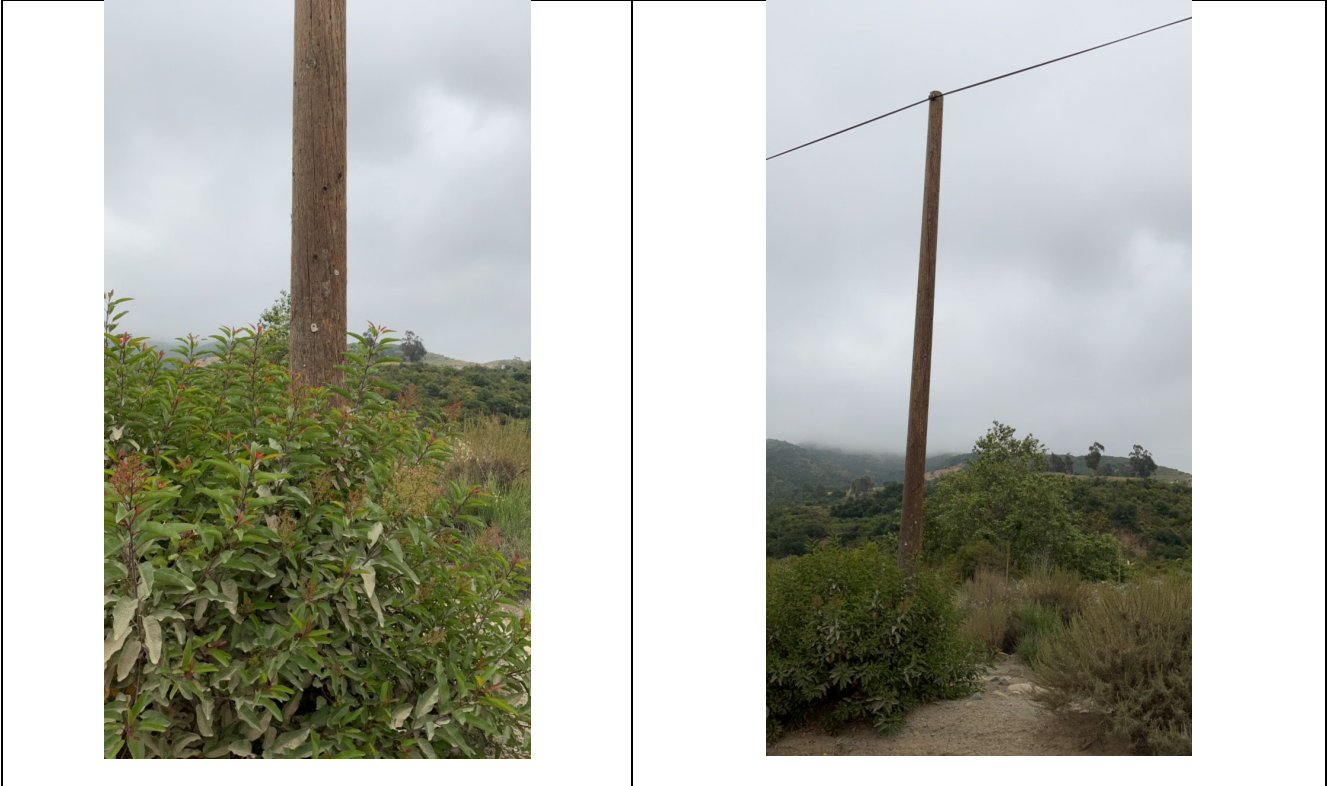
On pole ID X8485E at 32187-32197 Trabuco Creek Rd, Trabuco Canyon, CA, 92679, USA, 33.66801439418881, -117.56562608196106, the inspector observed that no covered conductor was present. The inspector's observation is documented in Violation 1 photographs, which are attachments to this report. Photo numbers Item1IG1Img1, Item1IG1Img2 and Item1IA1Img1 depict that no covered conductor was installed at the location.

1. Southern California Edison Company's 2023 WMP Covered Conductor (8.1.2.1.1) work was identified as complete at this location.
2. Covered Conductor (8.1.2.1.1) was not installed.
3. Only communication cable was present on the pole.

Item1G1mg1: Missing Pole ID

Item1G1mg2: Overall Pole

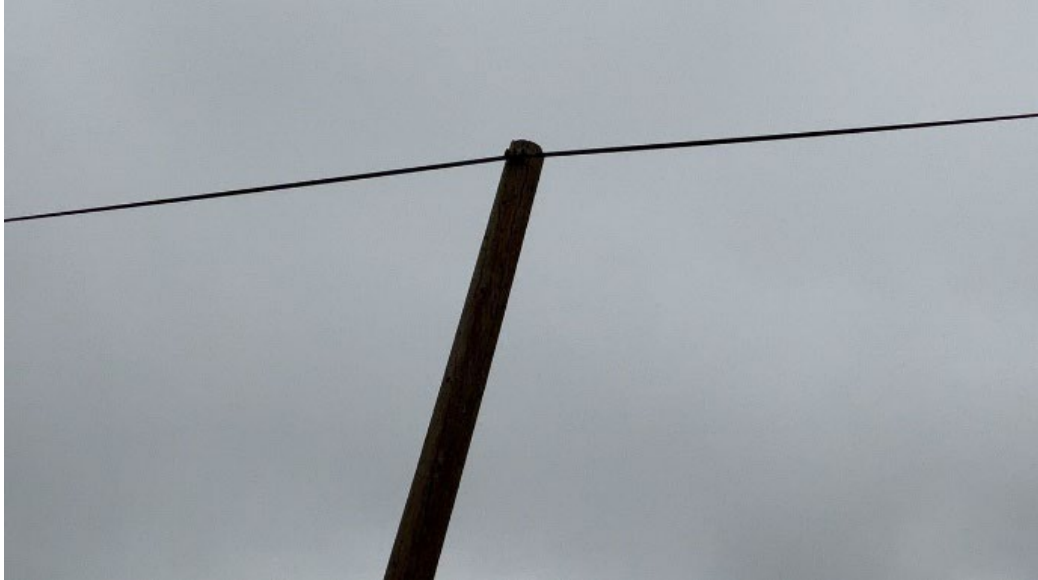
Item1IA1mg1: No covered conductor present

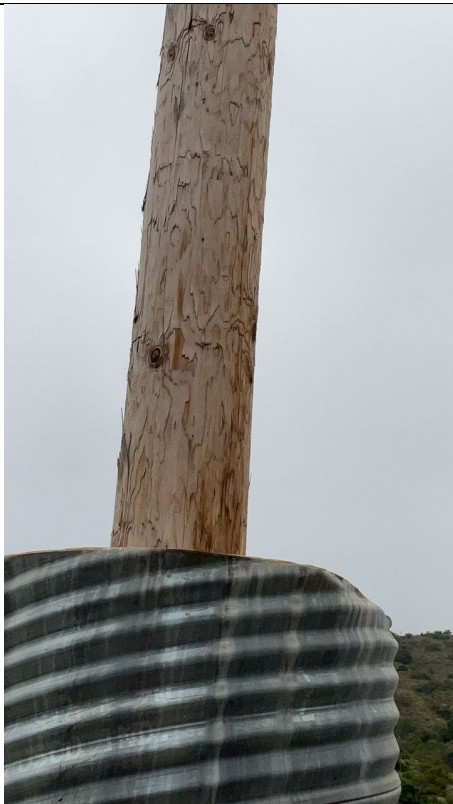
On pole ID 4617117E at 32170-32180 Trabuco Creek Rd, Trabuco Canyon, CA, 92679, USA, 33.667179818333864, -117.5669496338174, the inspector observed that no covered conductor was present. The inspector's observation is documented in Violation 2 photographs, which are attachments to this report. Photo numbers Item2IG1Img1, Item2IG1Img2 and Item2IA1Img1 depict that no covered conductor was installed at the location.

Item2GImg1: Missing Pole ID

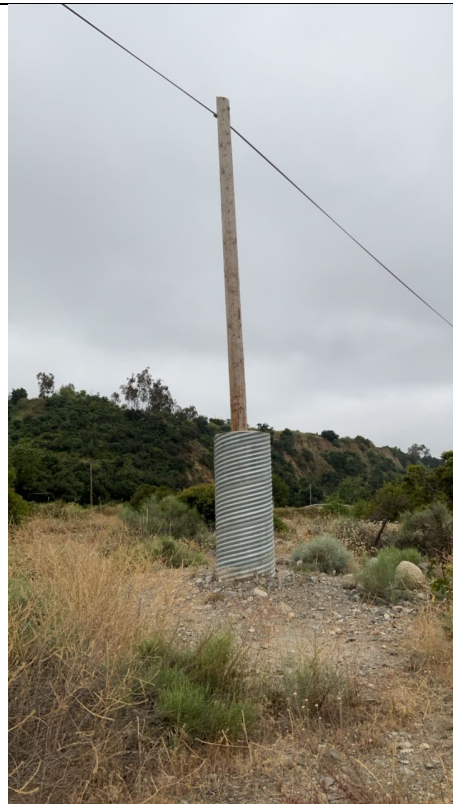
Item2GImg2: Overall Pole

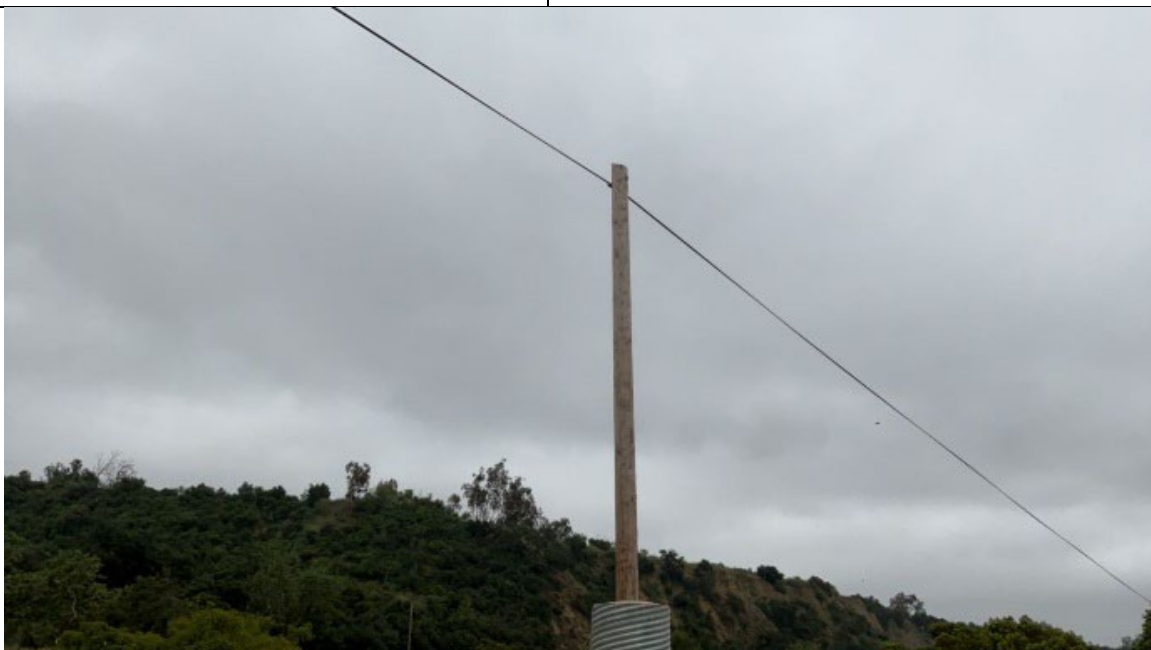
1. Southern California Edison Company's 2023 WMP Covered Conductor (8.1.2.1.1) work was identified as complete at this location.
2. Covered Conductor (8.1.2.1.1) was not installed.
3. Only communication cable was present on the pole.

Item2IA1Img1: No covered conductor present
