NOTICE OF VIOLATION

INSPECTION REPORT

Electrical Corporation:	PG&E
Report Number:	NOV ESD_PGE_RIB_20241112_1000
Inspector:	Ramzi Ibrahim
WMP Year Inspected:	2024
Quarterly Data Report (QDR) Referenced:	N/A
Inspection Selection:	Energy Safety inspected the location based on a public complaint received by Energy Safety
Relevant WMP Initiative(s):	8.2.2.2 Distribution Second Patrol (VM-17)
Date of inspections:	September 6, 2024, and November 12, 2024
City and/or County of Inspection:	Placerville, CA, El Dorado County
Inspection Purpose:	Investigate public complaint and confirm if PG&E completed the work identified from its Second Patrol inspection.

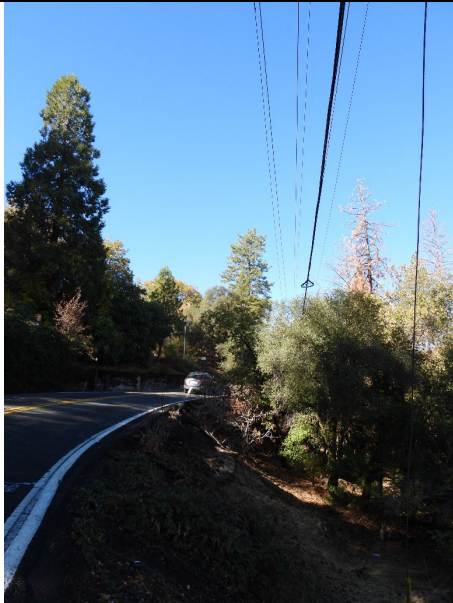
<p>Item1Gimg1: Location of pole ID 121575549 to the east with the first two declining ponderosa pines.</p>	<p>Item1Gimg2: Photograph of Sacramento Street looking to the west toward pole ID 121461981.</p>

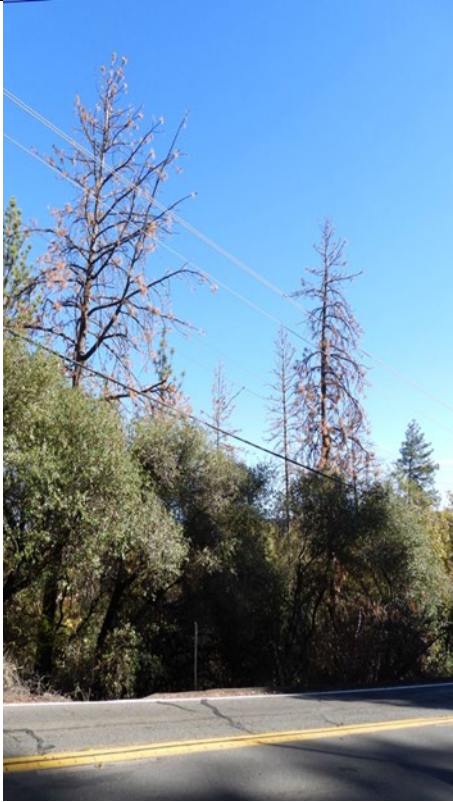
Item1G1mg3: Photo of the second and third pines along Sacramento Street near pole 121424322.

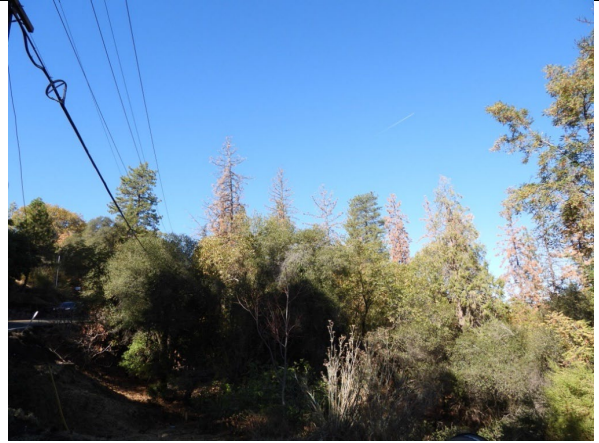
Energy Safety concludes that Violation 1 is classified as "Moderate" because the trees are neither touching the conductors nor leaning in a way that suggests imminent failure, however the trees show signs of decline such as loss of foliage and dead branches which increases fire ignition risk.

Item1IA1mg1: Photograph taken from across the street east from pole ID 121575549. The first tree is north of the conductors at 0.2 span and second, third, and fourth trees are north of the conductors at 0.4 span.

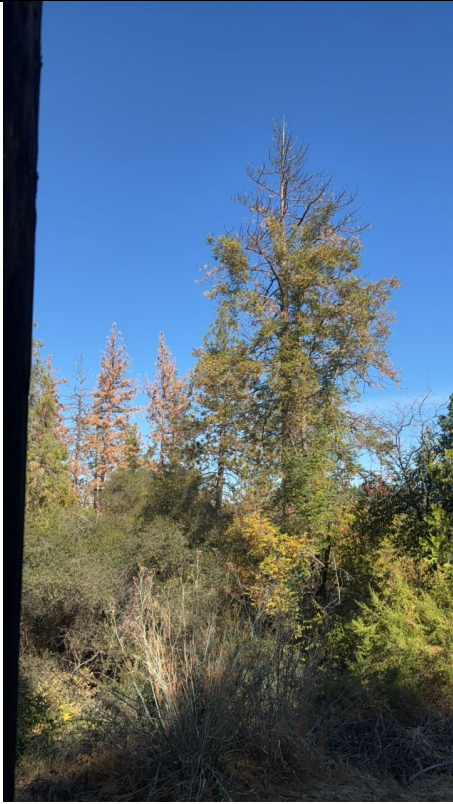
Item1IA1mg2: The five declining trees west of pole ID 121424322.
