NOTICE OF VIOLATION

INSPECTION REPORT

Electrical Corporation:	San Diego Gas & Electric Company
Report Number:	CAD_SDGE_LOK_20241105_1438
Inspector:	Lovepreet Kaur
WMP Year Inspected:	2024
Quarterly Data Report (QDR) Referenced:	Quarter 2 (Q2)
Inspection Selection:	Energy Safety viewed the contents of the Q2 QDR and performed an analysis that resulted in the selection of the WMP initiatives and locations referenced in this report.
Relevant WMP Initiative(s):	8.1.2.10.1 Avian Protection Program (WMP.972)
Date of inspection:	November 5, 2024
City and/or County of Inspection:	Bonsall, San Diego County
Inspection Purpose:	Assess the accuracy of SDG&E’s QDR data, completeness of its work, compliance with WMP requirements, and compliance with its protocols.

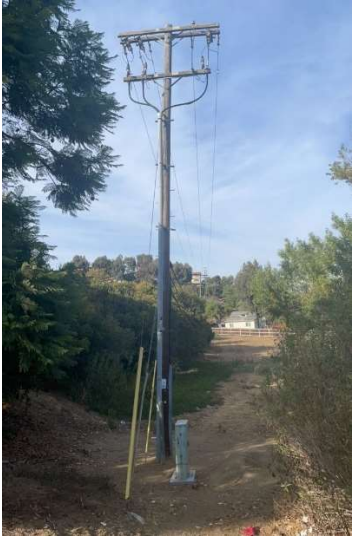
On Pole ID P611012, Grid Hardening ID 530000338845-P611012 at 5768-5768 Camino del Cielo, Bonsall, CA, 92003, USA, 33.29414100199491, -117.20869477988714, the inspector observed that avian protection covers were not installed. The inspector's observation is documented in Violation 1 photographs, which are attachments to this report. Photo numbers Item1G1mg1, Item1G1mg2, Item1IA11mg1, and Item1IA11mg2 depict missing avian protection covers.

Item1G1mg1: Overview of pole

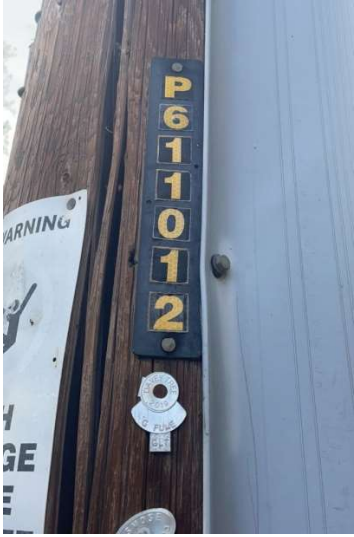
Item1G1mg2: Pole ID

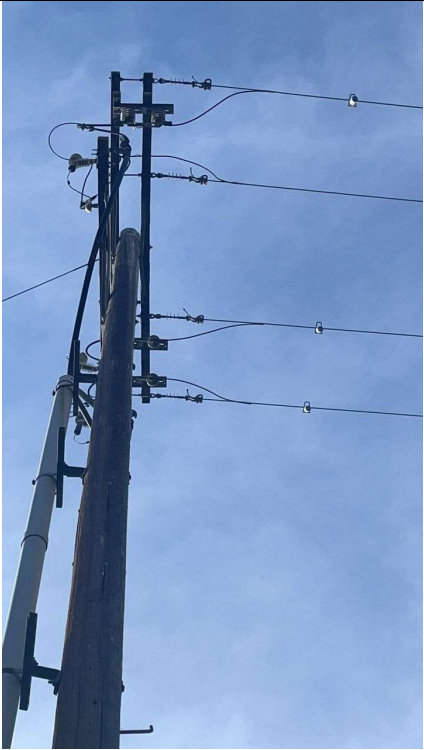
1. The reported location provided by SDG&E indicated that work on the Avian Protection Program (WMP.972, 2023 WMP Initiative 8.1.2.10.1) was reported as completed.
2. Avian protection covers were not installed at the location.

Item1IA1mg1: No avian covers observed

Energy Safety may prescribe a timeframe for resolution of a violation associated with the assigned risk category.² Within 30 days from the issuance date of this NOV, the electrical corporation must provide a response advising Energy Safety of corrective actions taken or planned to remedy the above identified violation(s) and prevent recurrence. Alternatively, the electrical corporation must advise Energy Safety that it will not correct the violation, including the reasoning or justification for inaction and all supporting documentation.³

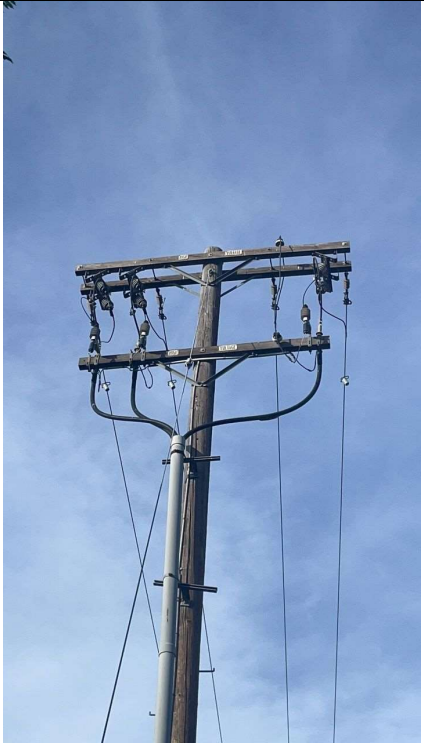
Item1IA1mg2: No avian covers observed
