NOTICE OF VIOLATION

INSPECTION REPORT

Electrical Corporation:	San Diego Gas & Electric Company
Report Number:	CAD_SDGE_LOK_20241009_0839
Inspector:	Lovepreet Kaur
WMP Year Inspected:	2024
Quarterly Data Report (QDR) Referenced:	Quarter 2 (Q2)
Inspection Selection:	Energy Safety viewed the contents of the Q2 QDR and performed an analysis that resulted in the selection of the WMP initiatives and locations referenced in this report.
Relevant WMP Initiative(s):	8.1.2.10.1 Avian Protection Program (WMP.972)
Date of inspection:	October 9, 2024
City and/or County of Inspection:	El Cajon, San Diego County
Inspection Purpose:	Assess the accuracy of SDG&E’s QDR data, completeness of its work, compliance with WMP requirements, and compliance with its protocols.

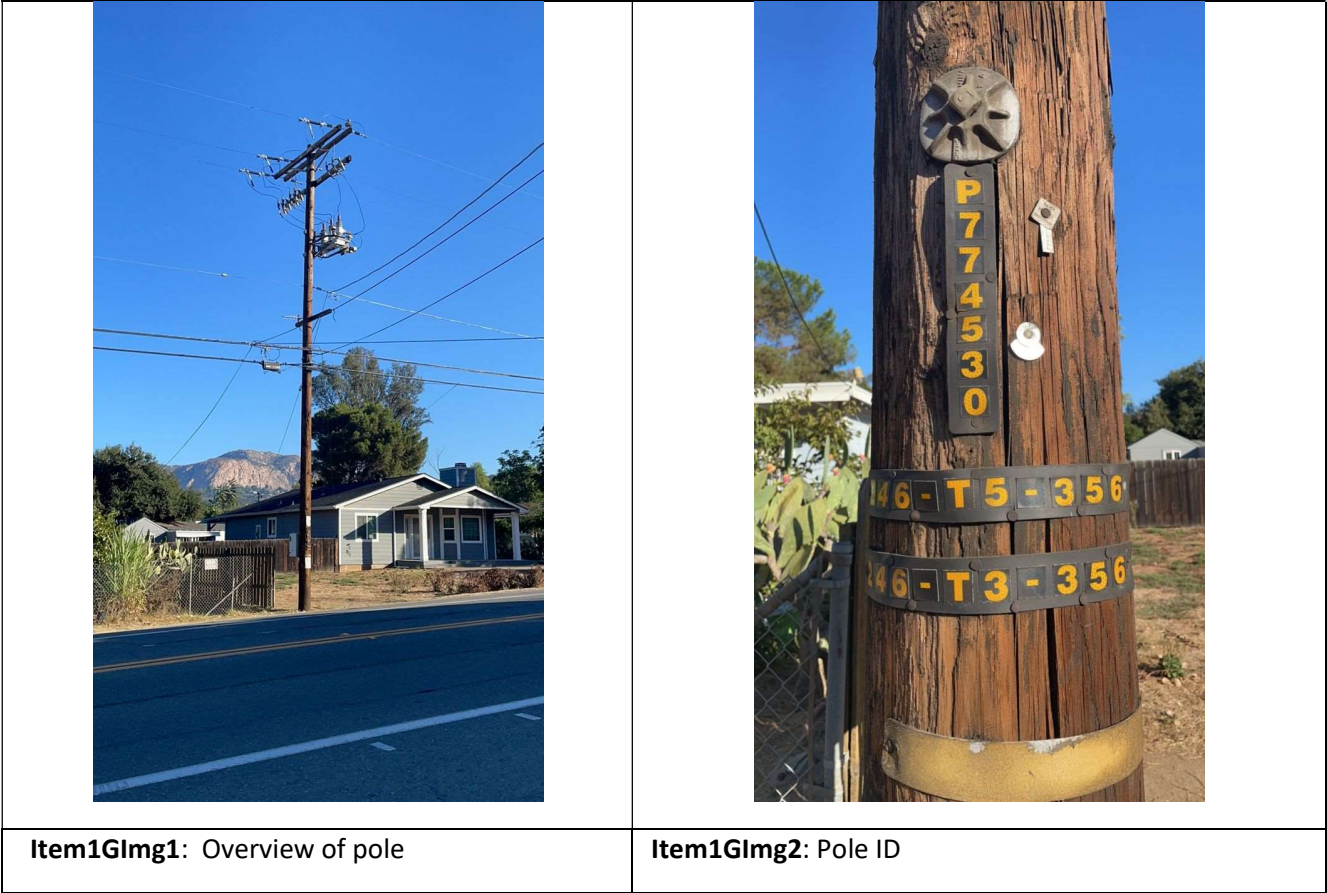
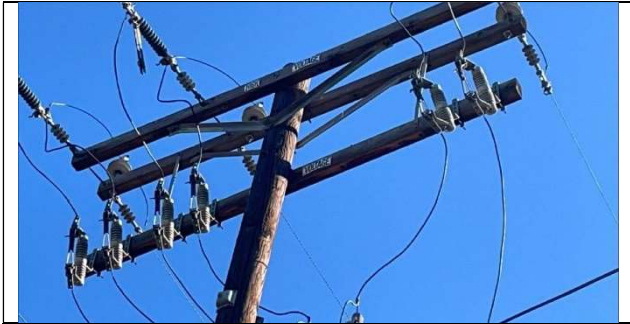
On Pole ID P774530, Grid Hardening ID 530000350444-P774530 at 15540 Olde Highway 80, El Cajon, CA, 92021, USA, 32.85614745479225, -116.83653518468476, the inspector observed that avian protection covers were not installed. The inspector's observation is documented in Violation 1 photographs, which are attachments to this report. Photo numbers Item1G1mg1, Item1G1mg2, Item1IA11mg1 depict that no avian protection covers were installed.

Item1IA1Img1: No avian protection covers
