NOTICE OF VIOLATION

On July 11, 2024, Energy Safety conducted an inspection of Liberty Utilities' WMP initiatives in the vicinity of the city of Homewood, California. The inspection report is enclosed herewith. Energy Safety found the following violation(s):

INSPECTION REPORT

Electrical Corporation:	Liberty Utilities
Report Number:	CADLU_CAC22_20240711_1406
Inspector:	CAC22
WMP Year Inspected:	2023
Quarterly Data Report (QDR) Referenced:	Quarter 4 (Q4)
Inspection Selection:	Energy Safety viewed the contents of the Q4 QDR and performed an analysis that resulted in the selection of the WMP initiatives and locations referenced in this report.
Relevant WMP Initiative(s):	8.1.2.1 Covered Conductor Installation
Date of inspection:	July 11, 2024
City and/or County of Inspection:	Homewood, Placer County
Inspection Purpose:	Assess the accuracy of Liberty Utilities' QDR data, completeness of its work, compliance with WMP requirements, and compliance with its protocols.

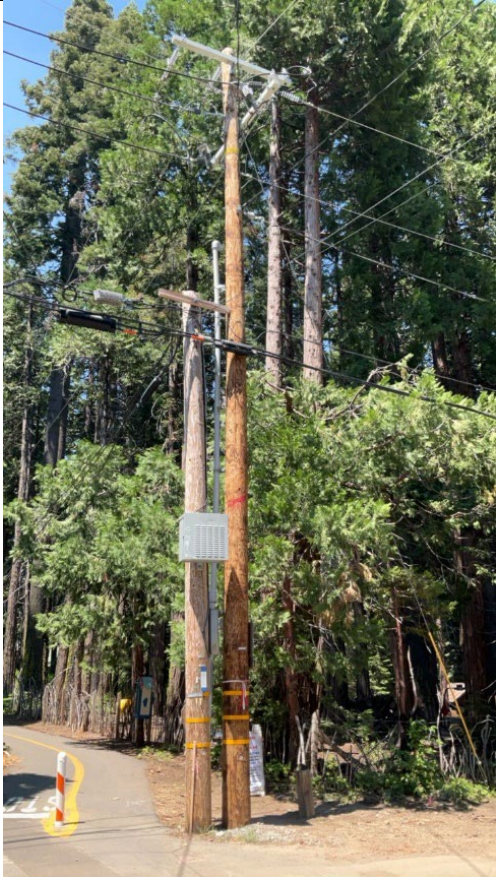
On Pole ID 296777, Grid Hardening ID TAH7300 Phase 8, at 5485 W. Lake Blvd, Homewood, CA, 96141, USA, the inspector observed that covered conductor did not continue to the north. The covered conductor installation stopped at pole ID 296777. LU reported that covered conductor was installed at this pole and continued to the next pole in the northern direction. Covered conductor was not installed in the northern direction. The inspector's observation is documented in Violation 1 photographs, which are attachments to this report. Photo numbers Item1GImg1, Item1GImg2, and Item1IA1Img2 depict that the covered conductor installed at the location did not continue to the north as indicated by Liberty in its QDR submission.

1. Liberty Utilities' 2023 WMP Covered Conductor Installation (8.1.2.1) work was identified as completed at this location.
2. Covered conductor was not installed to the north of pole ID 296777 as reported.

Item1Gimg2: Overall Pole, showing that covered conductor was not installed in a northerly direction from the pole as reported in the QDR.

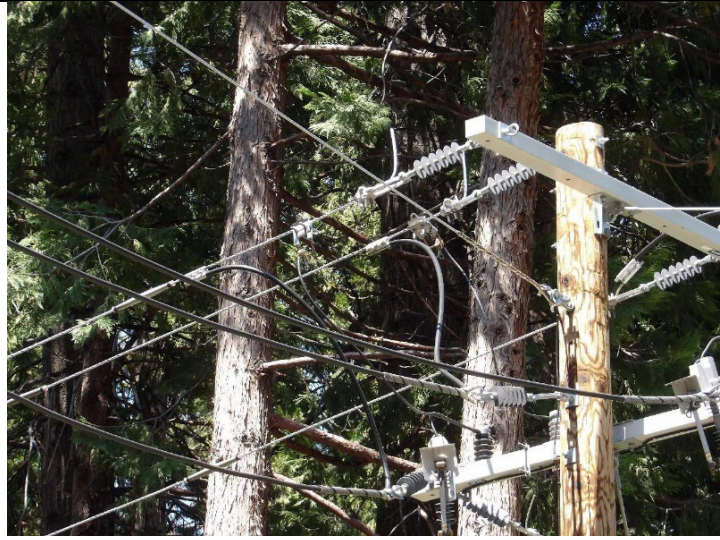
Item1IA1Img2: No Covered Conductor Present on Top Span
