February 20, 2025

Patrick Doherty
Program Manager | Compliance Assurance Division
Office of Energy Infrastructure Safety
715 P Street, 20th Floor
Sacramento, CA 95814

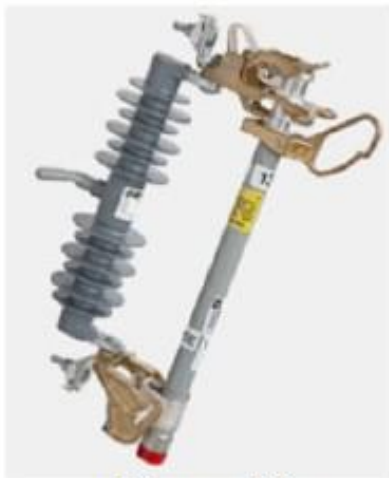
The exempt fuses are shown hanging on the poles steps and conform to PG&E guidance document 15225 (1.C.1) for care and handling of Type E Power fuses. As shown in Image 1 and Image 2 below, both the Part63H cutout and the Type E Power Fuse have distinct features that distinguish them from Part 44H cutouts and the non-exempt universal fuses they can accept. Part63H cutouts are noticeably larger than Part 44H cutouts and the Type E Power Fuses have an oblong ring to support installation and removal. Another identification characteristic is the cap installed on the bottom of the fuse and the absence of a visible fuse element exiting the fuse holder.
