NOTICE OF VIOLATION

Violation 1. Energy Safety observed that in implementing 2024 WMP initiative 8.1.2.10.5 – Non-Exempt Expulsion Fuses, PG&E failed to complete work on pole ID 121601516, Grid Hardening ID 31660981, at coordinates 38.97146345757337, -121. 01969665625211. Energy Safety considers this completeness violation to be in the Minor risk category.

INSPECTION REPORT

Violation 1

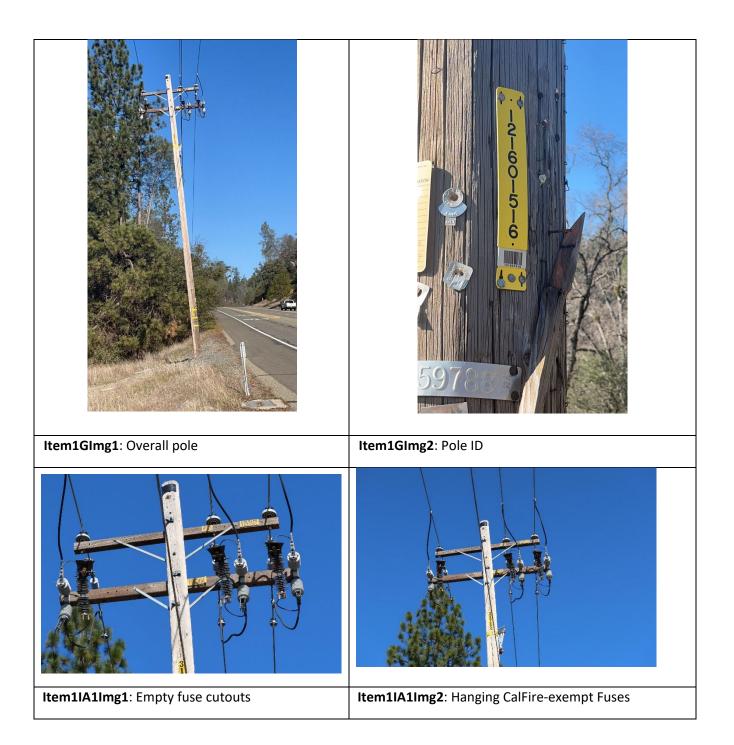
Exhibit A: Photo Log Structure ID: 121601516 Violation 1

On pole ID 121601516, Grid Hardening ID 31660981 at 15819-15823 Placer Hills Road, Meadow Vista, CA, 95722, USA, 38.97146345757337, -121. 01969665625211, the inspector observed that the CalFire-exempt fuses were not attached to the cutouts. The inspector's observation is documented in Violation 1 photographs, which are attachments to this report. Photo numbers Item1GImg1, Item1GImg2, Item1IA1Img2, Item1IA1Img2, depict incomplete installation of CalFire-exempt fuses. PG&E reported that work on WMP initiative 8.1.2.10.5 – Non-Exempt Expulsion Fuses was completed at this location.

1. The CalFire-exempt fuses were not attached to the cutouts.
