May 13, 2025

Shinjini Menon
Vice President, Asset Management and Wildfire Safety
Southern California Edison Company
2244 Walnut Grove
Rosemead, CA 91770

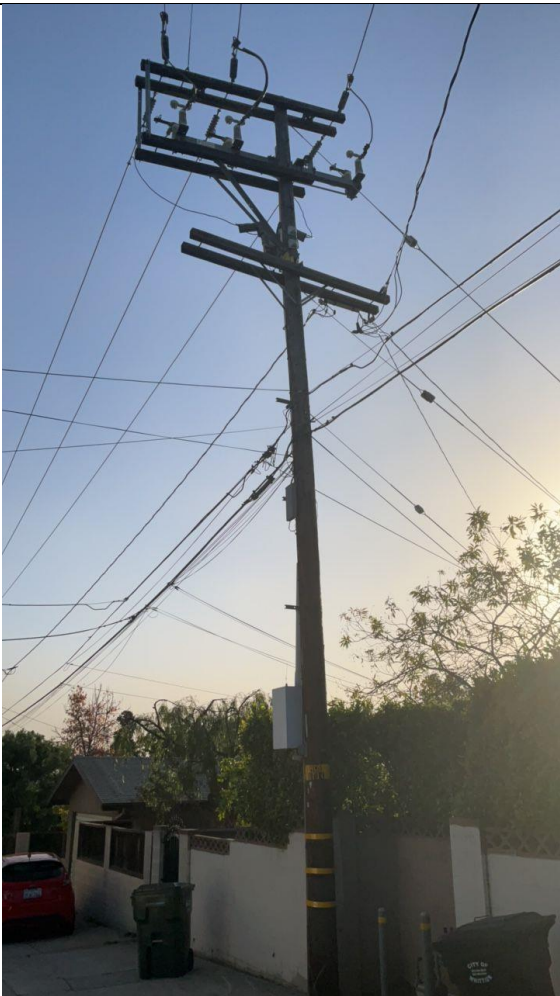
Item1GImg1: Overall pole.
