NOTICE OF VIOLATION

INSPECTION REPORT

Electrical Corporation:	Southern California Edison Company
Report Number:	CAD_SCE_CAC20_20241114_1328
Inspector:	CAC20
WMP Year Inspected:	2024
Quarterly Data Report (QDR) Referenced:	Quarter 2 (Q2)
Inspection Selection:	Energy Safety reviewed the contents of the Q2 QDR and performed an analysis that resulted in the selection of the WMP initiatives and locations referenced in this report.
Relevant WMP Initiative(s):	8.1.2.1.1 Covered Conductor (SH-1)
Date of inspection:	November 14, 2024
City and/or County of Inspection:	Grand Terrace, San Bernardino County
Inspection Purpose:	Assess the accuracy of Southern California Edison Company's QDR data, completeness of its work, compliance with WMP requirements, and compliance with its protocols.

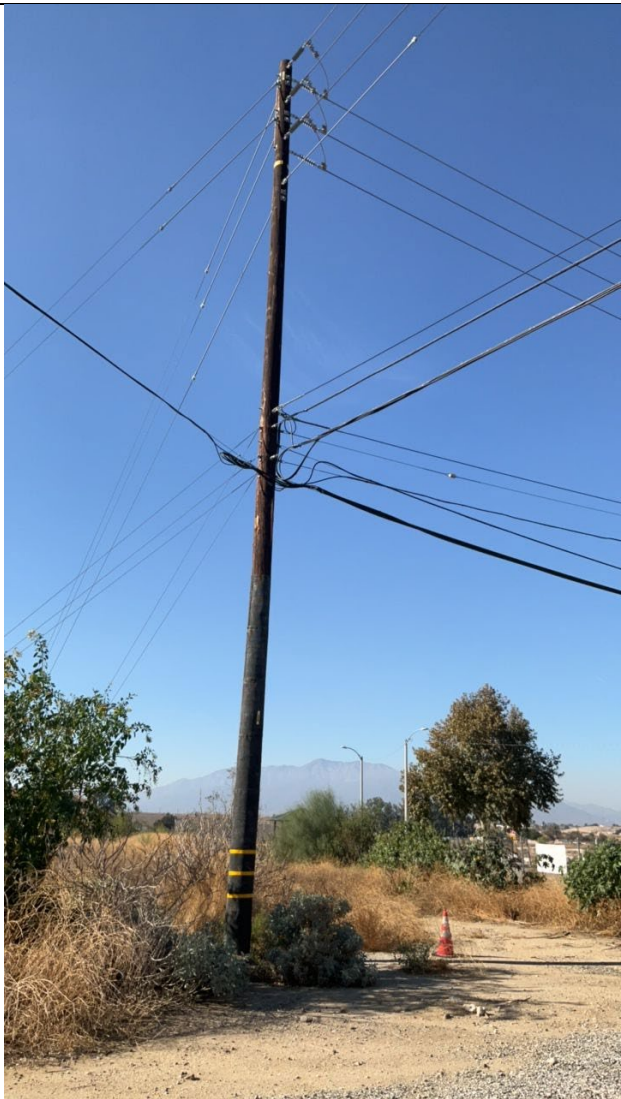
On pole ID 7723E, Grid Hardening ID TD2071094-7723S, at 11918-11926 La Cadena Dr, Grand Terrace, CA, 92313, USA, coordinates 34.043943, -117.332007, the inspector observed that no covered conductor was present. The inspector's observation is documented in Violation 1 photographs, which are attachments to this report. Photo numbers Item1GImg1, Item1GImg2, Item1IA1Img1, and Item1IA1Img2 depict that no covered conductor was installed at the location.

Item1GImg2: Overall pole.

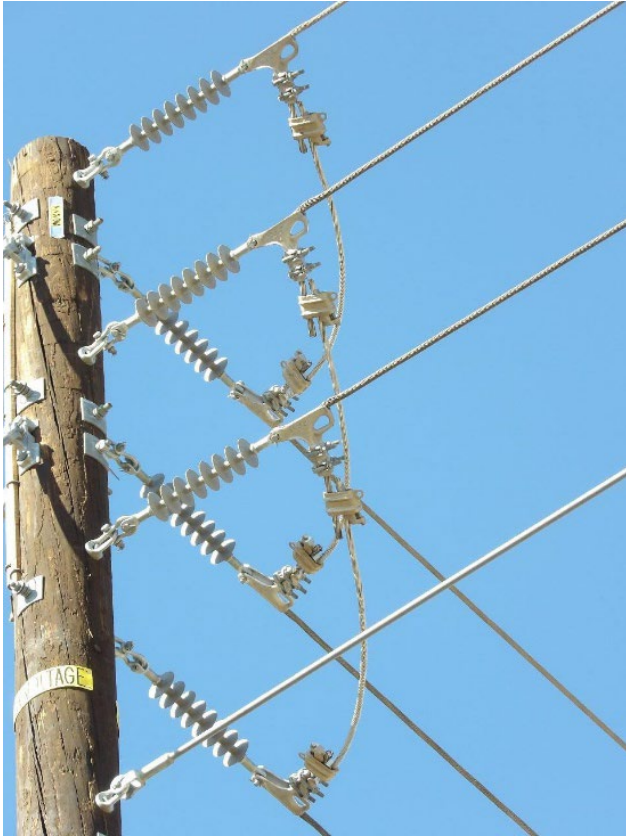
1. Southern California Edison Company's 2024 WMP Covered Conductor (8.1.2.1.1) work was identified as complete at this location.
2. Covered conductor was not installed.

Item1IA1Img1: View of bare conductor with no covered conductor present.

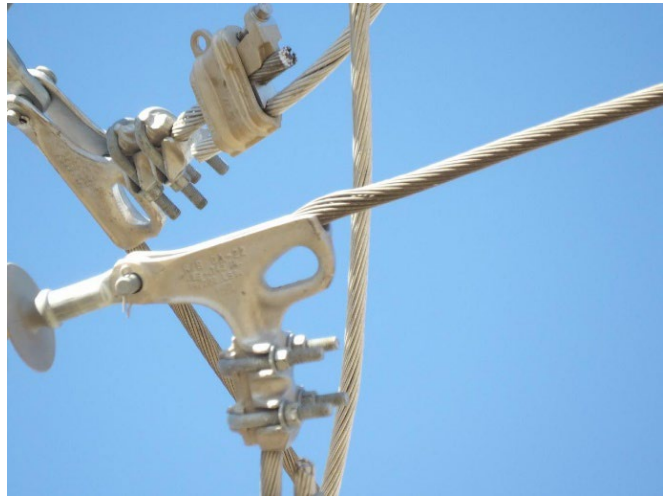
Item1IA1Img2: Close-up view of bare conductor with no covered conductor present.
