Jerrod Meier Director Electric Compliance 300 Lakeside Drive Oakland, CA 94612 **E-mail:** Jerrod.Meier@pge.com

May 23, 2025

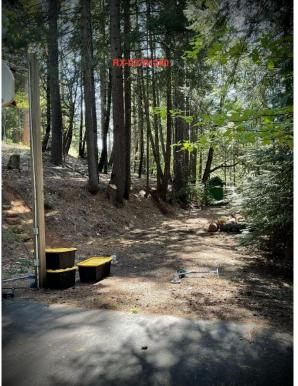
1) Site Clean Up occurred on 05/08/2025 as shown in Image 1 below.
