NOTICE OF VIOLATION

On March 25, 2025, Energy Safety conducted an inspection of PG&E's WMP initiatives in the vicinity of the city of Hat Creek, California. The inspection report is enclosed herewith. Energy Safety found the following violation(s):

Violation 1. Energy Safety observed that in implementing 2024 WMP initiative 8.1.2.5.1 - Traditional Overhead Hardening - Transmission Conductor, PG&E failed to adhere to data accuracy on pole ID 011/228, Grid Hardening ID 74057080-2 at coordinates 40.829510, -121.382330.

INSPECTION REPORT

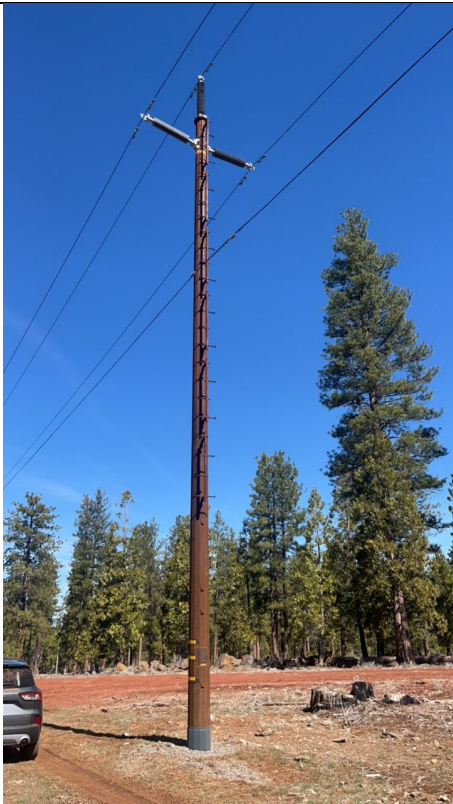
A close-up photograph of the side of a weathered wooden utility pole. A yellow identification tag is attached to the pole, displaying the number '1' on the top line and '228' on the bottom line. The background shows a blue sky with some clouds and the tops of trees.
<p>Item1GImg1: Overall Pole and Spans</p>	<p>Item1GImg2: Pole ID</p>

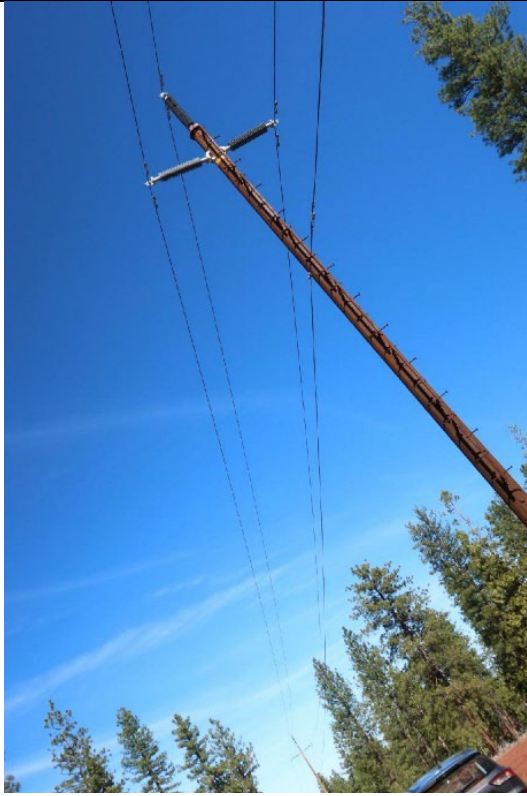
On pole ID 011/228, Grid Hardening ID 74057080-2 at Pole Line Rd, Hat Creek, CA, 96040, USA, 40.829510, -121.382330, the inspector observed that no shunts or splices were present on the spans on both sides of the pole. The inspector's observation is documented in Violation 1 photographs, which are attachments to this report. Photo numbers Item1GIImg1, Item1IA1Img1, and Item1IA1Img2 depict no existing splice or shunt on the incoming or outgoing spans. For Grid Hardening ID 74057080-2, PG&E reported completed work under WMP tracking ID GH-06 at the location, with the Description of Work field reading "Shunt Splice Installation."

1. No splice or shunt were present on the spans on both sides of the pole 011/228.

Item1IA1Img1: One of the spans with no existing splice

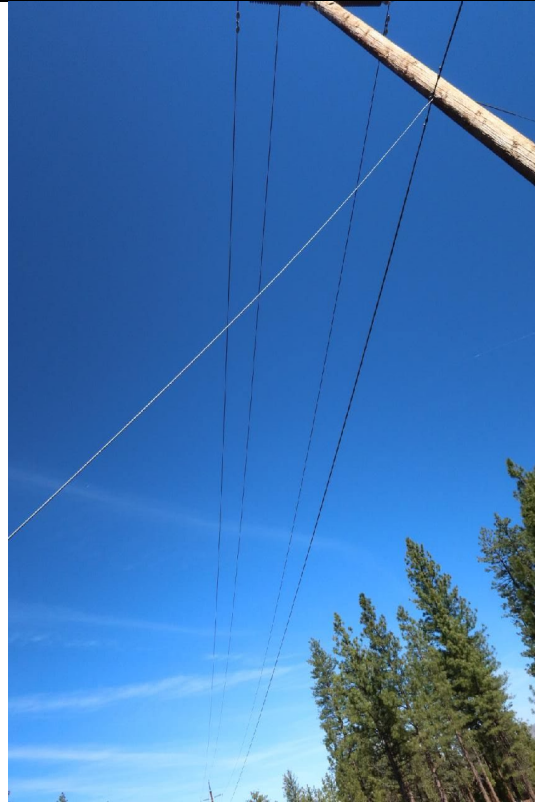
Item1IA1Img2: Other span with no existing splice
