September 11, 2025

Shinjini Menon  
Vice President, Asset Management and Wildfire Safety  
Southern California Edison Company  
2244 Walnut Grove  
Rosemead, CA 91770

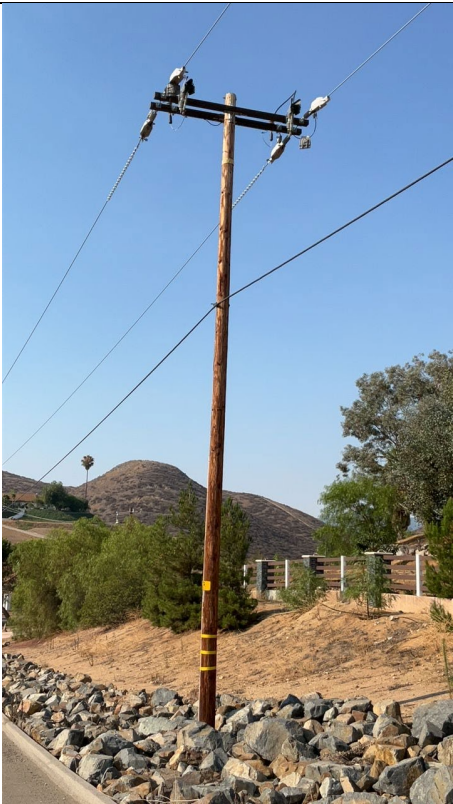
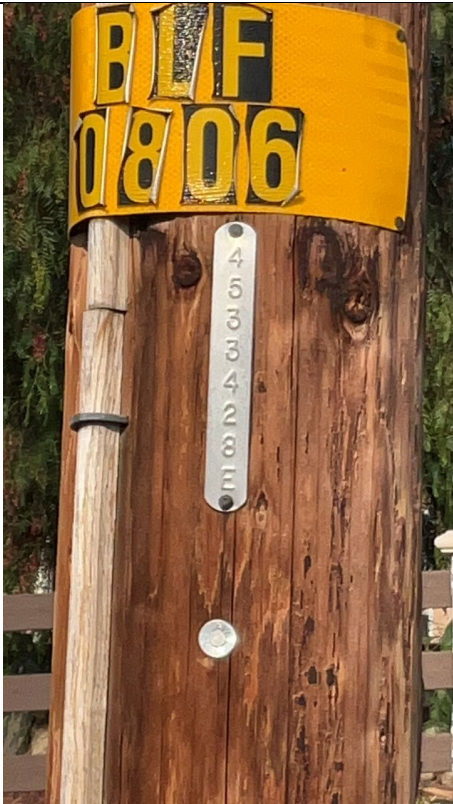
| <p><b>G1mg1:</b> Overall Structure</p> | <p><b>G1mg2:</b> Structure ID</p> |
