September 15, 2025

Shinjini Menon
Vice President, Asset Management and Wildfire Safety
Southern California Edison Company
2244 Walnut Grove
Rosemead, CA 91770

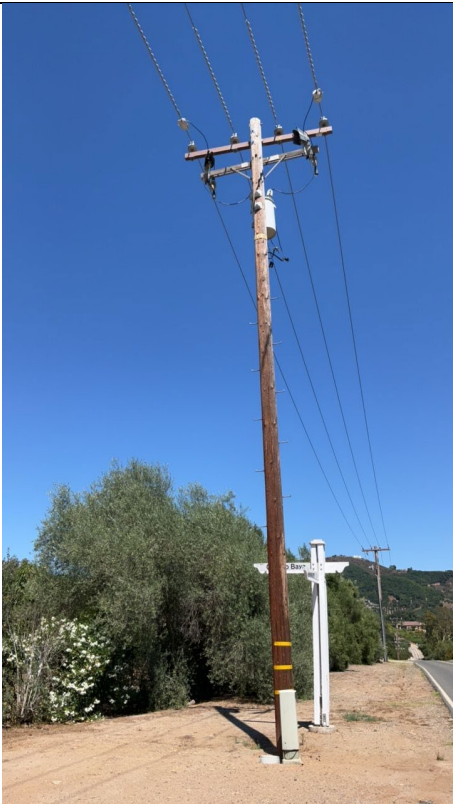
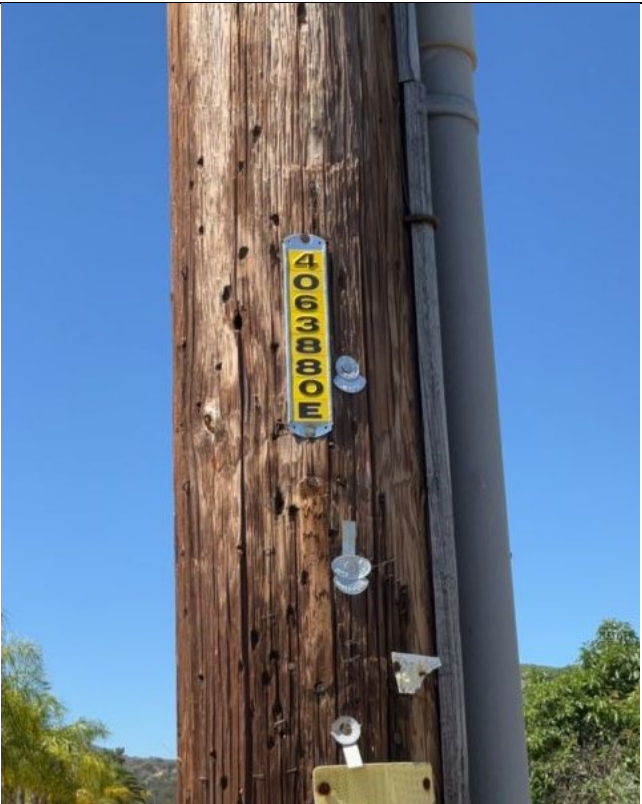
<p>G1mg1: Overall Structure</p>	<p>G1mg2: Structure ID</p>
