SUBJECT: Southern California Edison Company's Response to Notice of Violation
NOV_CAD_SCE_SIS_20250708_1316

Finding: Completeness

Notice	Violation	Structures
NOV_CAD_SCE_SIS_20250708_1316	1	2343288E

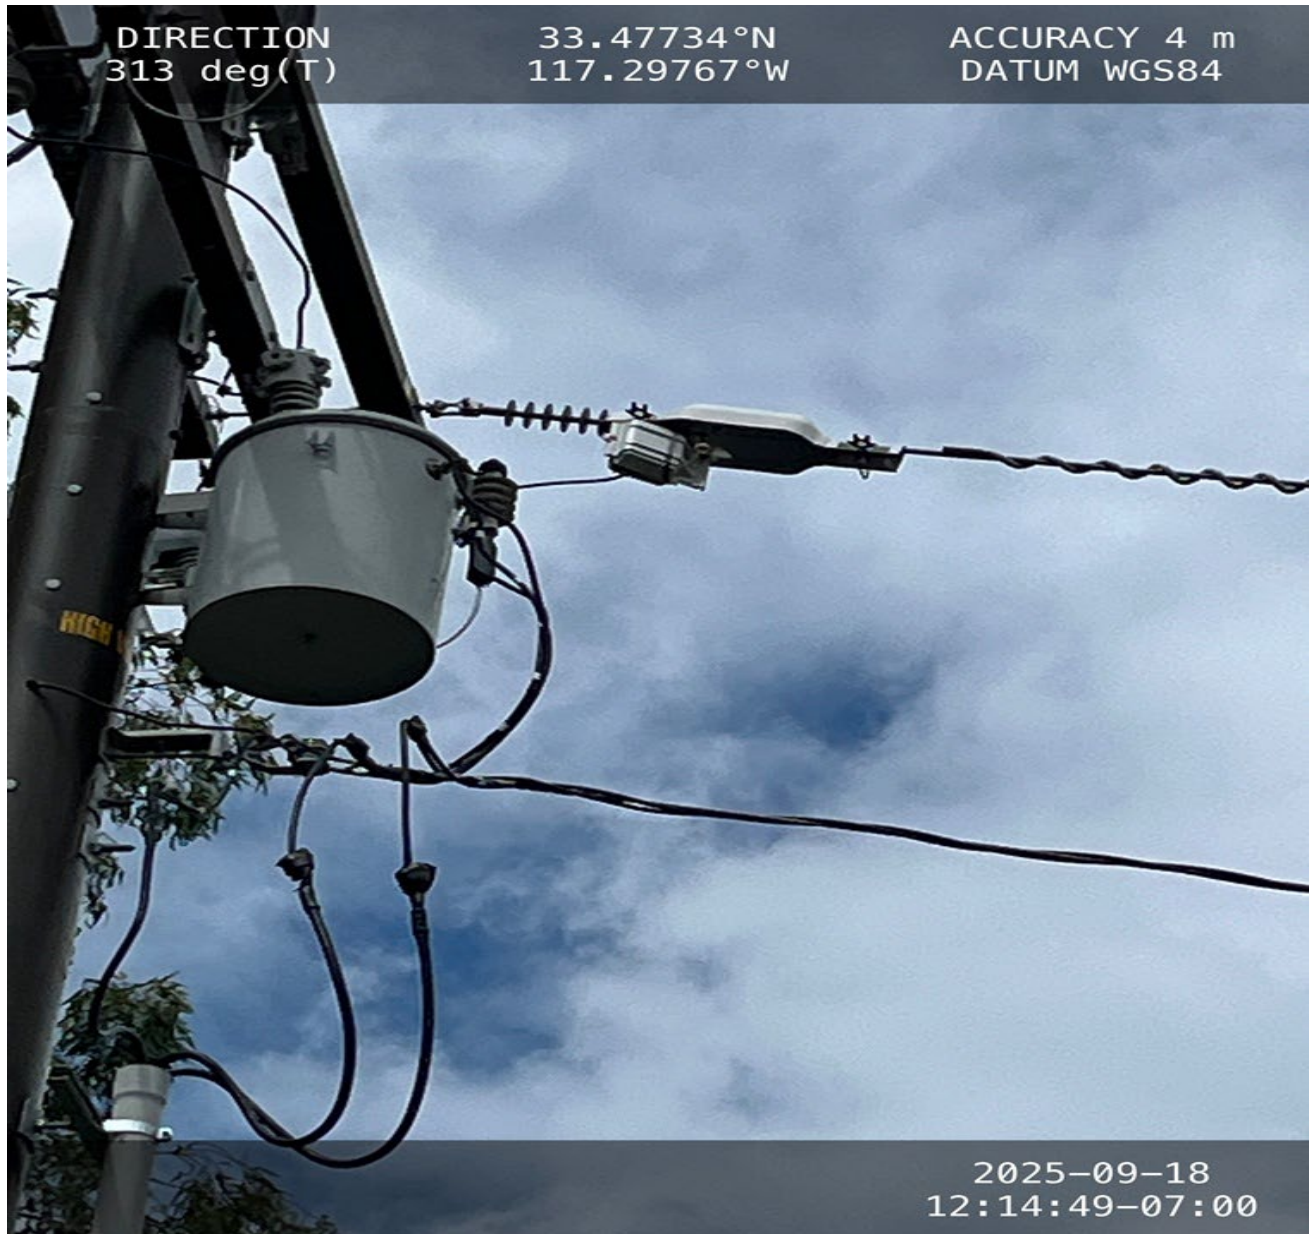
SCE confirms that the unhinged avian protection on the transformer bushings on structure ID 2343288E was remediated on October 7, 2024. During a subsequent inspection in response to this Notice, SCE's Field Operations team identified that the previously installed avian protection on the transformer bushings had become dislodged

likely due to environmental exposure or other external factors. On September 18, 2025, SCE personnel secured the avian protection on the transformer bushings on structure 2343288E once again. Please find the photo evidence below of the most recently completed transformer bushing remediation.
