**SUBJECT:** Southern California Edison Company's Response to Notice of Violation  
NOV\_CAD\_SCE\_SIS\_20250708\_1348

### **Finding: Completeness**

<b>Notice</b>	<b>Violation</b>	<b>Structures</b>
NOV_CAD_SCE_SIS_20250708_1348	1	2064582E

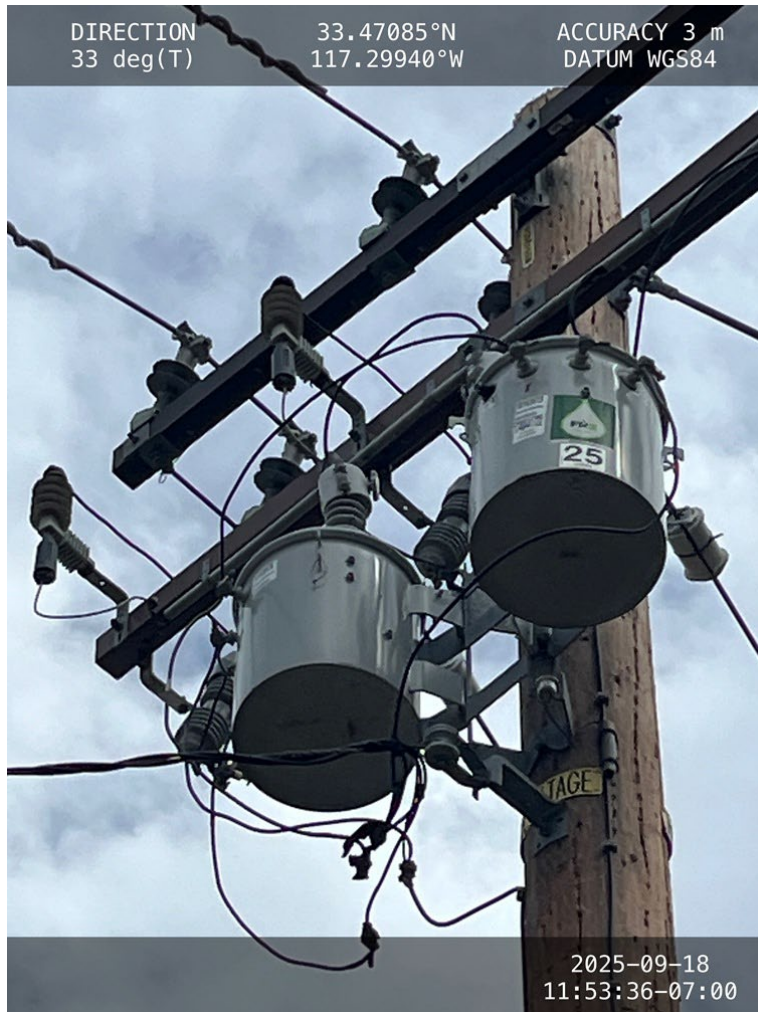
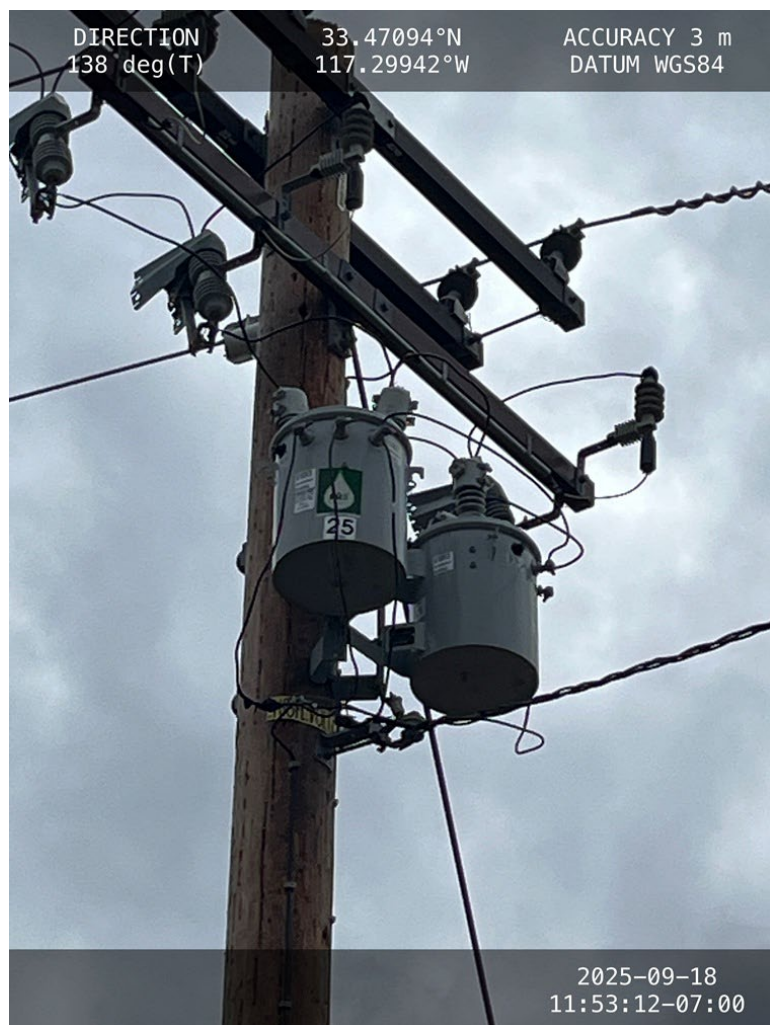
SCE confirms that the unhinged avian protection on the transformer bushings on structure ID 2064582E was remediated on October 7, 2024. During a subsequent inspection in response to this Notice, SCE's Field Operations team identified that the previously installed avian protection on the transformer bushings had become dislodged

likely due to environmental exposure or other external factors. On September 18, 2025, SCE personnel secured the avian protection on the transformer bushings on structure

064582E once again. Please find the photo evidence below of the most recently completed avian protection on the transformer bushings remediation.
